Case report

An Interesting Case of Osteolysis With Accompanying Metallosis in a Primary Total Knee Arthroplasty

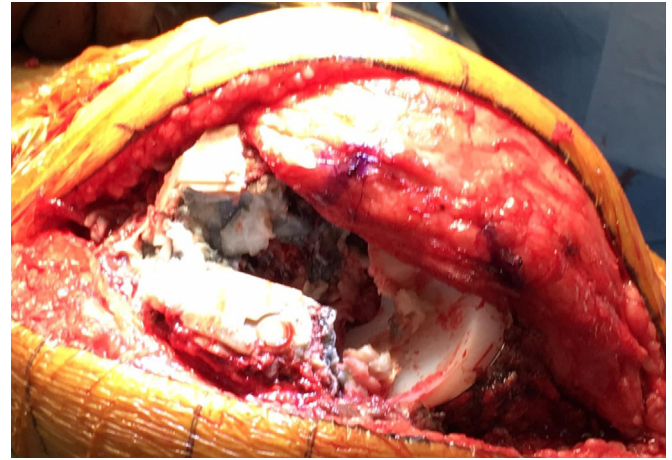
At the time of revision surgery, prominent synovitis was noted throughout the knee joint. The femoral component was found to be grossly loose and therefore removed with minimal effort. There was significant bone loss in the area of the lateral femoral condyle. This region contained unusual gray metallic fibrinous tissue prompting several samples to be sent for histopathologic analysis. In addition, there was complete loss of the lateral stabilizing soft-tissue structures of the knee including the lateral joint capsule, lateral collateral ligament, popliteus tendon, and most of the Iliotibial band (Figs. 2 and 3). After debriding all nonviable fibrinous tissues, a large uncontained defect (50 mm × 40 mm × 20 mm) remained in the area of the lateral femoral condyle. Extensive bone loss also extended medially into the lateral portion of the intercondylar region of the distal femur. Lesser bone loss was also noted at the posterior medial femoral condyle.

Figure 2. Intraoperative lateral view depicting gray and white fibrous material in the region of the lateral femoral condyle after removal of femoral implant.

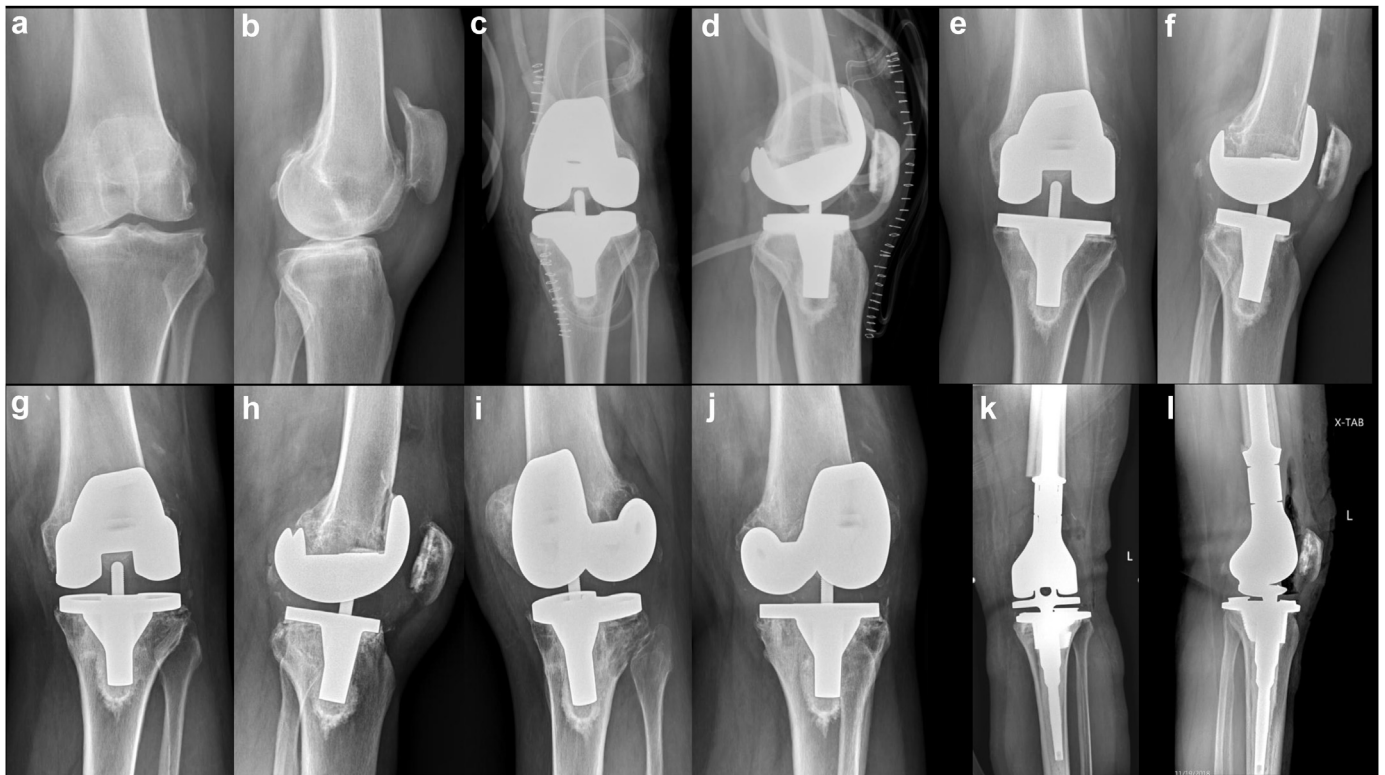
Surveillance radiographs 7 years later revealed progressive osteolysis and worsening signs of knee instability (Fig. 1). Varus collapse of the tibial baseplate and obvious loosening of the knee prosthesis prompted computed tomography (CT) evaluation which denoted large voids of osteolysis within the distal femur and proximal tibia. Thus, the decision was made to proceed with a revision TKA after infection workup was negative.

Figure 1. Radiographs: Preoperative anteroposterior (a) and lateral (b) views. Immediate postoperative anteroposterior (c) and lateral (d) views. Five-year postoperative anteroposterior (e) and lateral (f) views. Seven-year postoperative anteroposterior (g), lateral (h), and oblique views (i and j). Note the gradual varus migration of the tibial and femoral components and progressive bone loss around the lateral femoral condyle and lateral tibial plateau. Postoperative anteroposterior (k) and lateral (l) views of the revision surgery to a distal femoral replacement.

After careful removal of the tibial baseplate, a contained defect (25 mm × 20 mm × 20 mm) was noted in the area of the lateral tibial plateau. Again metallic-stained fibrinous tissues were debrided from the defect and sent for analysis. The decision was made to proceed with a cemented distal femoral replacement given the extensive loss of lateral femoral condyle and supporting capsuloligamentous structures (Fig. 1). The patient had an uneventful recovery process, and she continues her rehabilitation program focusing on functional balance and endurance exercises 18 months after revision surgery.

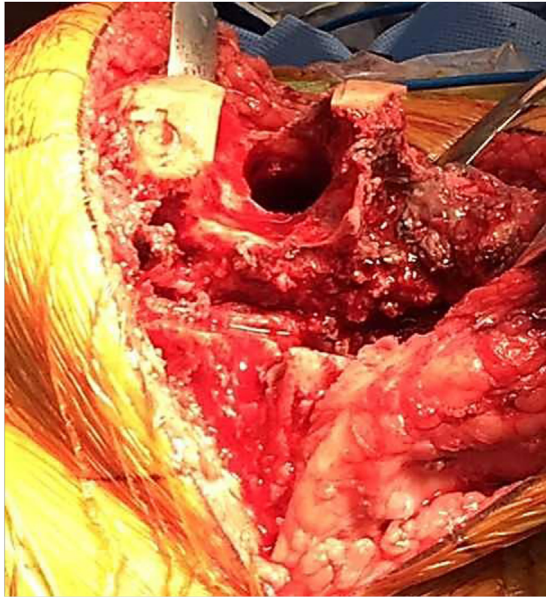
Figure 3. Intraoperative anterior view of the distal femur demonstrating complete loss of lateral femoral condyle after debridement of nonviable fibrous tissue.

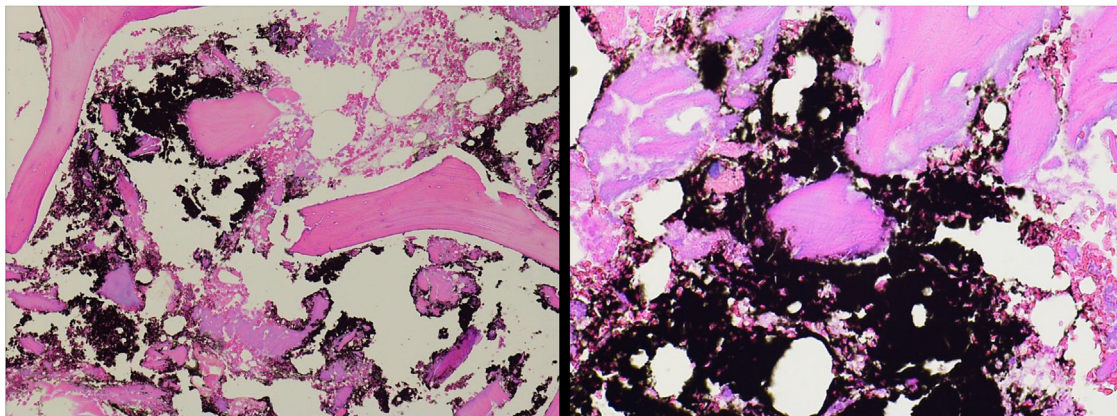
Intraoperative cultures failed to isolate bacteria. Histopathologic analysis confirmed tissue fibrosis with histiocytic proliferation with black-pigmented debris consistent with metallosis (Fig. 4). Laboratory analysis of the explanted components was performed to determine the root cause of the metallosis present in the peri-prosthetic tissues.

Figure 4. Representative histology samples from the fibrous tissue collected from the lateral femoral condyle displaying benign bone fragments with areas of remodeling and fibrosis among black pigmented debris material. (left 100x; right 200x).

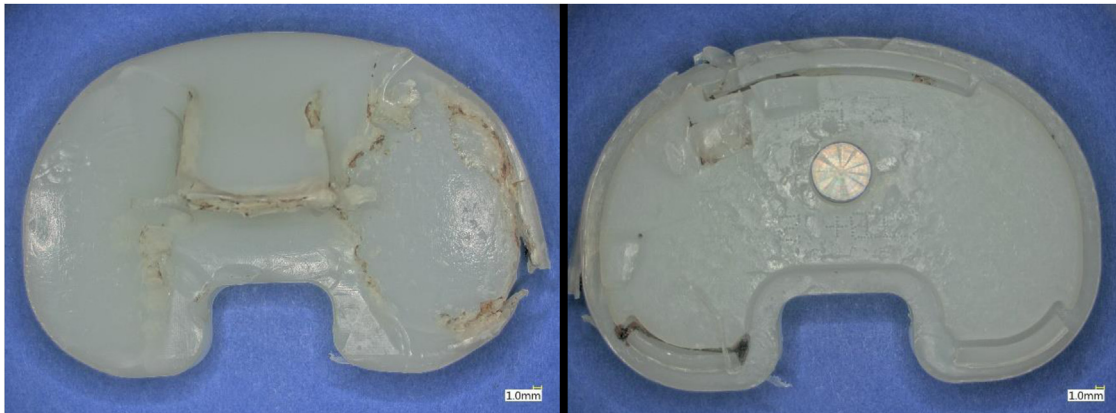
Visual assessment of the PE component revealed signs of wear, burnishing, and local delamination (Fig. 5). The damage of the bearing surface of the PE was more extensive on the medial aspect than the lateral. There was evidence of impingement between the PE component and the femoral box given the extent of damage noted along the anteromedial aspect of the PE post. Inspection of the backside of the PE component also exhibited signs of wear (Fig. 6). These wear findings are most consistent with rotational instability.

Figure 5. Representative images of the bearing surface and backside of the retrieved tibial insert in this case.

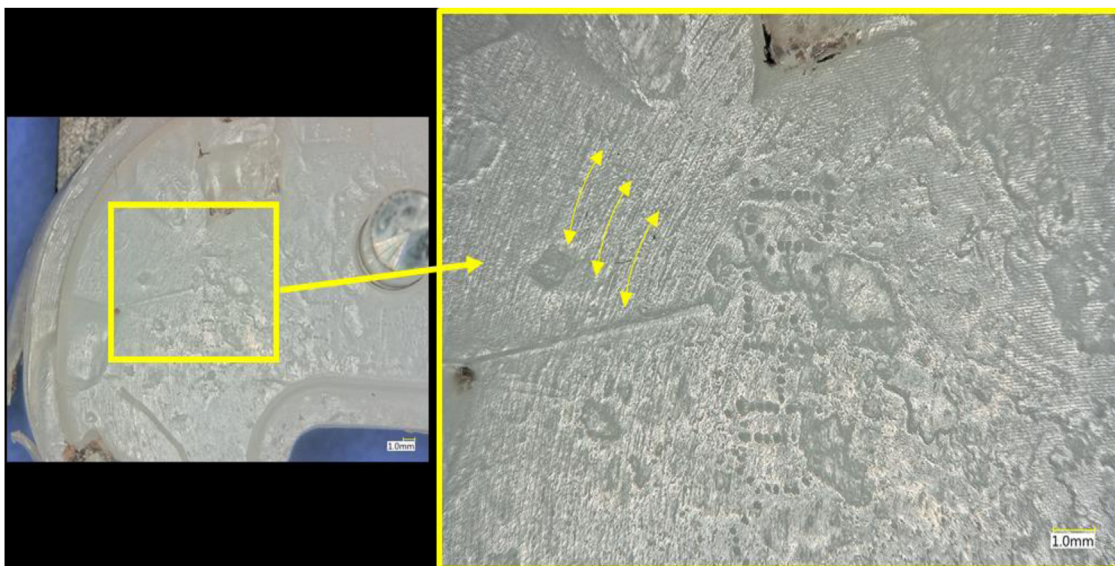
Figure 6. Optical micrographs of the PE component backside, showing evidence of wear that is consistent with rotational motion of the PE component against the CoCr baseplate. Yellow arrows indicate direction of rotational wear.

The backside burnishing and wear of the PE indicates movement of the component relative to the baseplate and corroborates the observed surface damage of the reinforcing pin. PE wear can occur on both the articular surface (in contact with the femoral component) and the backside (in contact with the tibial baseplate) [2]. The wear at the articular surface of PE occurs primarily through abrasion and adhesion mechanisms during loading and articulation of the knee joint, while the undersurface of the PE wears due to micromotion between the PE and the tibial baseplate [2,12].

The observed backside wear, while lesser in apparent magnitude than that of the articular surface, exhibited signs of rotational motion which supports the hypothesis of biomechanical instability [2,12]. Backside wear occurs as a result of micromotion between the PE component and tibial baseplate and is contingent upon the design of the locking mechanism to mitigate micromotion and, to a lesser extent, the surface roughness of the tibial baseplate [12]. In this case, the relative contributions to micromotion of the abnormal

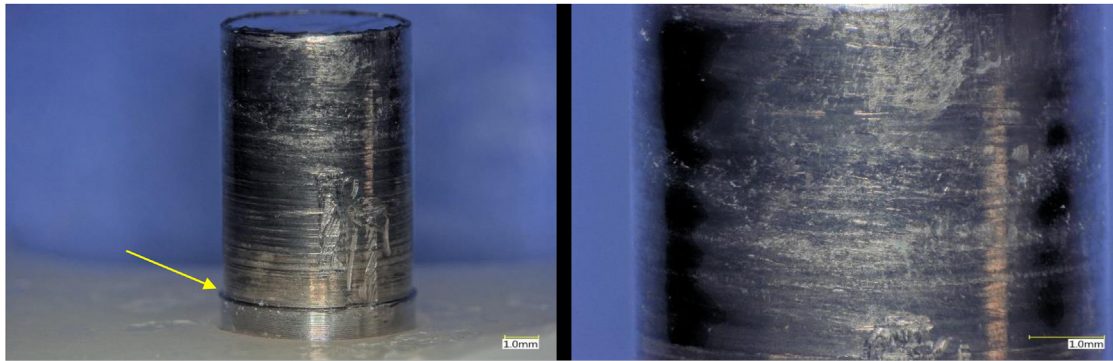
Optical microscopy of the pin contained within the PE component showed that there was extensive abrasion and material loss due to wear while assembled within the tibial component (Fig. 7). It was unclear if some of the features and overall appearance of the pin were consistent with corrosion after visual inspection.

Figure 7. Optical micrographs of the Ti post within the tibial insert. There is a clear region of material loss (yellow arrow).

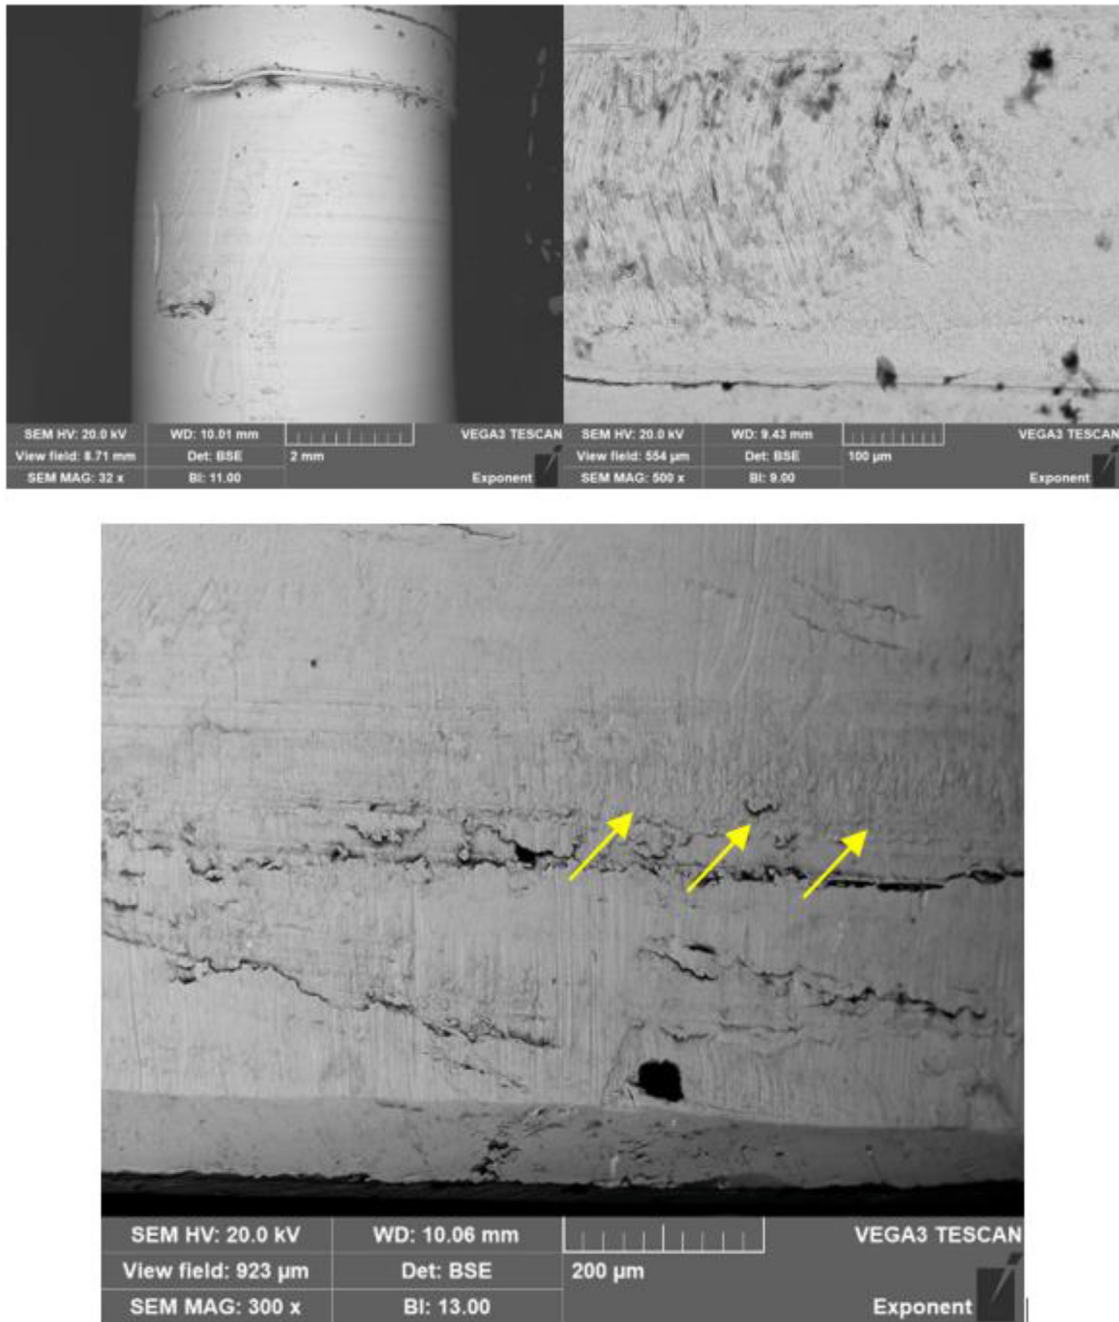
Scanning electron microscopy (SEM) and energy dispersive x-ray spectroscopy (EDS) verified if the nature of the damage to the pin was primarily mechanical (Fig. 8). The surface of the pin, within the section of material loss, had localized regions consistent with fretting. In addition, some larger scale mechanical damage was noted, which may be consistent with either insertion or removal of the PE component during the index procedure or at the time of revision surgery, respectively. Importantly, there was no apparent evidence of material transfer between the pin and the accompanying receiving feature on the tibial baseplate. There was localized evidence of mechanically assisted corrosion damage on the distal region of the pin. This, however, appeared to be outweighed by the magnitude of the material loss that could be attributed to larger scale relative motion between the pin and baseplate. The damage mechanisms observed in the backside surface of the PE indicate that there was likely both axial and torsional components to the micromotion, both from the observed fretting and marks on the reinforcement pin and from the wear patterns observed on the condylar bearing surfaces of the PE insert (Fig. 8, top right).

EDS mapping of the pin did not reveal evidence of oxygen in the areas investigated, which would be expected if there had been any accumulation of oxide due to corrosion. Rather, the majority of the elemental composition of the interrogated areas were Ti, aluminum (Al), and vanadium (V), as would be expected from a Ti alloy consistent with the manufacturer specifications [7]. This further supports that mechanically assisted corrosion, although it may have occurred locally, was not the primary mechanism responsible for the magnitude of material loss from the pin. EDS analysis again demonstrated that there was no evidence of transfer of cobalt-

Figure 8. Representative SEM images of the anterior aspect of the metallic post using backscattered imaging. Top left: There is a visible transition between the as-manufactured region and region of apparent material loss on the pin (32x). Top right, bottom: higher magnification images (500x, 300x) of the region of material loss. In the bottom image, the yellow arrows indicate a localized region of mechanically assisted corrosion damage.

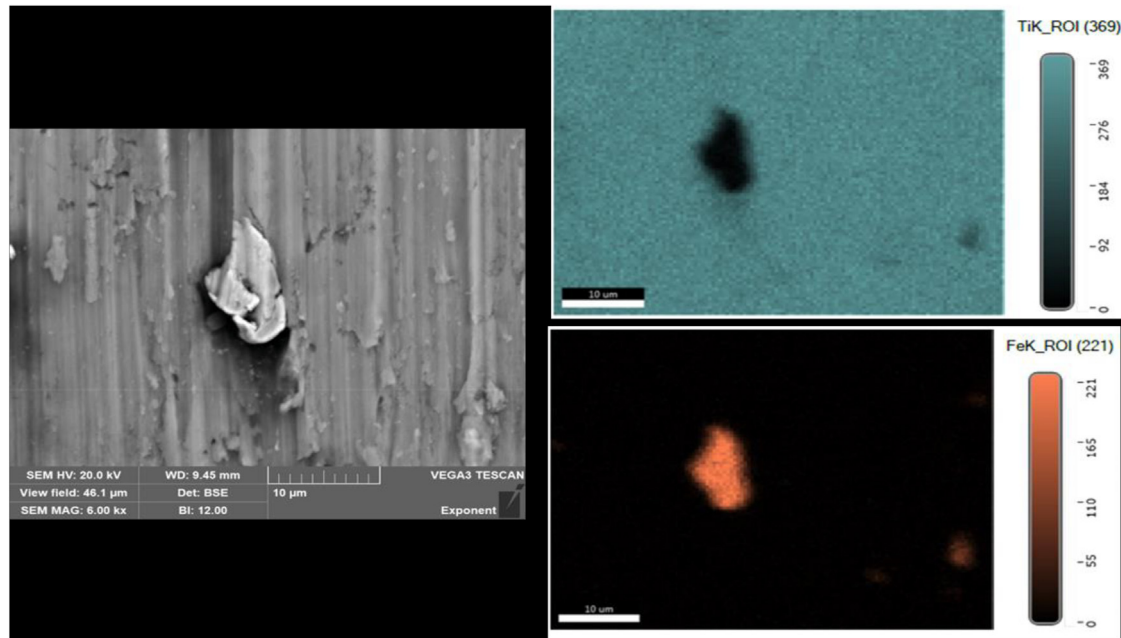
chromium (CoCr) material from the tibial baseplate to the Ti pin. One area exhibited material transfer on the surface of the pin. However, a small amount of iron (2.15 weight %) and cobalt (0.9 weight %) was present. Because iron would not be expected to be present due to abrasion with the tibial baseplate, its origin was most likely a surgical tool at the time of the index procedure or revision surgery (Fig. 9).

Figure 9. Image of one region of interest of possible material transfer and corresponding maps of elemental composition for titanium and iron. The material transferred to the surface was comprised primarily of iron (bottom right).
