Case report

Early fracture of the modular neck of a MODULUS femoral stem

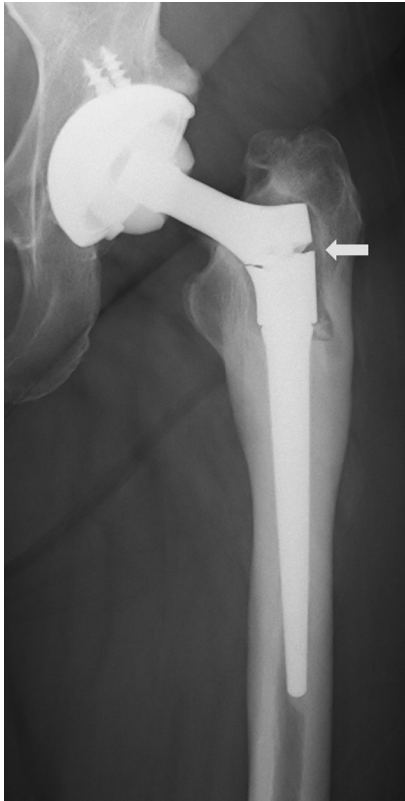
Three years and 8 months following the left-sided THA, the patient reported sudden-onset groin pain on the left side while helping a heavy patient out of bed and experienced immediate loss of weight-bearing ability. Radiography revealed a fracture of the modular neck component of the MODULUS (Lima Corporate, Villanova di San Daniele del Friuli, Italy) stem (Fig. 1). Revision surgery was performed using an anterolateral approach with the patient in the right lateral decubitus position. The hip was dislocated anteriorly and the fractured modular neck component was removed (Fig. 2; white arrow). The safety locking screw securing

Figure 1. Radiographic examination of the patient's left total hip arthroplasty at 3 years and 8 months postoperatively showing a fracture of the modular neck component.

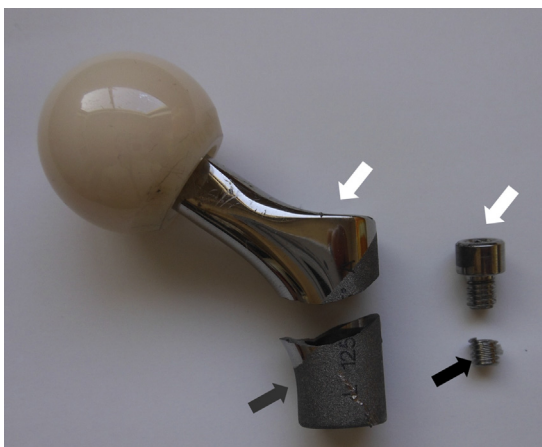
the 2 modular components was also broken. We could only remove the distal fragment of the screw, which remained within the stem, by turning it with a small flat chisel (Fig. 2; black arrow). An extended trochanteric osteotomy was performed to remove the remnant of the fractured modular neck, which was still coupled to the stem (Fig. 2; gray arrow), by hammering from the bottom rim of the component. Because the surface at the stem taper junction appeared to be scratched (Fig. 3), the surgeon attempted to replace the distal stem, but it was not possible without risking extensive damage to the bone. Leaving the distal stem in situ, the modular neck was replaced with a new 135° standard-offset modular neck

Figure 2. Picture of the broken components after retrieval.

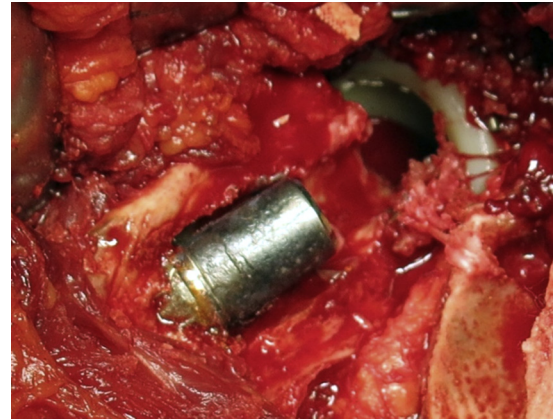
Figure 3. Intraoperative picture of the tapered portion of the proximal stem with evidence of scalloping and pitting.

SEM revealed weakening of the implant and increased susceptibility to cyclic fatigue fractures. Clear signs of these processes were present in some areas of both the neck (the inner surface along the propagation of the crack, together with rough bone/tissue residuals) and the locking screw (both the head and the threaded section). Relative *in vivo* micromovements between the neck and the stem, favored by the presence of bone/tissue residuals on the inner surface of the neck [12], could have significantly contributed to the breakage of the prosthesis in this case.

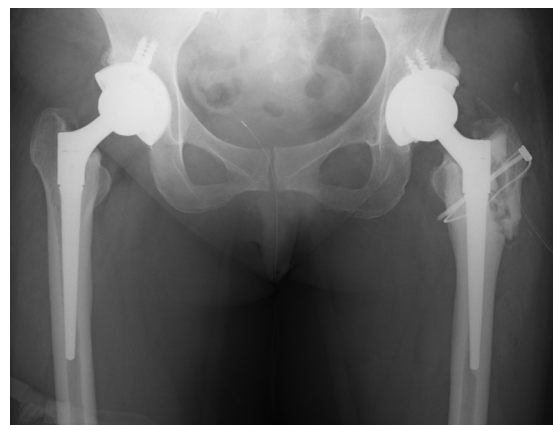
Figure 4. Immediate postoperative radiographic control image after revision of the broken components.

and a Delta ceramic head (32/0 mm). The greater trochanter was then reattached using a pin-sleeve system (AI-medica, Tokyo, Japan) [9] and ultra-high-molecular-weight polyethylene fiber cable (although the fiber cable is not observable on the radiographic images; NESPLON Cable System; Alfresa Pharma Co., Osaka, Japan) [10]. The properly fixed, cementless acetabular cup was preserved along with its highly cross-linked polyethylene liner (Fig. 4). One year postoperatively, the patient's pain resolved and she was able to return to work without using a walking aid.

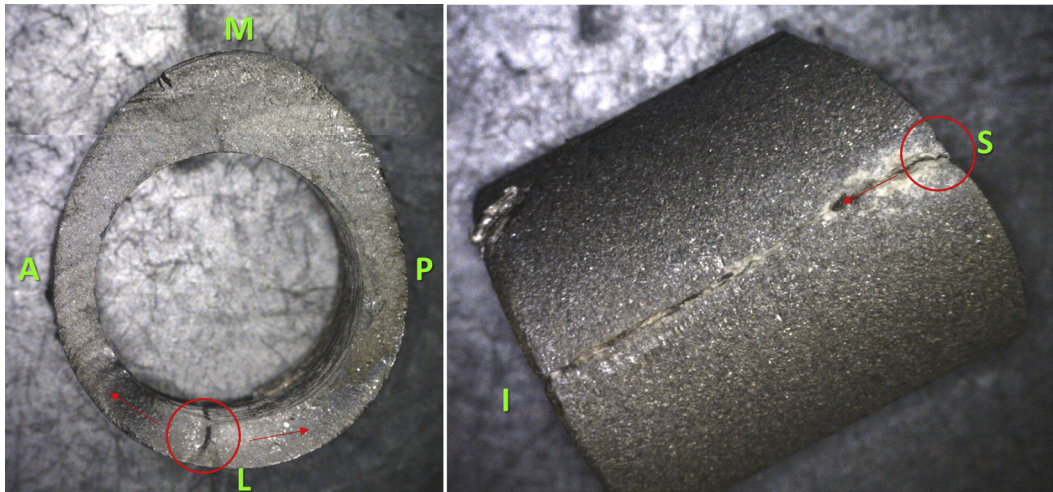
Figure 5. Pictures of the neck fracture surfaces (left: inferior fragment from the top; right: inferior fragment from the side). We identified the anterior, medial, posterior, and lateral zones of the neck with the letters A, M, P, and L, respectively. The letters I and S denote the inferior and superior parts of the neck fragments, respectively.

The fractured surfaces of the retrieved implant were inspected by optical and scanning electron microscopy (SEM) by Lima Corporate (Fig. 5). The neck fracture occurred where the small diameter of the male taper of the stem engaged the neck component. The crack originated in the lateral part of the neck (red circle) and propagated medially (red arrows). Figure 5 also shows the crack propagation along the inferior fragment of the neck. It was reported that this crack occurred in vivo and was not caused by the removal of the neck during revision surgery. Figure 6 (left) shows that the screw broke close to the minor cross-section at the level of the poly pin. The origin and propagation of the fracture are highlighted by a red circle and a red arrow, respectively (Fig. 6). SEM analysis of the retrieved broken components revealed that the system formed by the MODULUS neck and the locking screw experienced a double fatigue rupture. (1) The neck experienced a

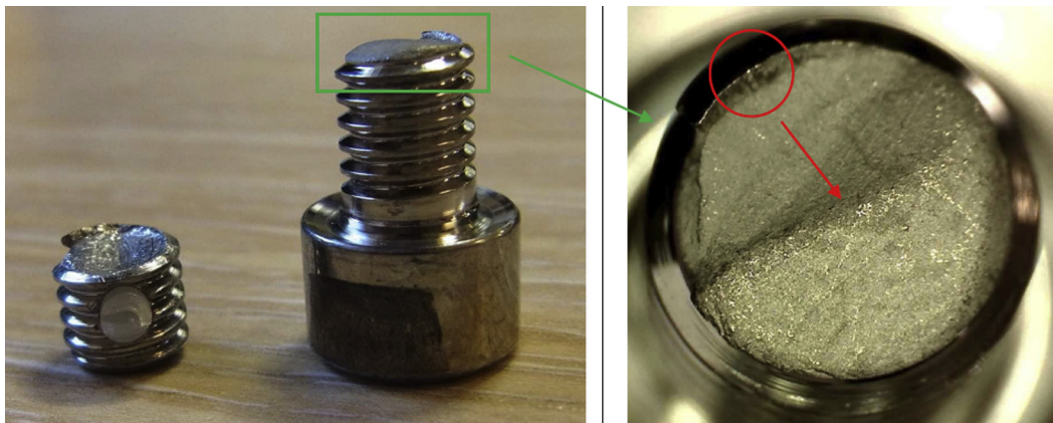
Figure 6. Broken screw (right: fracture surface of the superior screw fragment).
