The big short: A lifesaving alternative to a catastrophic lead failure

Jamie L. Kowal, DO, Matthew J. Singleton, MD, MBE, MHS, MSc, FIT-HRS,
S. Patrick Whalen, MD, FHRS, Prashant D. Bhawe, MD, FHRS

From the Section of Cardiology, Department of Internal Medicine, Wake Forest School of Medicine, Winston-Salem, North Carolina.

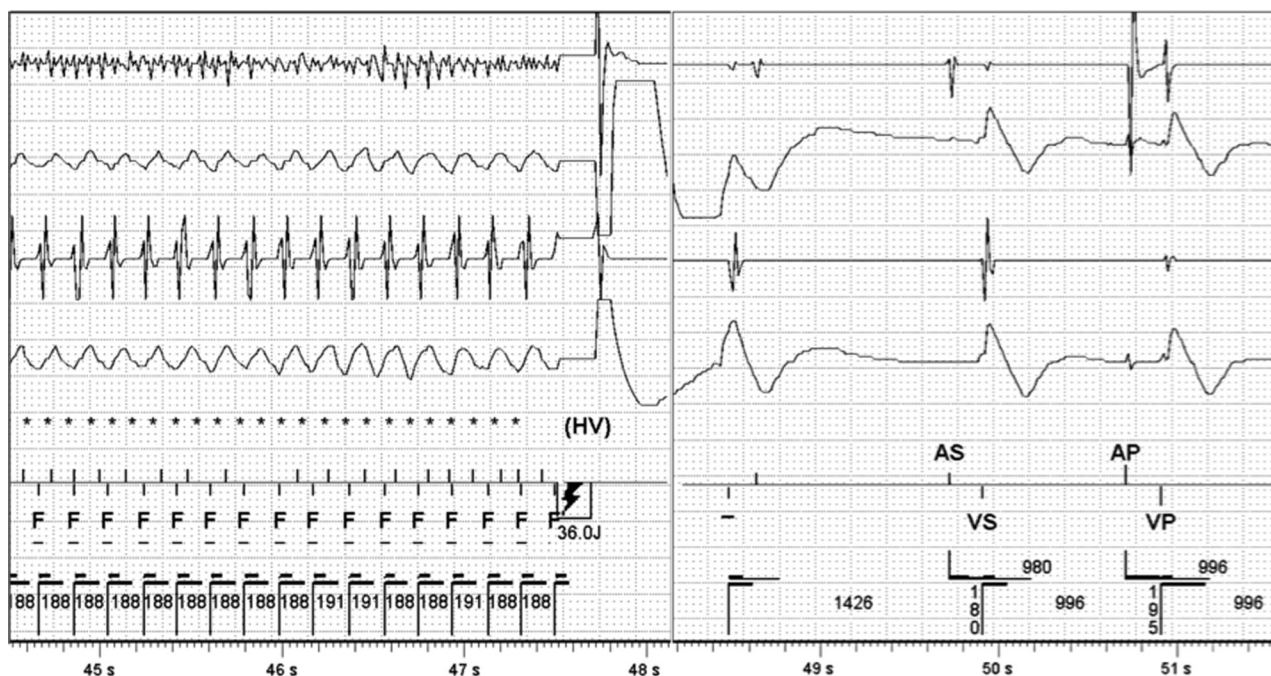
Figure 2 Final shock delivered through right ventricular coil to superior vena cava coil configuration with conversion of both atrial fibrillation and ventricular fibrillation.
