Seal plug damage causing inappropriate detection and therapy in a subcutaneous defibrillator system

Anne Barnett, PA-C, Lee Eckhardt, MD, FHRS, Miguel A. Leal, MD, FHRS

From the Division of Cardiovascular Medicine, Department of Medicine, University of Wisconsin School of Medicine and Public Health, Madison, Wisconsin.

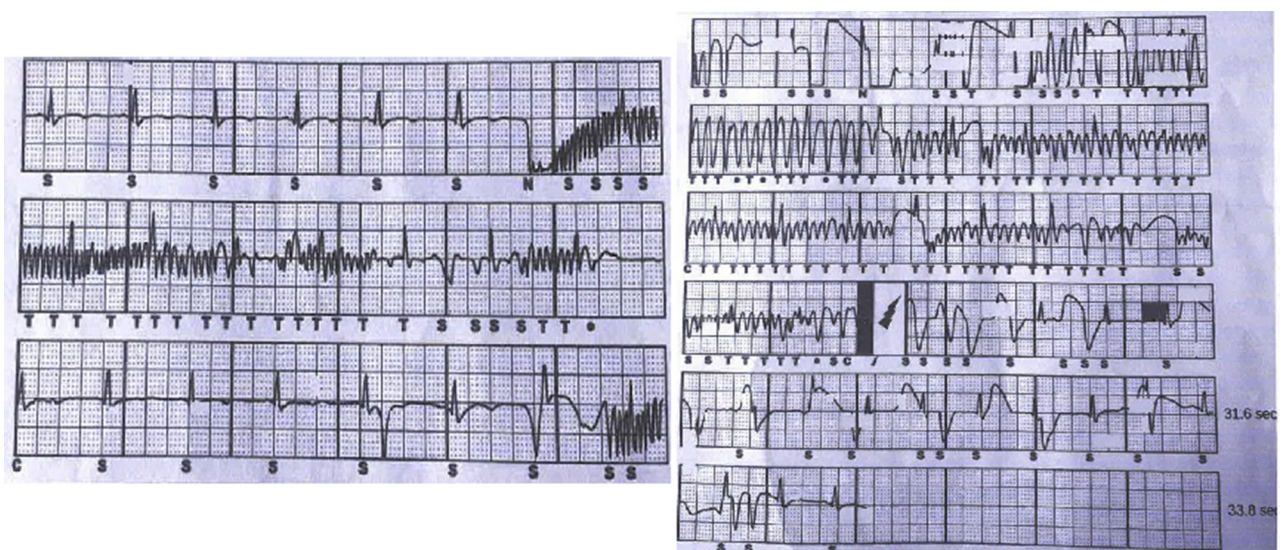
The patient was discharged home the following day with recommendation to return to the Device Clinic 2 weeks later for a routine wound check and system interrogation. Five days after implant, however, the patient received a shock from her device while at home in her usual state of health. She returned to the hospital and a device interrogation revealed lead noise with evidence of noise oversensing. In addition to the episode that led to the shock, 4 other “nonsustained VF” episodes had been recorded over the few days that followed the procedure. All of these events indicated the occurrence of noise oversensing (Figure 1).

Figure 1 Intermittent noise oversensing noted on postoperative day 2 (left) and continuous noise oversensing noted on postoperative day 5 (right). The marker channel indicates that the device mislabels noise as ventricular tachyarrhythmia, leading to the inappropriate shock (lightning bolt).

The patient was brought back to the electrophysiology laboratory for inspection of the S-ICD system. The set screw was tight and the lead tip completely inserted in the device header. The decision was then made to proceed with an S-ICD pulse generator replacement and the originally implanted generator was returned to the manufacturer for evaluation.

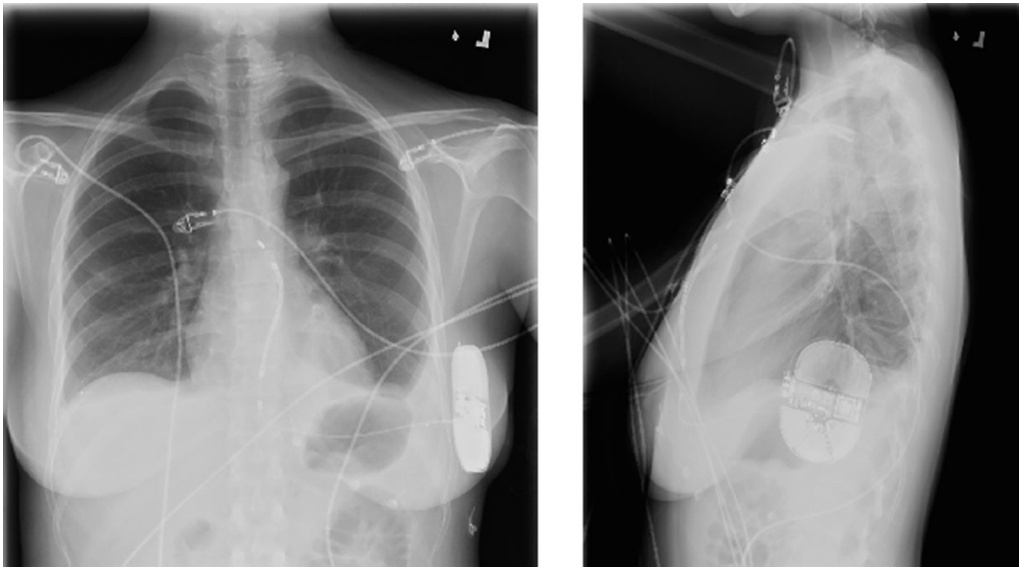
A 2-view (posteroanterior and lateral) chest radiograph was obtained and revealed that the system remained stable in its positioning (Figure 2), with no obvious evidence of lead fracture, dislodgment, or discontinuity of the circuit.

Figure 2 Chest radiograph post-device implant (posteroanterior and left lateral projections).

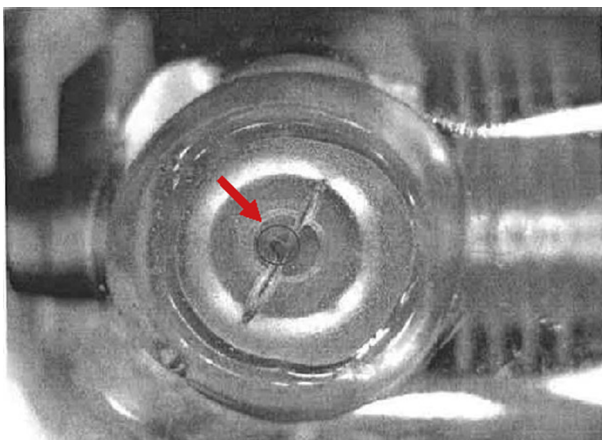
A comprehensive analysis of the returned device revealed the presence of a hole in the seal plug, shown in detail in Figure 3. The analysis concluded that the hole in the seal

plug introduced air and/or fluid around the lead tip and contributed to the observed noise oversensing events that were followed by inappropriate therapy delivery.

Figure 3 Magnified view of the device header exhibiting a hole (center of circle) in the seal plug.

In the S-ICD device, the seal plug is positioned over the tip, or distal connector block. A hole in the seal plug can cause noise artifact involving the secondary and/or alternate vectors, as the lead tip is part of the sensing circuit in both those vectors. The resultant deflections are rapid in rate and medium-frequency in appearance, and have been reported to cause intermittent pacing inhibition in transvenous devices.¹²

In our case, the manufacturer analysis results indicated the presence of damage to the set screw seal plug. This puncture could have been the consequence of a perforation of the header plastic material by the sharp wrench tool or subsequent damage caused by other surgical instruments following device placement in the pocket. The seal plug damage likely resulted in bodily fluid intrusion in the header and, subsequently, the reported clinical observations of noise oversensing by the S-ICD system. Damage to seal plugs may also occur during the initial insertion of the torque wrench.
