Case report

Two pegs are better than one: rare mode of femoral component failure in unicompartmental arthroplasty requiring revision to total knee arthroplasty

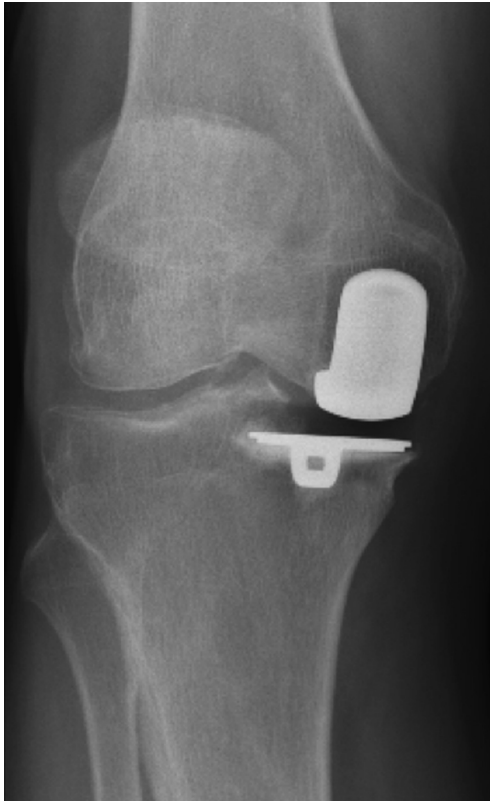
Radiographs demonstrated a fracture of the femoral component just posterior to the single peg with a lucency noted at the bone-cement interface of the component segment posterior to the fracture (Figs. 1 and 2). The tibial component appeared intact and well fixed. The patient was indicated for revision to a total knee arthroplasty (TKA) given the catastrophic mechanical failure of his UKA. The risks and benefits of the procedure were discussed and informed consent was obtained. He was made non-weight-bearing in a knee immobilizer for 4 weeks until he was medically cleared for surgery.

Figure 1. Anteroposterior radiograph of right knee with no evidence of UKA failure.

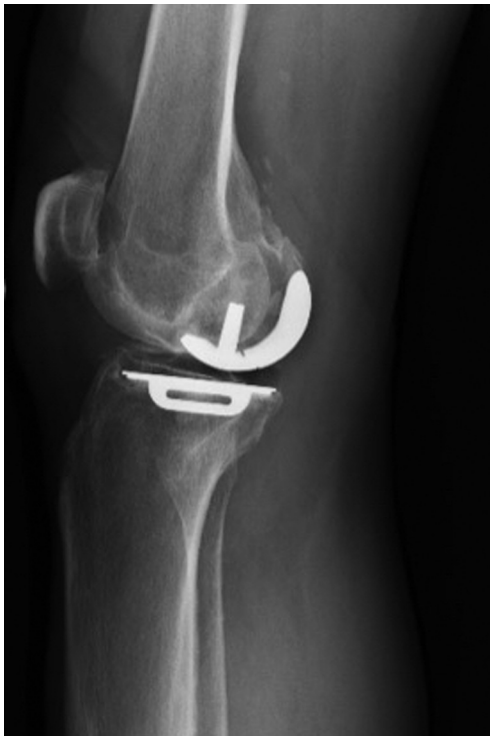
Figure 2. Lateral radiograph of a right knee with a medial UKA. Note the lucency posterior to the single femoral peg.

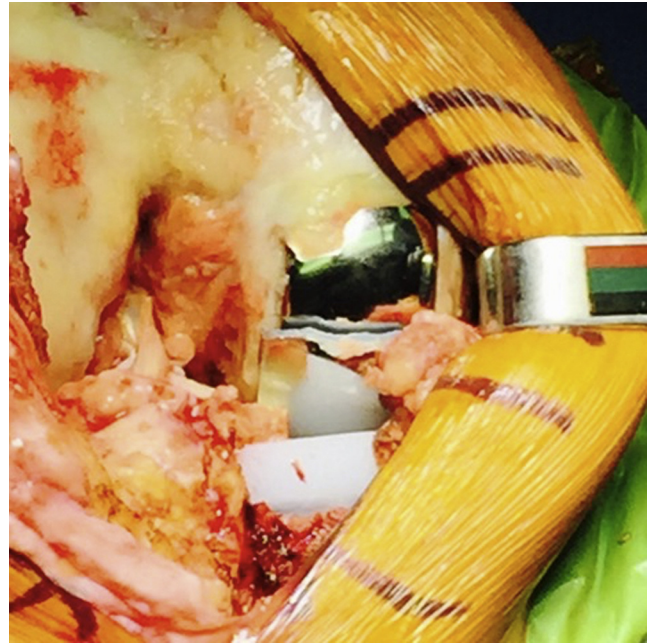
The patient was taken to the operating room for conversion to a TKA. The patient's previous medial parapatellar incision was used and extended 2 cm in either direction. Upon entering the joint, the portion of the femoral component previously abutting the posterior condyle was grossly loose and was removed (Fig. 3). The remaining portion of the femoral component was intact and well fixed. An intramedullary guide with a cutting block was placed and the medial distal femoral cut was made around the femoral component. Bone was removed around the component peg and the component was then tapped out using a bone impactor with minimal bone loss.

Figure 3. Intraoperative photograph showing the clearly fractured and grossly loose femoral UKA component.

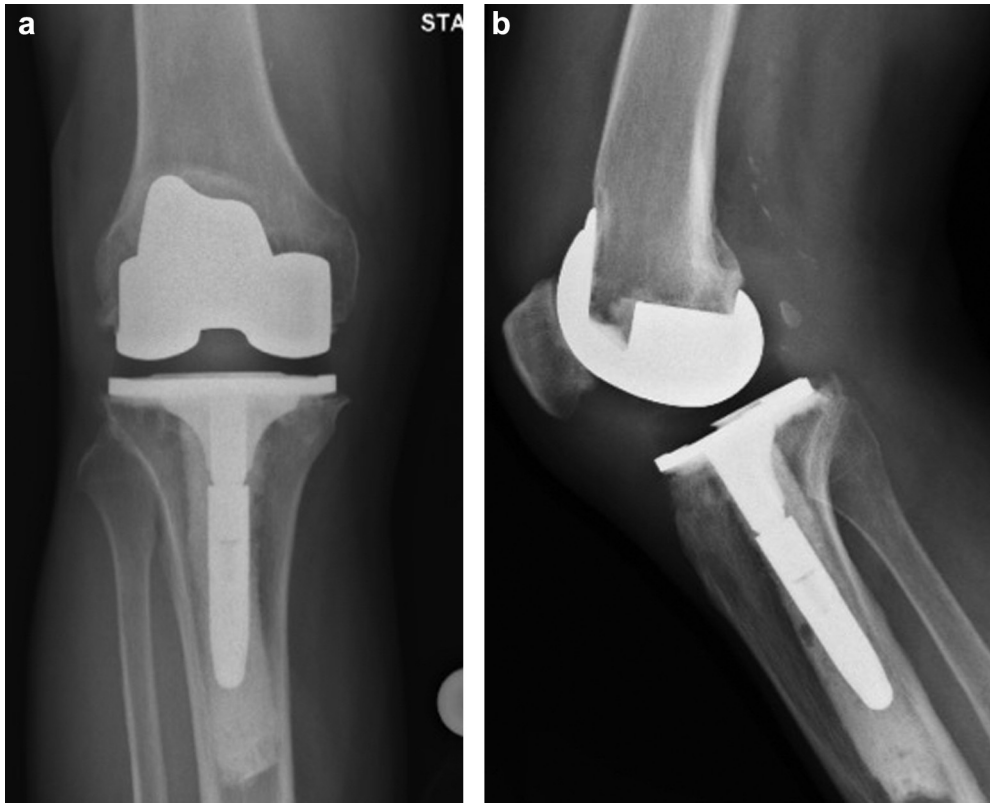
Figure 4. (a) Anteroposterior and (b) lateral radiographs of final TKA components at 1 year postoperatively.

explant component's keel site was performed. A cemented stem extension was used to enhance tibial base plate fixation around the graft and also because of increased metaphyseal bone porosity noted throughout the tibia. Additional components included a primary posterior-stabilized oxinium femoral component and highly cross-linked polyethylene articular insert (Smith and Nephew, Memphis, TN). The patella was left unresurfaced as there was no evidence of chondrolysis (Fig. 4a and b).

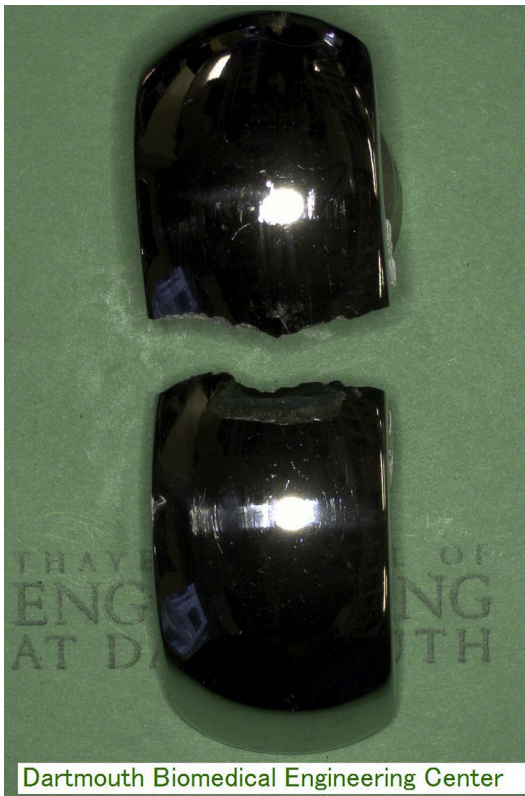
The explanted Biomet Vanguard UKA components were sent to an institutional review board–approved retrieval laboratory for analysis (Fig. 5). Following disinfection in formalin, the components were graded for damage by an experienced clinician investigator using a 10× digital microscope. The femoral component was sectioned using a metallurgical diamond saw in the M/L direction immediately next to the 2 exposed fracture surfaces. The fracture surfaces were subsequently mounted on an aluminum stub using double-sided conductive tape and imaged using scanning electron microscopy at up to 200× magnification and accelerating voltages of 10 kV. Additional sections of the femoral component were mounted in Bakelite and progressively ground and polished using metallurgical preparation equipment to a final polish of 0.05 micron polishing compound. Polished faces were etched with aqua regia and imaged under optical microscopy at up to 1000×.

Figure 5. Explanted Vanguard femoral UKA component.

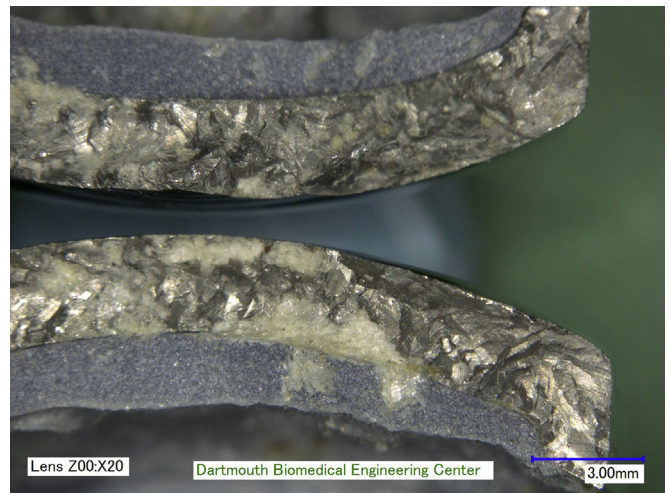
The cobalt-chrome femoral component showed evidence of relative motion between cement and bone with sparse osseous integration and little to no plastic deformation. The articular surface showed a transverse fracture with evidence of fatigue striations and some embedded polyethylene on the fractured surface (Fig. 6). The component showed grade 2 scratching (10%–50% surface area) and grade 1 burnishing (<10%) [3] (Fig. 7). The tibial component showed excellent osseous integration and no evidence of motion. The polyethylene insert demonstrated the posteromedial damage from abrasion against the fractured femoral component.

Figure 6. Close-up of fracture through femoral UKA component with evidence of fatigue striations.

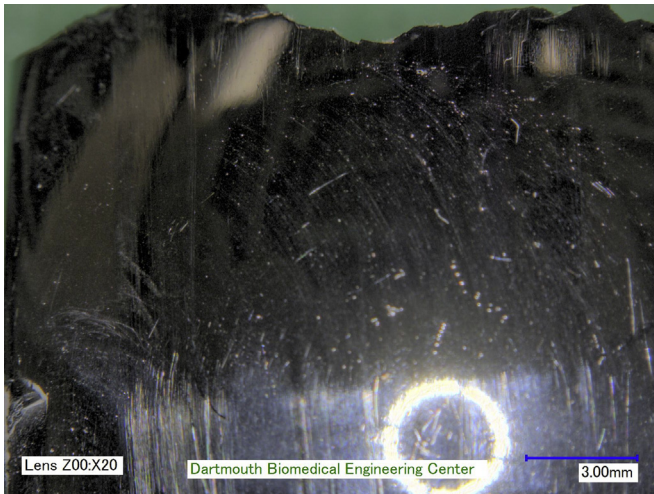
Figure 7. Close-up of the articular surface of the explanted femoral component with signs of scratching and burnishing.

stress in flexion and ultimately component fracture. Our patient additionally was not obese, eliminating this as a potentially predisposing factor. During ambulation, loosening at the anterior cement mantle, as indicated by burnishing of the matte cobalt backside of the component, and compression or subsidence of the distal femoral condyle would permit sliding of the device up the inclined anterior bone face. Such a motion would serve as a wedge to open the “C” shape of the device, thereby putting it in a fatigue state of tensile stress at the region of crack initiation. Crack initiation at the corner of the femoral casting, a stress riser, would then lead to propagation during subsequent ambulation and eventual fracture.

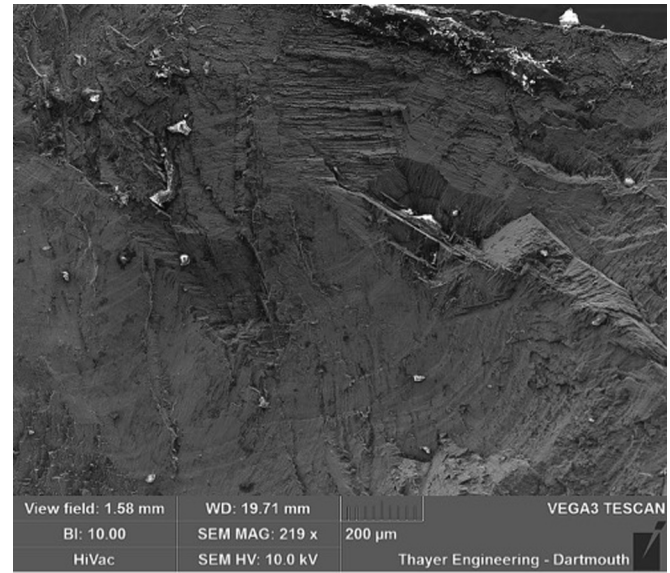
surface, with evidence of grain boundary cracks (Fig. 9). The stress state leading to such a fracture would be one of opening the “C” shape of the device. Metallurgical analysis suggests a characteristic

Figure 9. Electron microscopy showing crack around grain boundaries.

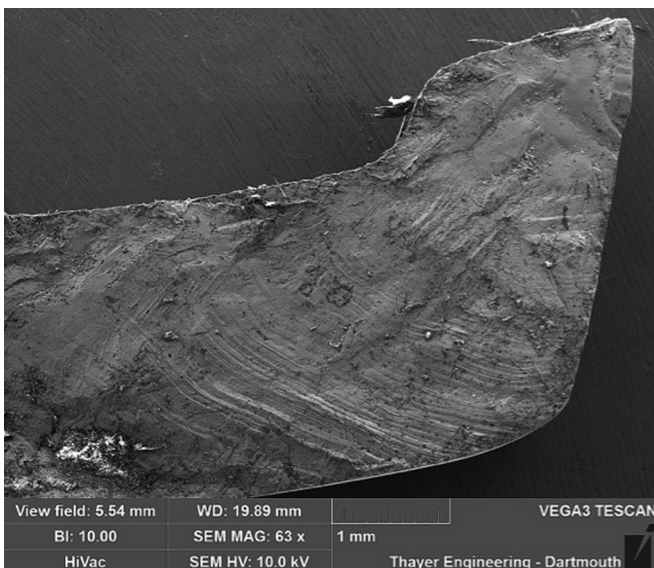
Electron microscopy revealed crack initiation and fatigue fracture propagation from the superior aspect of the femoral implant at a region coincident with an interior corner of the device (Fig. 8). Fast fracture is indicated toward the center (M/L) of the fracture

Figure 8. Electron microscopy revealing crack initiation and propagation sites.

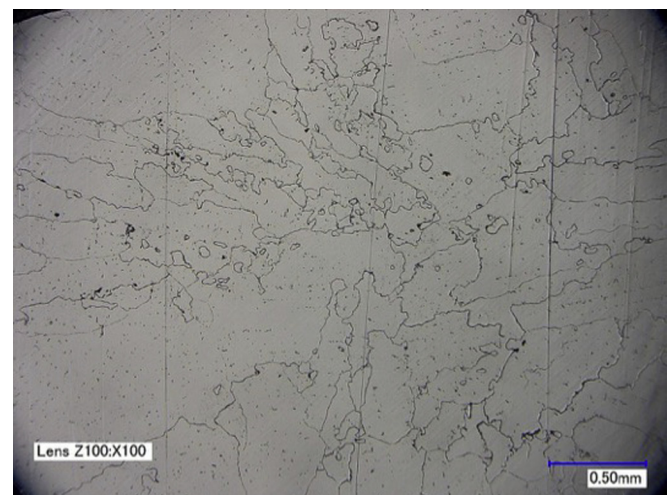
dendritic cast structure with evenly distributed carbide precipitates throughout, occasional intermetallic deposits at grain boundaries, and no evidence of residual pores from casting. Grain sizes are typically 30–40 microns (Fig. 10).

Figure 10. Microstructure overview showing the presence of carbide precipitates within the grains as well as intermetallic phases along the grain boundaries.
