Importance of Understanding and Analyzing Daily Quality Assurance Test of Positron Emission Tomography/Computed Tomography Equipment in Minimizing the Downtime of Equipment in Remote Places

This article briefly describes the event of a defective detector block in a daily quality assurance scan/blank scan and insists on implementing guidelines to scan or not to scan in such a scenario. The nuclear medicine physicist should have a clear understanding of the blank scan graph, which shall help rectify the right cause of problem and give confidence to the physician in reporting the acquired study. A routine blank scan in positron emission tomography signifies various parameters of the crystal (coincidence count rate, single count rate, dead time, and coincidence time along with energy response) and in some respect is analogous to the daily uniformity flood image for gamma cameras, providing an overall assessment of detector response. We encountered a bad detector block in our routine quality assurance scan/blank scan and analyzed the root cause behind such an error which was finally restored to normalcy by replacing the defected part with a new one and an error-free blank scan was esta

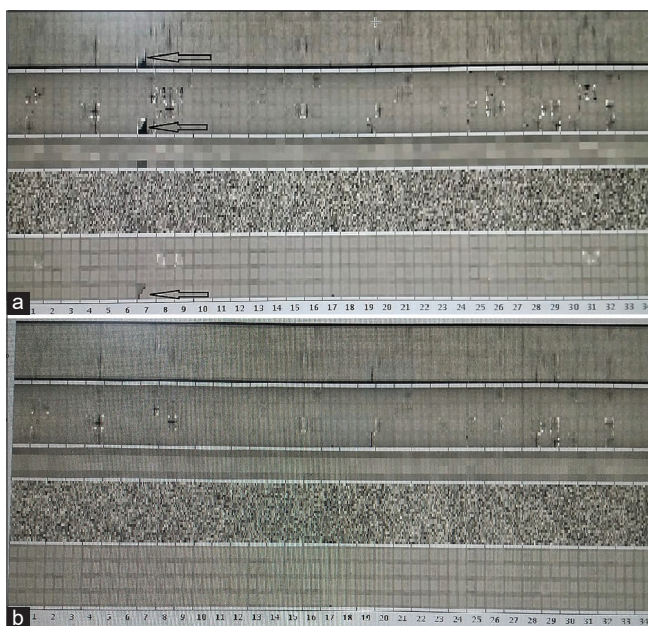
As per the routine practice, we were acquiring a DQA scan, with the inbuilt Ge-68 rod source of our PET-computed tomography (CT) scanner (Discovery STE, GE Medical System, USA) before injecting the patients with F18-Fluoro Deoxy Glucose for PET-CT study. On completion of the DQA scan, we observed a black spot at module 7 of block 6 [Figure 1a arrow mark]. From our previous experience; we could understand that it could be due to reasons such as malfunctioning of detector, temperature-humidity variation, or Cassette Electronic Module board (CEM board) error. We started analyzing each point to rule out the cause of a bad block detector. The temperature-humidity factor was ruled out as the gantry and console room temperature and humidity were well within the prescribed limit ($20^{\circ}\text{C} \pm 2^{\circ}\text{C}$; $45 \pm 5\%$) and stable for quite a few days, neither was there any error in the CEM board because an error in CEM board causes malfunctioning of a whole module and not a single block of a module. Hence, we shifted our analysis to detector malfunctioning, which could have been due to a nonfunctional detector or having a substantial lower sensitivity than that of the other detectors.^[7,8] We looked up the two-dimensional (2D) generated crystal decoding map of module 7, block 6. It clearly showed the distorted map with uneven/loss of

Figure 1: Daily Quality assurance graph, (a) Shows defective graph arrow sign (b) shows a normal graph

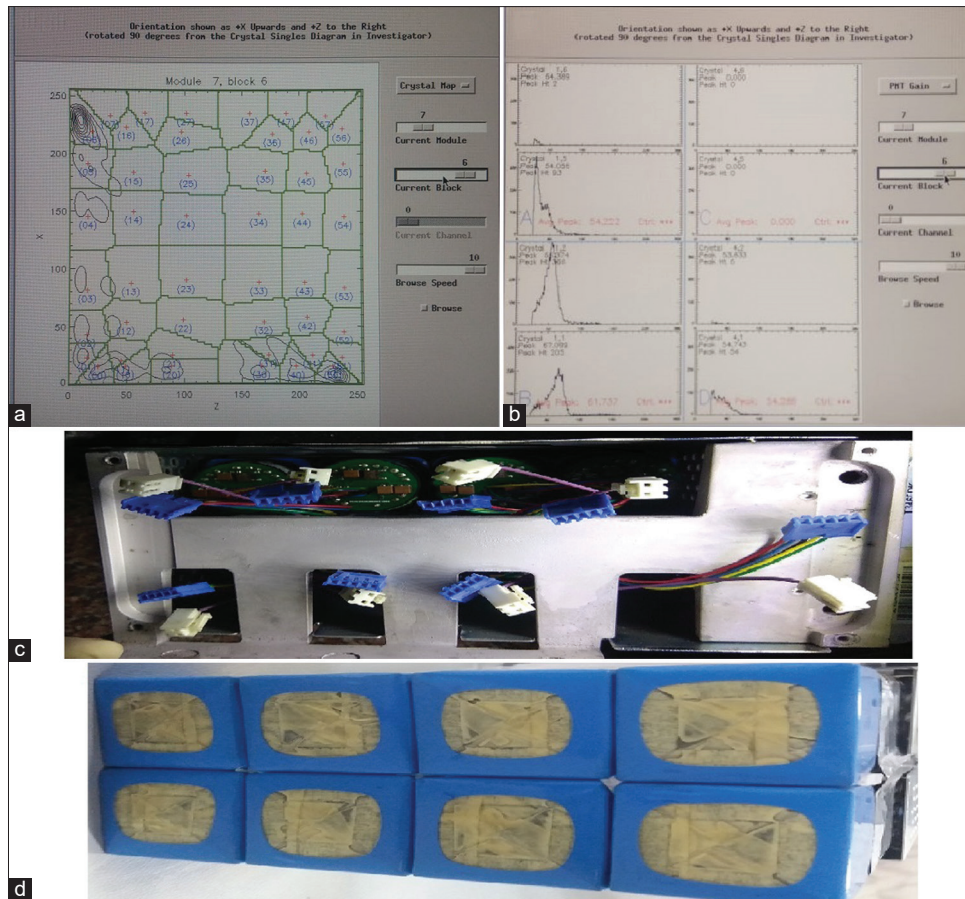
distribution of signal [Figure 2a]. Meanwhile, we contacted a service engineer and briefed the situation and discussed with him. This prompted us to proceed further for analyzing the PMT gain/peak of the supporting module's block. The peak was completely derailed; which was leading to poor outcomes of the detector block [Figure 2b]. We discussed the outcome of PMT gain with service engineer and concluded the problem in one of the PMT in the 7th module. Service engineer ordered the detector module from a nearby warehouse. We also discussed this issue with our Nuclear medicine physician to decide whether to inject patients or not under such a situation. After the discussion, we performed a dummy scan to see whether the system was generating raw data for both attenuation correction and nonattenuation correction files and whether the fusion was taking place with the selected CT data. On its assurance, we along with the Nuclear medicine physician reanalyzed the DQA graph and since the region of a defect was confined to $< 1\%$ of total crystals, we decided to proceed ahead with selected routine PET-CT studies where accuracy in standardized uptake value (SUV) quantification was not really mandatory as per Nuclear medicine physician and rescheduled the cases in which SUV quantification was of prime importance: Like early response evaluation after therapy and at the same time registered a service call as per departmental protocol to GE service support. The images acquired were clearly interpretable with minimal degradation in the qualitative analysis [Figure 3a-c arrow mark]. By the time, we completed a study of selected few patients the service engineer arrived. After scrutinizing thoroughly through the software and error log along with inspection of completed studies and internal components/hardware, we again proceeded first with system calibration, which makes coarse and fine gain adjustments to the PMT, but we had the same graph of DQA.^[11] Late in the evening part ordered also arrived and replaced it successfully in the early morning the next day. The detector module is shown in Figure 2c and d. On installation and updating the PMT gain, we performed the DQA scan. On review by the service engineer and physicist in the department, DQA was found to be normal [Figure 1b]. On complete satisfaction, we performed a clinical PET-CT study successfully and there were no artifacts in the PET images [Figure 3d-f].

Figure 2: Detailed graph at module level; (a) graph shows loss of signal on two-dimensional generated crystal decoding map of module 7, block 6, (b) graph shows loss of signal in energy peaking map of module 7, block 6, (c) figure shows the upper part of the detector module, and (d) figure shows the lower part of a detector module

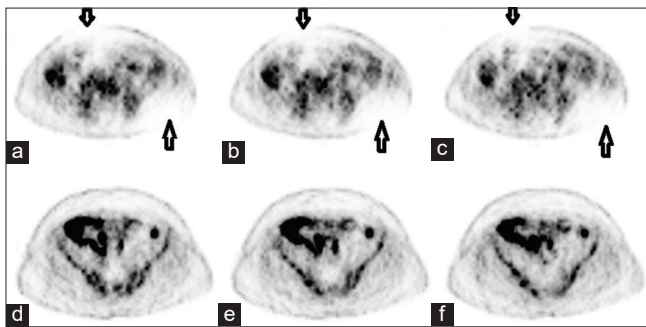
Figure 3: Clinical scan with a defective module and after replacement; (a-c) arrows show photo deficient area on a clinical scan performed with defective detectors. (d-f) No photo deficient area in the clinical image performed after replacement of the detector module
