An unusual defect in the nitrous oxide pipeline

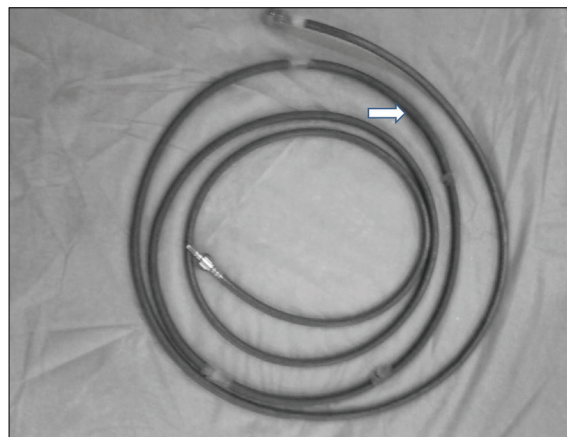
A close inspection of the N₂O hose demonstrated 18 cm long segment of fusiform dilatation [Figure 1] with a minute hole [Figure 2]. This portion of the hose was soft on texture and crepitations could be felt over it. Defect occurred possibly following the initial damage of internal nylon braided pipe resulting in the seepage of N₂O (at intermediate pressures) between the external polyvinylchloride (PVC) coating and nylon braiding. The gas leaked between the two layers of pipe, before puncture of the PVC coating resulting in sudden drop in the N₂O pipeline pressures occurred at the machine end. The most likely cause of the defect was the repeated wheeling of the anesthesia machine over the pipeline. Pipeline of N₂O was changed later.

Figure 1: Nitrous oxide pipeline with arrow showing a dilated segment

Such a damage to the N₂O pipeline could present as sudden burst of pipeline and can even occur in an oxygen pipeline. The damage can be prevented by raising pipelines off the floor or by using gas columns/pendants/ceiling hose drops/articulating arms. Inspection of the anesthesia pipelines along with the test recommended for leaks^[2] should be performed carefully and this should be added to the list of defects reported in the anesthesia gas pipeline systems.^[3-5]

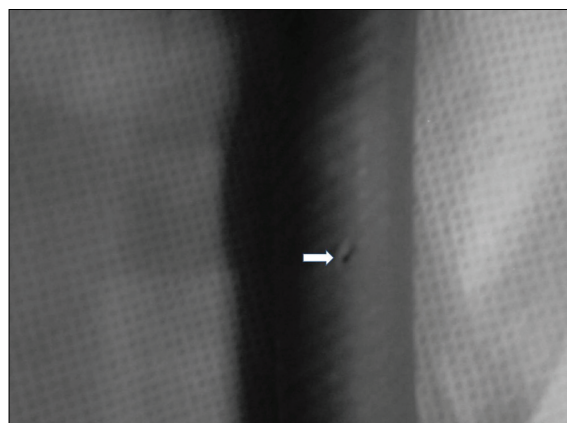
Figure 2: Arrow pointing hole in the dilated portion of nitrous oxide pipeline
