Fracture of Fully-coated Femoral Stem after Primary Total Hip Arthroplasty for Nonunion of Intertrochanteric Fracture: A Case Report

Young Soo Chun, MD, Hyung Suk Juh, MD, Yoon Je Cho, MD*, Kee Hyung Rhyu, MD

*Department of Orthopaedic Surgery, Kyung Hee University Hospital at Gangdong, Seoul, Korea,
Department of Orthopaedic Surgery, Kyung Hee University Hospital, Seoul, Korea**

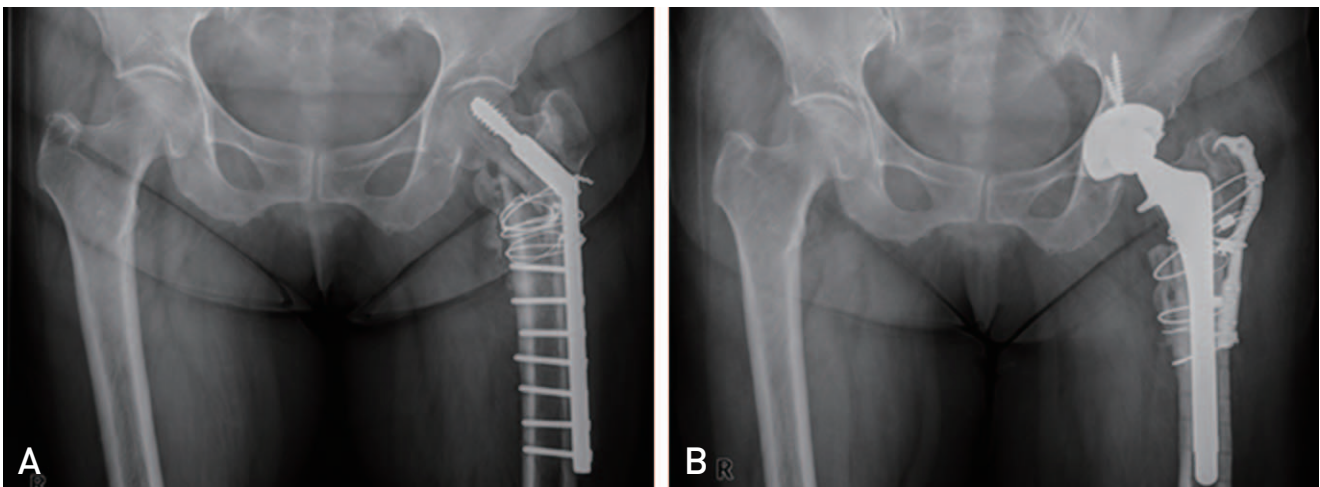
A 77-year-old female with a body mass index (BMI) of 33.3 kg/m² presented after falling on her left hip. An intertrochanteric fracture of the left femur was diagnosed, which was treated by open reduction and internal fixation with compression hip screws in other hospital. Fourteen months after the index operation, she visited our clinic because of severe left hip pain. She could not stand or walk without a walker. Plain radiographs revealed loss of fixation and possible nonunion (Fig. 1A). After close observation for 4

Fig. 1. (A) Anteroposterior radiograph shows possible non-union of the intertrochanteric fracture and loss of fixation. (B) Four months later, conversion total hip arthroplasty was performed using a fully coated femoral stem.

months, the patient underwent conversion THA with a fully coated femoral stem (Versys beaded fullcoat; Zimmer, Warsaw, IN, USA). The stem had a diameter of 14 mm and a length of 150 mm (Fig. 1B). Migration of greater trochanteric fragment with breakage of circlage cables was noted on the radiograph taken at 6 weeks after the operation. Despite greater trochanteric non-union, she did not complain of left hip pain and was able to walk with a cane. Four years after the operation, she presented to the emergency department of our hospital for left hip pain after having fallen from a chair. Plain radiographs demonstrated a transverse fracture in the femoral stem and the breakage of multiple cerclage cables (Fig. 2A, B). Although the level of bone defect was 2.5 cm distal to collar of stem, fractured level was different from the level of bone defect. It was 8 cm distal to collar of the stem. The femoral component was

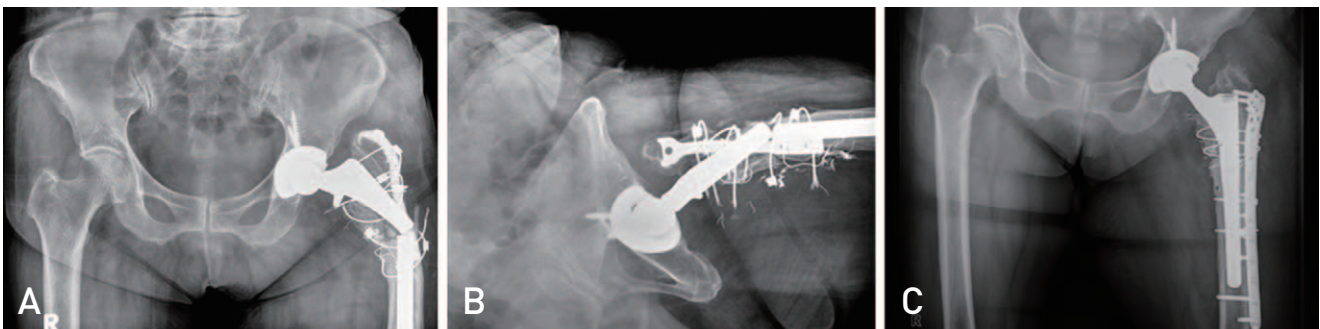
Fig. 2. (A) Anteroposterior and (B) cross-table lateral radiograph of the hip taken in the emergency department 4 years after the conversion total hip arthroplasty show stem fracture at a level lower than the initially deficient area on the medial aspect of the proximal femur. (C) Revision surgery was performed using a distal fixing modular stem with a larger diameter and bone grafts.

revised using a modular femoral stem 18 mm in diameter and 140 mm distal with 55 mm proximal parts in length (Revitan; Zimmer). The remaining trochanteric fragments were reduced and fixed with a reversed anatomical plate for the right distal femur (Fig. 2C) together with a mixed auto- and allogeneic bone graft. Autograft was harvested at the iliac tubercle at the ipsilateral side. Mobilization with toe touch using walker was started 1 week after the operation. Use of walker or two crutches was recommended until 3 months after the operation. Full weight bearing was allowed 6 month after revision. At the most recent follow-up (1 year post-operatively) the patient was able to walk with a cane and without noticeable hip pain.

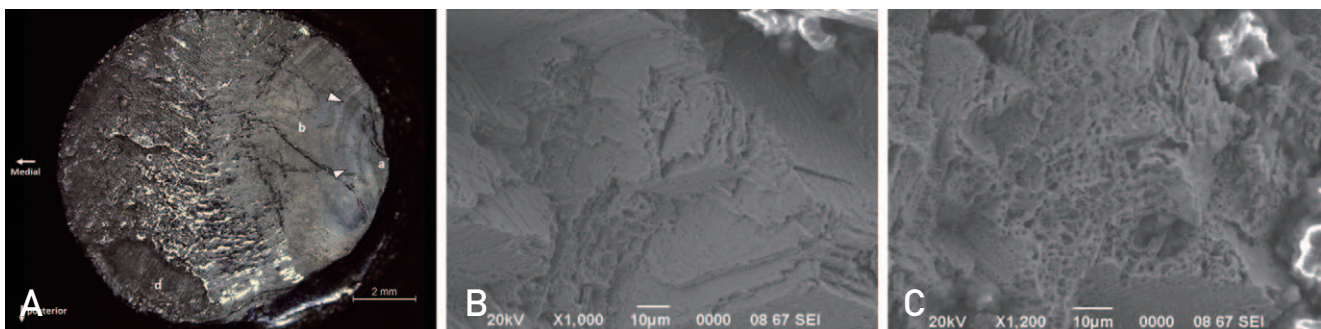
The failed femoral stem was sent to the Korean Testing & Research Institute (Seoul, Korea), certified for the testing of industrial products and standardization conformance. The fractured section of the stem was analyzed by stereoscopic microscopy (M-125; Leica, Wetzlar, Germany) and scanning electron microscopy-energy dispersive spectroscopy (SEM-EDS, 6490LV; JEOL, Tokyo, Japan) at high magnification to determine the elemental composition of the stem and fracture development. It was confirmed that the stem was made of cobalt chrome alloy by SEM-EDS. Grossly, the fracture line was transverse and there was no defect. The fractured plane showed signs of fatigue failure with “beach marks” in the crack starting from the lateral end and ductile failure on the other end of the fracture (Fig. 3A). Beach marks and stair-step morphology confirmed the crack was made by fatigue failure (Fig. 3B). As the crack propagated, ductile failure, confirmed by the dimple morphology, finally led to complete separation (Fig. 3C). The fracture propagated in circular fashion. The final separation occurred on the posterior aspect, 270° from the starting point, rather than on the medial aspect of the stem.

Fig. 3. (A) The fracture plane of the femoral stem ($\times 8$) shows fatigue failure starting from area 'a'. The beach marks (arrowheads) reveal the initiation of fatigue failure. Failure propagated through area 'c' to the area 'd' in counter-clockwise manner. Area 'd' shows ductile failure leading to final separation. (B) The stair-step morphology as seen on scanning electron microscopy (SEM, $\times 1,000$) and the beach mark area ('b' in Fig. 3A) confirm that the initiating mechanism was fatigue failure. (C) Dimple pattern as seen on SEM ($\times 1,200$) along the medial area ('c' in Fig. 3A) shows that the final separation was propagated by ductile failure.

To our knowledge, this is the first case report to include a metallurgic analysis of the failure mechanism in a cementless, fully coated stem used in a primary THA. The fracture was initiated by fatigue failure along the lateral aspect of stem and eventually resulted in ductile failure at its posterior aspect. Propagation of the fracture was not in the lateromedial direction as expected, but rather counter-clockwise. This might reflect the normal biomechanics of the hip, in which the physiological load on the femoral head is from lateral to medial and from anterior to posterior. Metallurgic analysis revealed that the minor fall eventually completed the final part of fracture, not initiated the whole process.
