Analysis of the Root Causes of Damage to the Edges of Tank Manholes on the Main Deck of Handy-Size Bulk Carriers

Abstract: This study analyzes the root causes of cracks in the deck plating around tank manholes. Four handy-size bulk carriers built in one shipyard were analyzed. In all cases, deck cracks were found near manholes, and the average time from the commencement of operation until the occurrence of cracks was 1356 days. Due to this short wear-life of the vessel's structural material, the authors believed that it was unlikely to be caused by corrosion fatigue. The authors hypothesized that main decks cracked around manholes because of very poor-quality welded joints and poor-quality steel (large amounts of non-metallic impurities) used to make the manholes. In order to verify this hypothesis, on each of the vessels, material samples were collected from near the cracks and then examined thoroughly. Each sample was subjected to the macroscopic examination of the natural surfaces of cracks and their vicinity, microscopic examination of the material, mechanical property tests, and scanning electron microscope fractography for samples obtained after impact tests. The examination

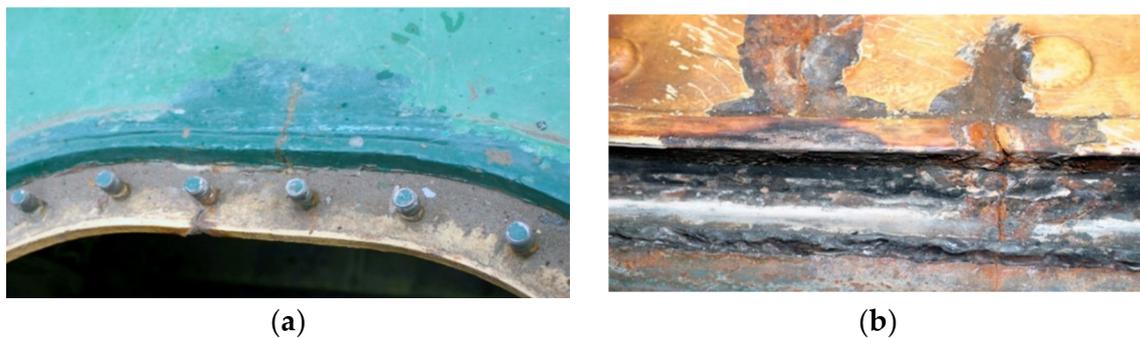
Figure 4. Pictures of origins of cracks: (a) view from the outside and (b) view from the inside of the tank (handy-size bulk carrier 30182 DWT). Macroscopic examination.

The crack on the right side of Figure 4b developed across a visible weld and then penetrated the insert between the manhole structure and the hole cut out in the deck. The crack does not reach the deck plate (Figure 5), but it is clear that further operation would lead to reaching it.

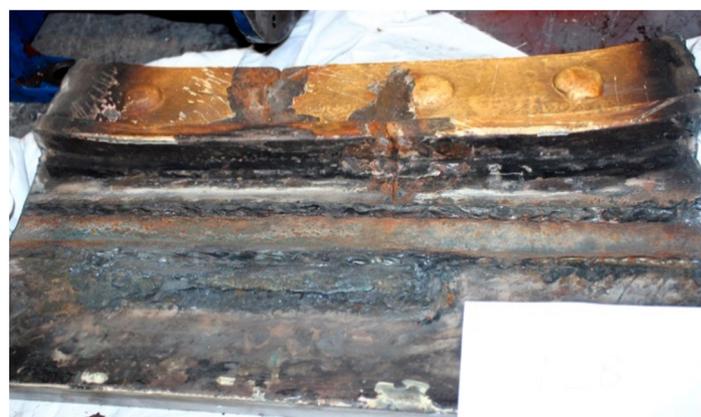
Figure 5. The insert and the welds that join the manhole structure and the deck (handy-size bulk carrier 30182 DWT). Macroscopic examination.

What contributes to the formation and development of cracks is the very poor quality of weld seams, their number, and the presence of the insert compensating for a hole's dimensional differences in the deck. There were no cracks in the deck plates, and they were only found in the manhole structure (material examination was limited to the manhole structure).

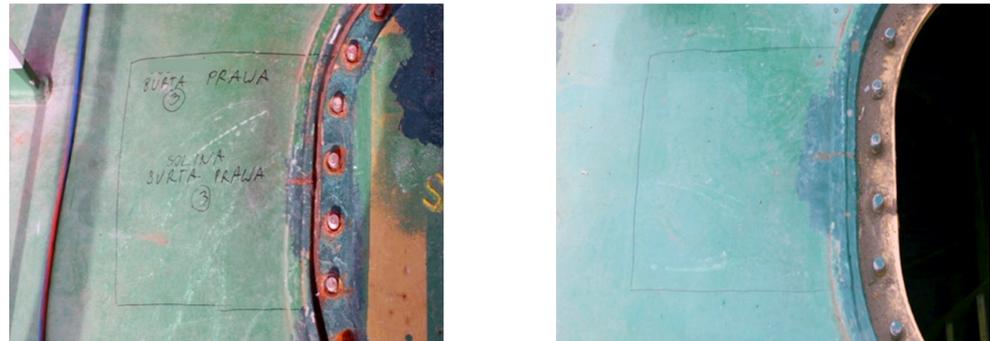
Figure 6. The sections of the manhole structure cut out for examination (handy-size bulk carrier 30182 DWT). Macroscopic examination.

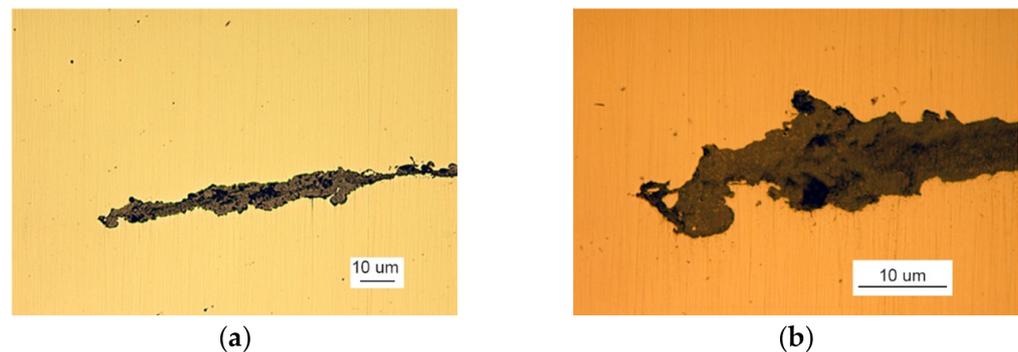
Figure 7. A crack view: (a) a crack filled with corrosion products and (b) branching crack face (handy-size bulk carrier 30182 DWT). Optical microscopy.

Despite the severe corrosion, observation of the crack face makes it possible to conclude that the crack developed along grain boundaries and was branched (Figure 7b).

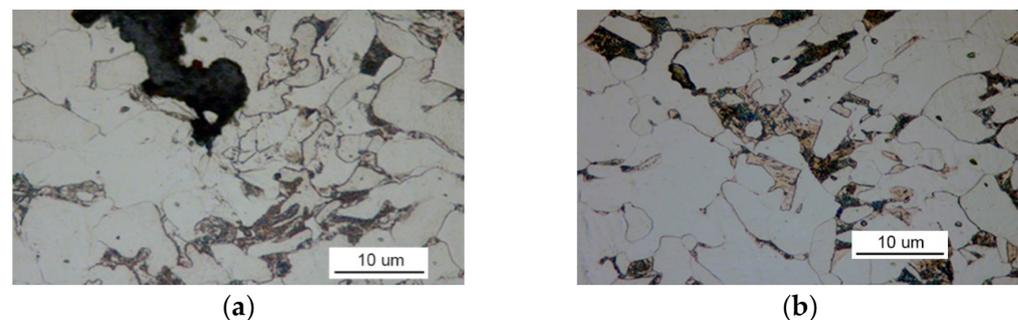
After etching the metallographic specimen with nitric acid and alcohol solution, traces of plastic strain followed by the crack front are seen (Figure 8a).

Figure 8. Optical microscopy views: (a) the face of the crack after etching with Nital and (b) the ferritic and pearlitic structure of the examined material (handy-size bulk carrier 30182 DWT).

Figure 8b shows that the examined material has a ferrite structure with a small amount of severely-degraded pearlite. At the boundaries of ferrite grains, an intermittent cementite network is visible.

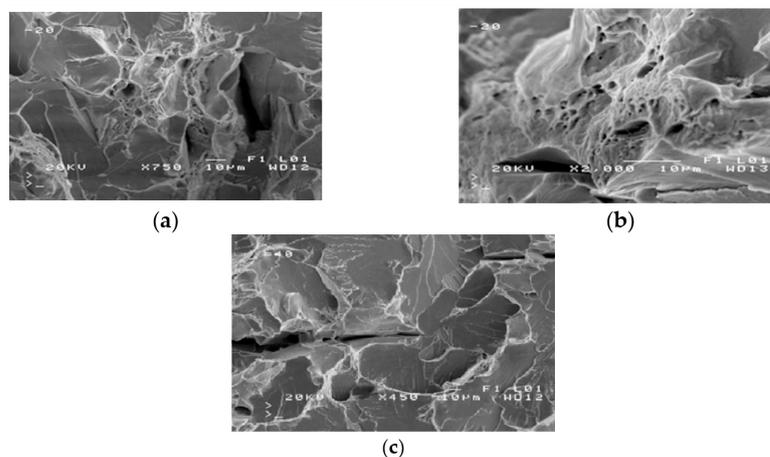
Figure 9. Scanning electron microscope (SEM) views: (a) a fracture with a mixed structure; (b) plastic fracture with a crater-like structure; and (c) brittle fracture obtained at −40 °C (handy-size bulk carrier 30182 DWT).

The area of a ductile crack with a crater-like structure is shown in Figure 9b. Figure 9c shows the fractures obtained in tests conducted at $-40\text{ }^{\circ}\text{C}$.

Fractures obtained in tests performed at $-40\text{ }^{\circ}\text{C}$ have a brittle structure. Running along cleavage planes, the cracks have a typical “river basin” appearance. Large fracture-based cracks are also observed.

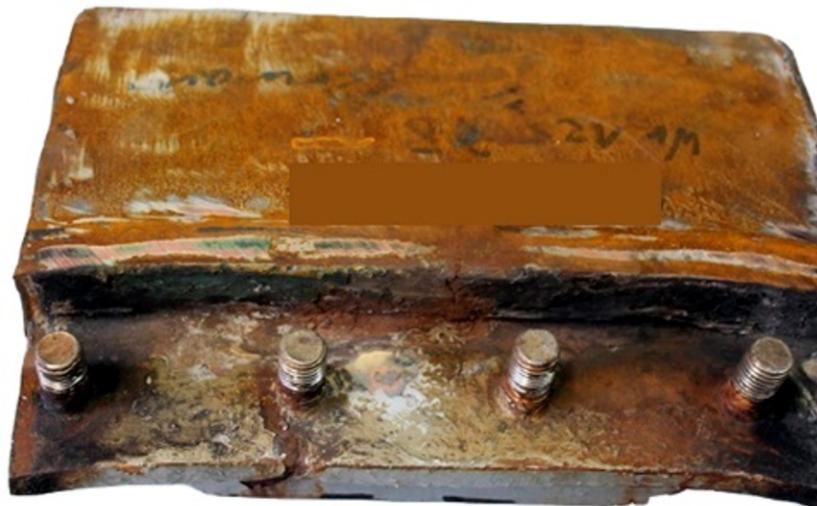
Figure 10. The section of a marine manhole from the handy-size bulk carrier 30206 DWT. Macroscopic examination.

Figure 10 shows two cracks, also numbered 1 and 2 in Figure 12a,b. Crack 1 probably originates on edge A of element I and runs next to the bolt toward element II. Crack 2 originates on edge C of element II (Figure 11). To analyze crack 1, a bar of the plate (12 mm in size, perpendicular to parts I and II) that contained crack 1 was cut out. Figure 13a shows the sample obtained after cutting off a large part of the cracked element I.

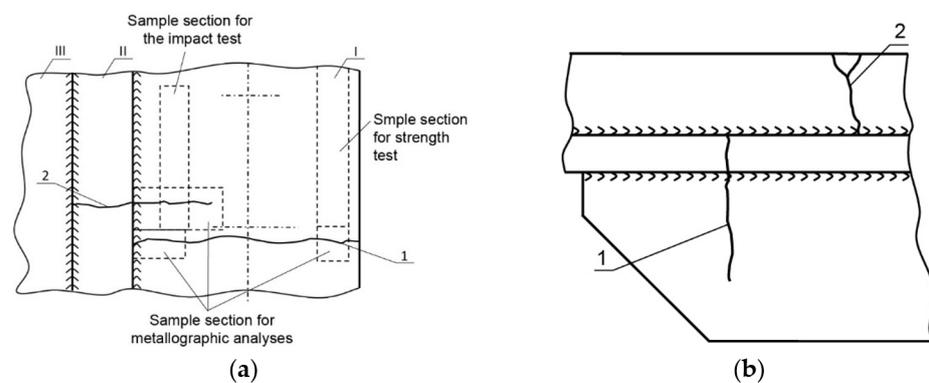
Figure 12. The picture of y cracks in a manhole from a handy-size bulk carrier 30206 DWT: (a) Y-view and (b) X-view.

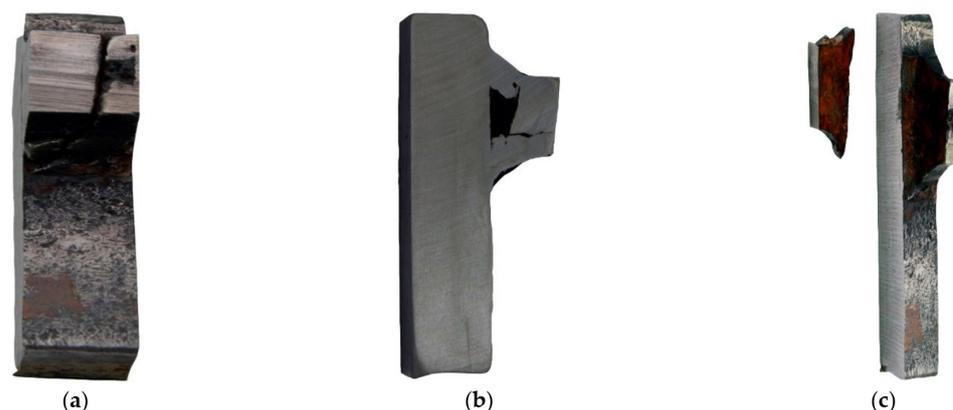
Figure 13. A macroscopic examination of crack 1 (handy-size bulk carrier 30206 DWT): (a) the bar cut from elements I and II, containing crack 1; (b) the joint between elements I and II and (c) the exit of crack 1.

A cross section of the joint between the two elements is shown in Figure 13b. The right part in Figure is element II, and the left part is the remainder of the cut-off element I. In the cross-section shown, both elements are virtually not welded together. The joints concerned are similar to two other cross-sections made at a distance of about 100 mm and 120 mm from the first section. In the condition of the area being examined, element I acts independently of the entire manhole structure—they do not form a whole. Because element

I is not reinforced by other structural components in this section, it undergoes significant local strain due to the work load. This probably initiates cracking on edge A, although massive corrosion on the fracture surfaces makes it impossible to pinpoint the origin of the crack. The crack extends towards element II, but it does not create another crack since there was no connection between them. It then passes through the weld and exits (Figure 13c).

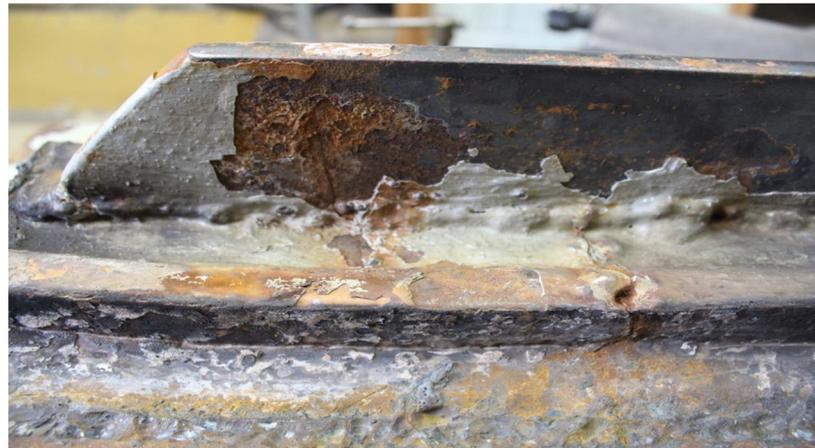
Figure 14. The crack in element IV (handy-size bulk carrier 30206 DWT). Macroscopic examination.

It is very important that element IV is not destroyed in a manner typical for stiffening ribs, in which a crack initiates on its free outer edge as a result of cyclic strain in the plane perpendicular to the deck. Thus, it can be concluded that deformations and the related stresses did not exceed the structure's ultimate strength in this plane. Element IV was destroyed due to the crack in element I.

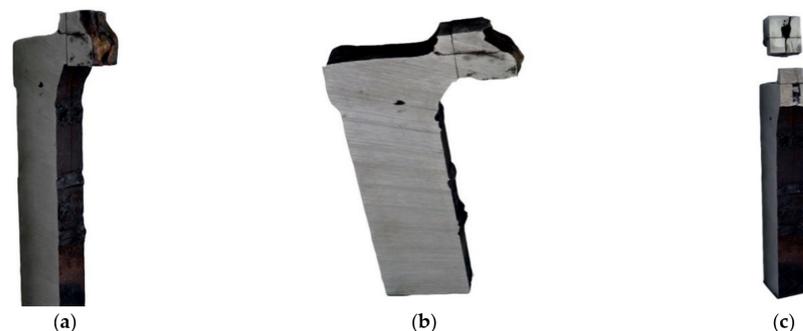
Figure 15. A macroscopic examination of crack 2 (handy-size bulk carrier 30206 DWT): (a) the crack running across parts I, II, and III; (b) the cross-cut of part II in the area of the origin of crack 2; and (c) the cross-cut of part II in the area of the origin of crack 2.

There is a very large metallurgical inclusion, approximately 10 mm in size, in the cross-sectional plane, situated near the origin of the crack. The inclusion is located in the material of part II, near surface C, and caused the initiation of crack 2. The formed crack developed across the entire height of element II up to surface D and reached part III. Next,

it ran inside the element over a significant length (Figure 15a) crossing successive welds and spacer pads between the hole excised in the deck and the manhole structure. The crack also developed in element I (Figure 12a).

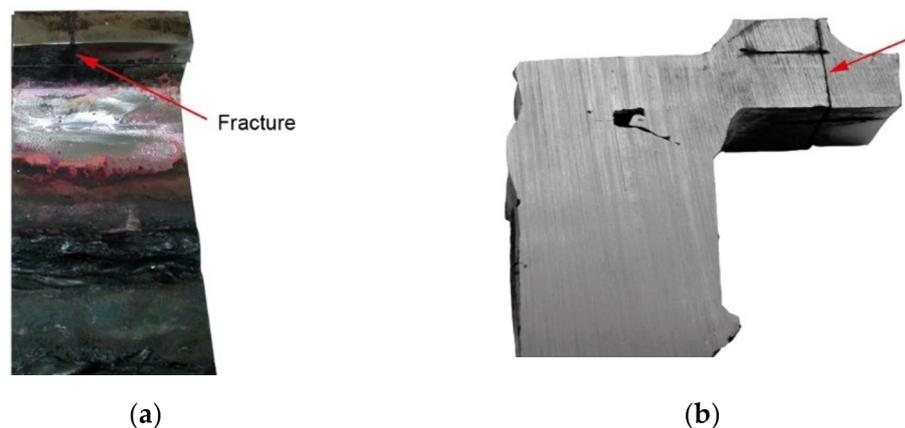
Crack 2 originated in part II next to surface X (Figure 12a) and extended toward part III. To analyze this crack, from part II, a 55 mm wide bar containing this crack was cut out perpendicular to the edge of the manhole. The cut-out bar seen from beneath the deck is shown in Figure 16a, and the cutting surface is shown in Figure 16b. In addition to defects of the welds joining the structural parts of the manhole, another cut near the crack origin was made 12 mm off surface X (Figure 12a). That cut created the surfaces depicted in Figure 15a. At the origin of crack II, a large metallurgical inclusion was found, located on the surface of part II adhered to part 1 and is very close to surface X (Figure 12a).

Figure 16. Macroscopic examination of the surface X surroundings (handy-size bulk carrier 30206 DWT): (a) the examined bar cut out from parts II and III with a visible crack and (b) the lateral surface of the bar cut out (the location of the next cut is shown).

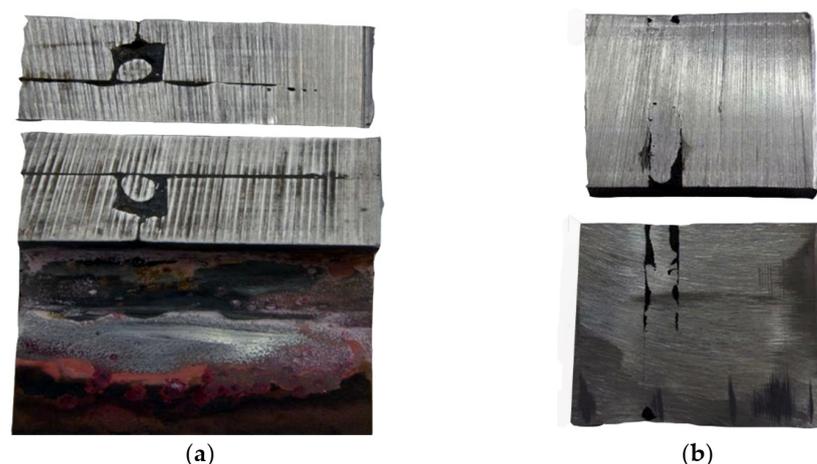
To show the extensiveness of the inclusion (Figure 17b), another cut was made perpendicular to the surface (Figure 17a), 5 mm off the line between parts I and II. The structure of the inclusion is shown in Figure 18.

Figure 17. The extensiveness of the inclusion analyzed with the use of macroscopic examination (handy-size bulk carrier 30206 DWT): (a) surfaces created by the cut shown in Figure 11 and (b) metallurgical inclusion running parallel to the surface of part II.

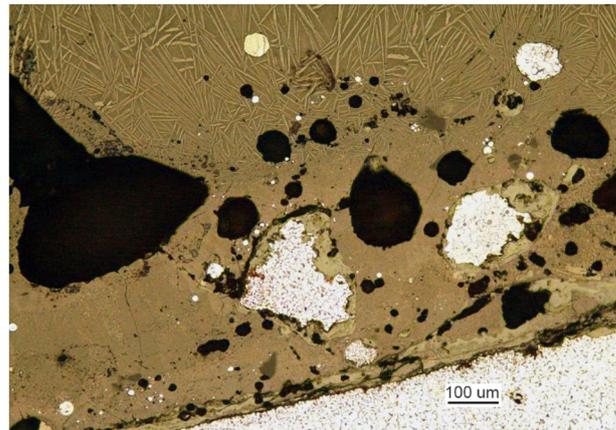
Figure 18. Fragment of the metallurgical inclusion that initiated crack 2 (handy-size bulk carrier 30206 DWT). Stereoscopic optical microscopy.

The analyzed inclusion is a portion of the scoured brick lining of a furnace mixed with charge. The analysis shows that the inclusion did not produce a corrosive but rather a mechanical effect that concentrated the stress and thereby initiated the crack and its development. When the crack reached the surface and contacted water, it started to rapidly expand due to stress corrosion that covered a large part of element II but did not reach element III; however, the crack passed through the weld and reached element I.

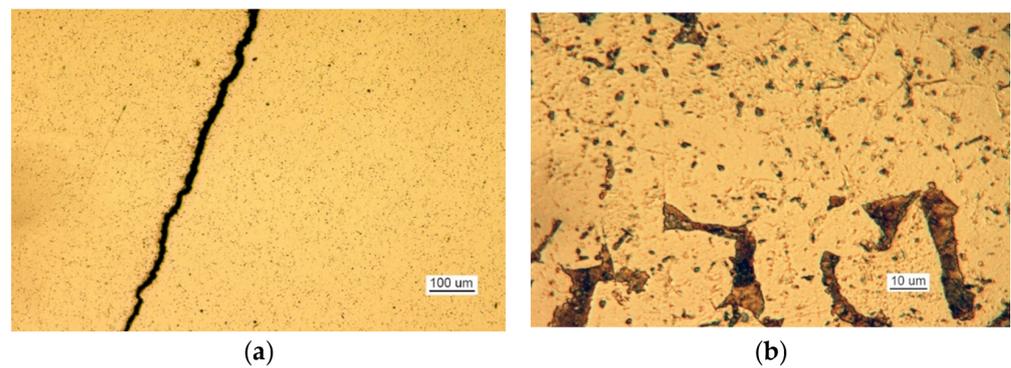
The metallographic examination was conducted on samples cut from elements I and III. A sample of element I was cut from the front of crack 2. The analysis of a non-etched specimen showed a very large amount of nonmetallic inclusions as spots of aluminum oxides and carbonitrides (Figure 19a). There were more oxides than in the TP5a pattern, and the amount of carbonitrides was higher than in the AA5b reference. The examined specimen was etched with an alcoholic solution of nitric acid to reveal the ferritic-pearlitic structure of the steel (Figure 19b). The pearlite has a varied structure with the largest interplate distance corresponding to pattern 7 on scale 1 according to PN-66/H-04505 [58].

Figure 19. Optical microscopy views (handy-size bulk carrier 30206 DWT): (a) the crack and a very large number of spot-wise oxides and carbonitrides. Non-etched specimen; and (b) the ferritic and pearlitic structure of the material of element I.

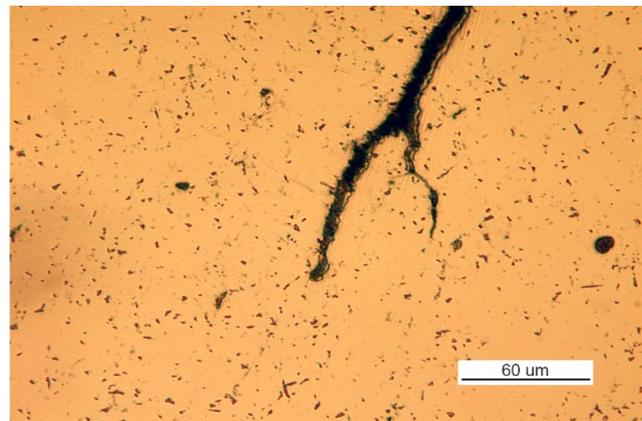
Over its entire length, including the front (Figure 20), the crack was filled with corrosion products, which indicates that cracking was based on stress and corrosion.

Figure 20. The crack front. Non-etched metallographic specimen (handy-size bulk carrier 30206 DWT). Optical microscopy.

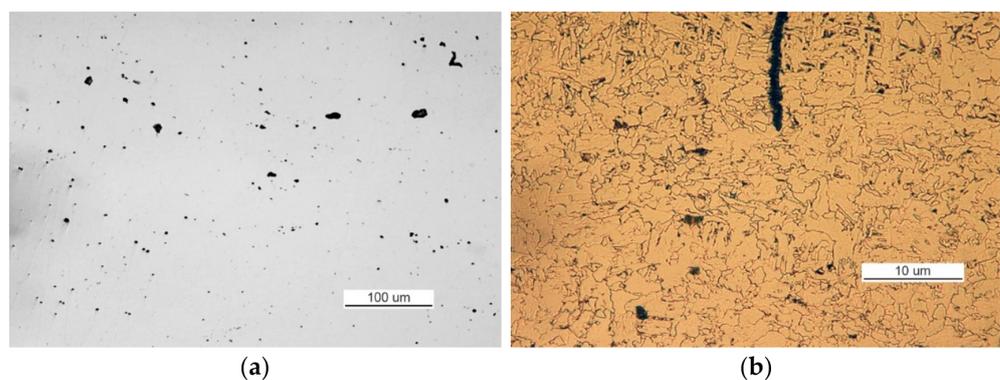
A sample of element III was cut from the front of crack 2. The examination of the non-etched specimen (Figure 21a) shows a large number of nonmetallic inclusions as spot-wise oxides, and this number corresponds to TP5a pattern and globular silicates corresponding to KN5b pattern according to PN-64/H-04510 [57].

Figure 21. Optical microscopy views (handy-size bulk carrier 30206 DWT): (a) nonmetallic inclusions in the structure of element III (non-etched metallographic specimen) and (b) structure of the steel near the front of crack 2.

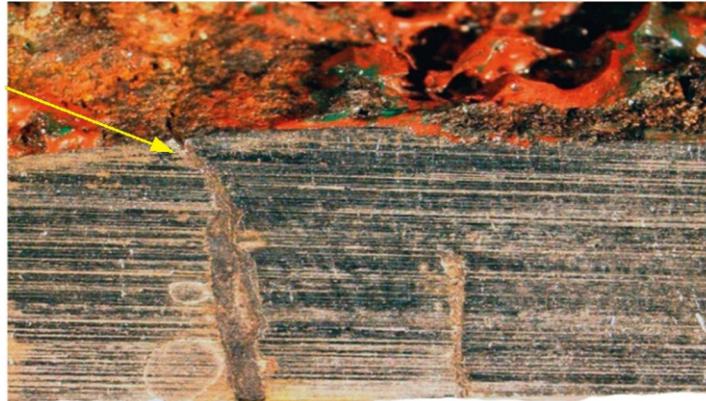
Over its entire length (including the front), the crack was filled with corrosion products, which indicates that cracking was based on stress and corrosion. At the origin of the crack, a very large metallurgic inclusion (Figure 22) was found that contained sulfides and other substances. Because the inclusion was located near the surface, water more easily entered the inclusion during vessel operation. In the presence of water, sulfides dissociate to form sulfuric acid; thus, a strong electrolyte is present, creating conditions for intense crack development, indicating that the crack is stress-corrosive.

Figure 22. The passage of the crack from part II into part I through the weld that joins the two parts (handy-size bulk carrier 30206 DWT). Macroscopic examination.

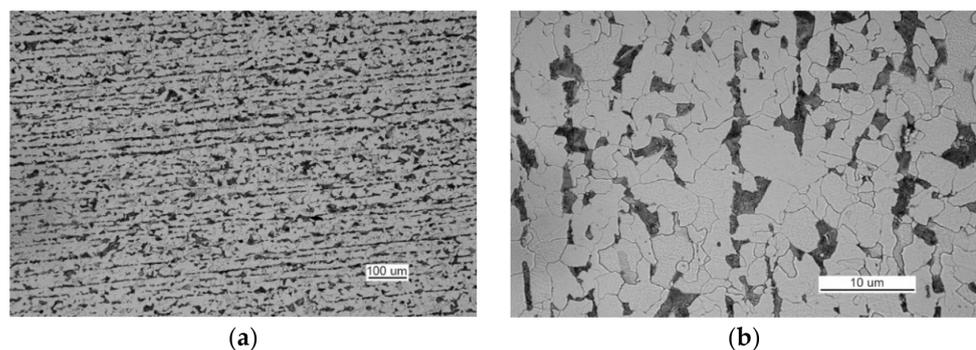
The structure of the steel used to make part II is ferritic and pearlitic (Figure 23a), with an intermittent cementite network at the ferrite grain boundaries (Figure 23b). The metallographic specimen was etched with an alcoholic solution of nitric acid, and it was observed on a Nikon MM-40 optical microscope (Nikon Instech Co., Ltd., Kawasaki, Kanagawa, Japan).

Figure 23. Optical microscopy views (handy-size bulk carrier 30206 DWT): (a) the ferritic and pearlitic structure of the steel of part II and (b) structure of the steel of part II (the cementite network is intermittent at the grain boundaries).

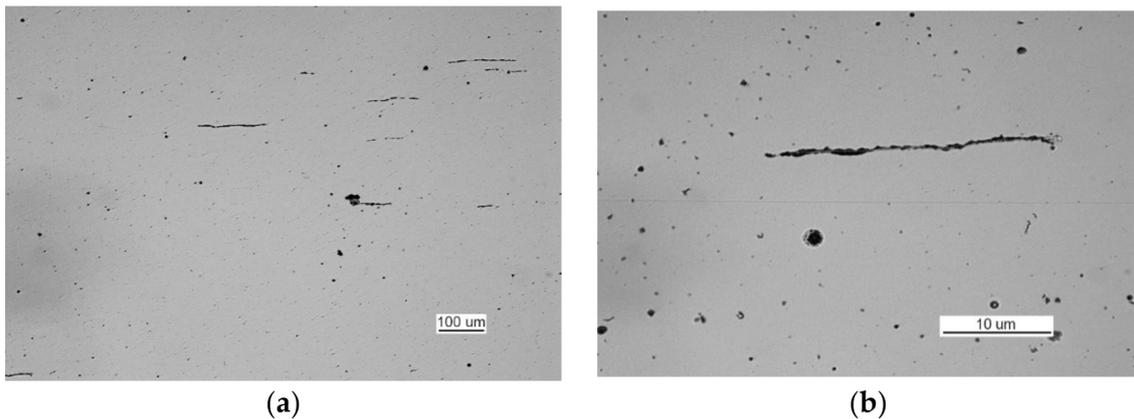
Figure 24. Optical microscopy views (handy-size bulk carrier 30206 DWT): (a) numerous rolled-out sulfides and oxide spots and (b) rolled-out manganese and iron sulfides with adjacent silicates and numerous oxide spots.

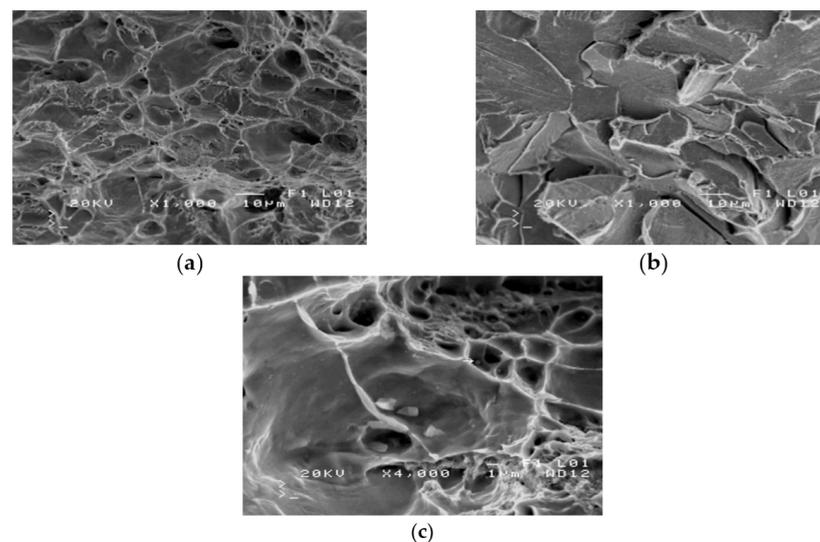
The observed fracture has a mixed structure (Figure 25b,c) that includes ductile, crater-shaped areas (Figure 25a) adjacent to areas of the brittle structure (Figure 25b). There are numerous non-metallic inclusions located inside the craters, as shown in Figure 25c.

Figure 25. Scanning electron microscope (SEM) views (handy-size bulk carrier 30206 DWT): (a) the ductile structure of the fracture; (b) the brittle structure of the fracture; and (c) nonmetallic inclusions inside craters.

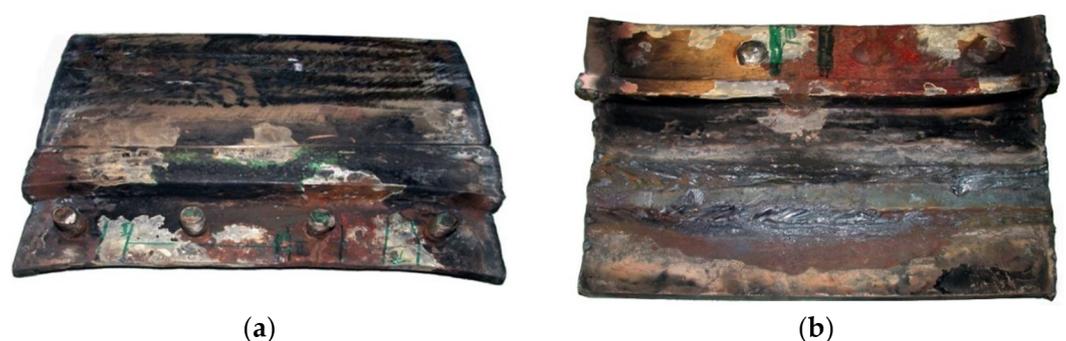
Figure 26. Macroscopic examination results (handy-size bulk carrier 30210 DWT): (a) view of a manhole section from the top of the deck and (b) view of a manhole section from the bottom of the deck.

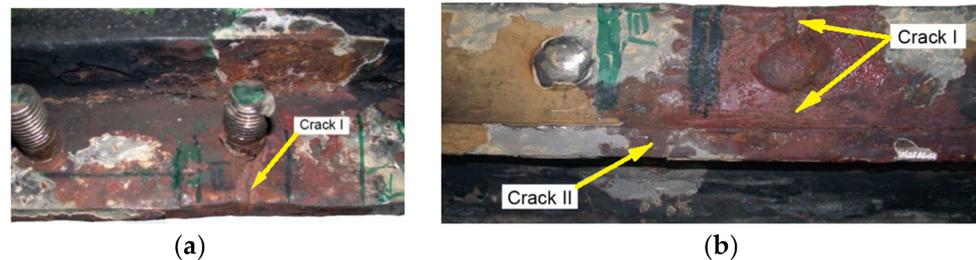
Figure 27. Macroscopic examination (handy-size bulk carrier 30210 DWT): (a) view of crack I, (b) view of crack II (crack I is visible on the right-hand side).

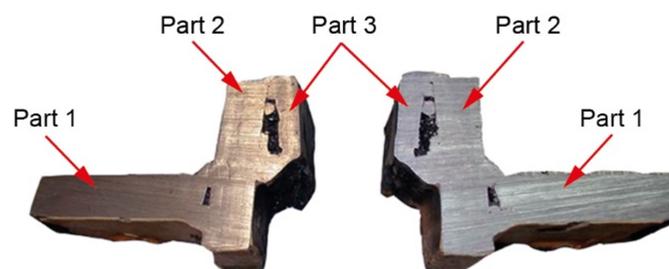
Figure 28. The cross-cut surface. Weld seam defects are shown (handy-size bulk carrier 30210 DWT). Macroscopic examination.

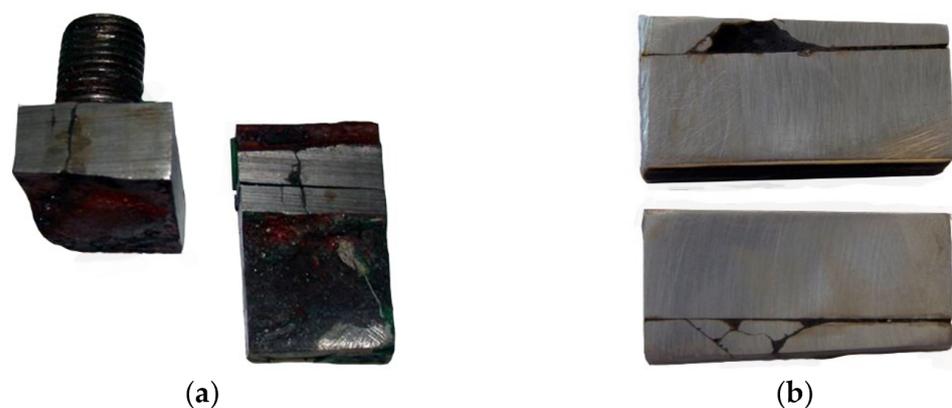
Figure 29. Macroscopic examination (handy-size bulk carrier 30210 DWT): (a) crack I and the cutting plane 2-2 and (b) the branching end of crack I.

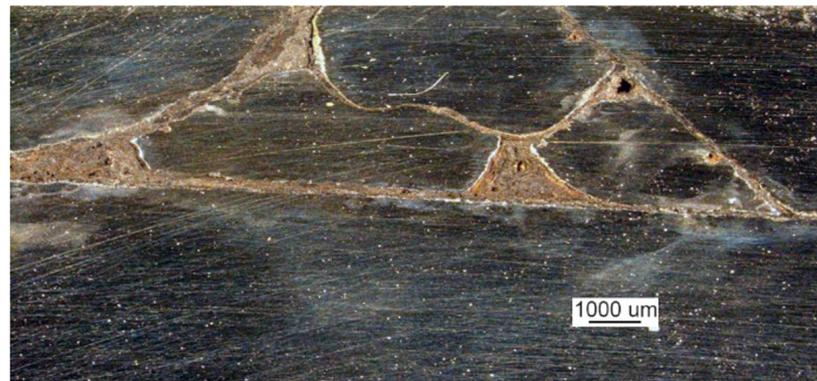
Figure 30. Degree of corrosion of crack I where it branches (handy-size bulk carrier 30210 DWT). Stereoscopic optical microscopy.

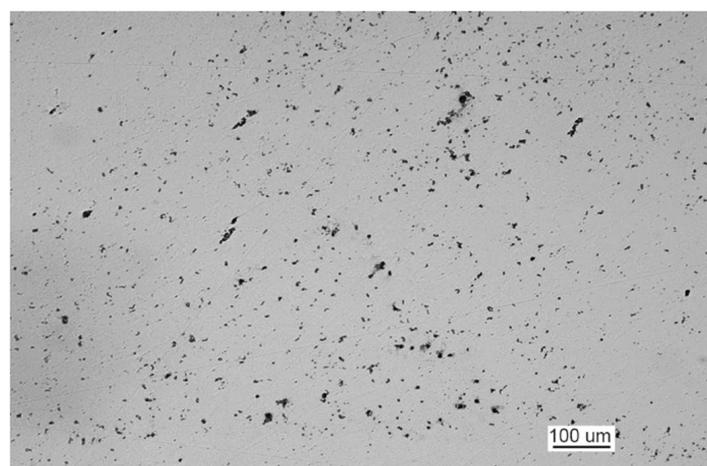
Figure 31. Non-etched metallographic specimen of part 1 showing the presence of spot-wise oxides (handy-size bulk carrier 30210 DWT).

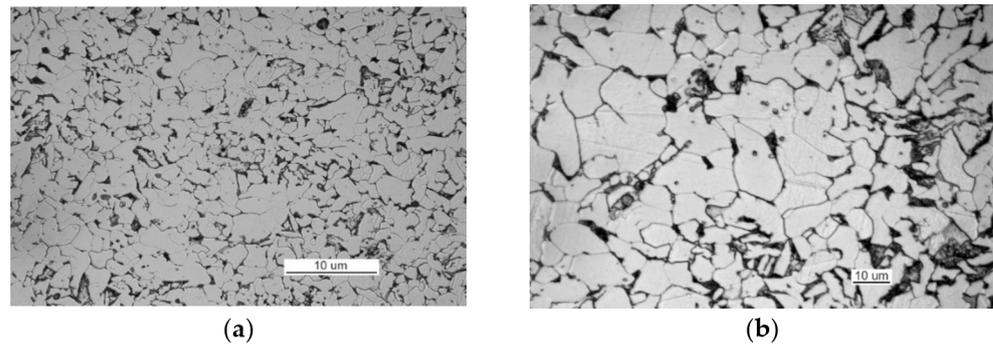
Figure 32. Optical microscopy views (handy-size bulk carrier 30210 DWT): (a) the ferritic and pearlitic structure of the material in part 1 and (b) the ferritic and pearlitic structure of the material, with visible non-continuous cementite network at the ferrite grain boundaries.

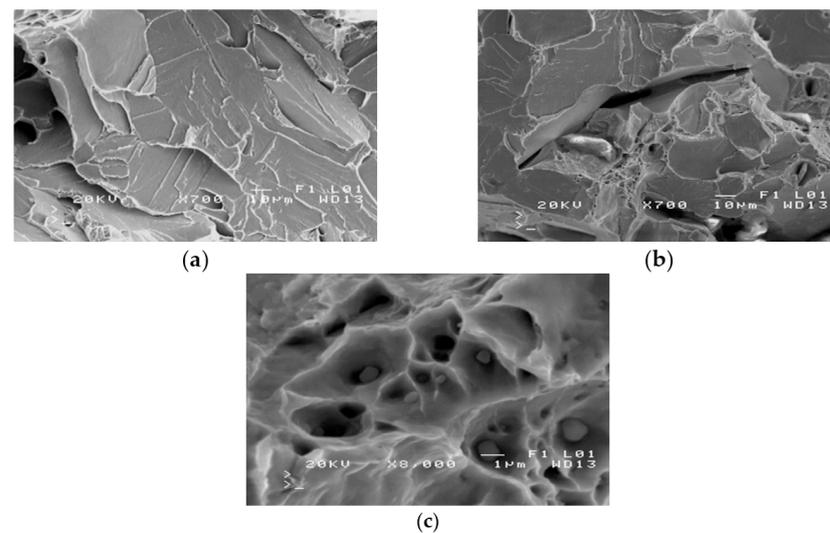
Figure 33. Scanning electron microscope (SEM) views (handy-size bulk carrier 30210 DWT): (a) the brittle fracture running along the cleavage planes; (b) fracture-based crack and small crater-like areas; and (c) spherical precipitates of silicon and aluminum oxides at the bottom of craters.

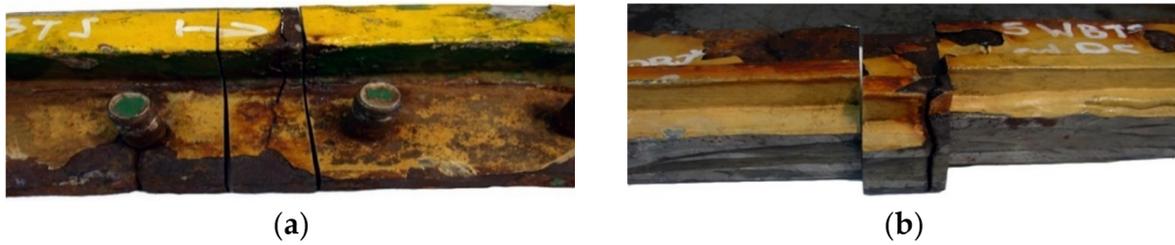
Figure 34. Macroscopic examination (handy-size bulk carrier 30185 DWT): (a) lid view of the manhole section marked 5WBTS and (b) bottom view of the manhole section marked 5WBTS.

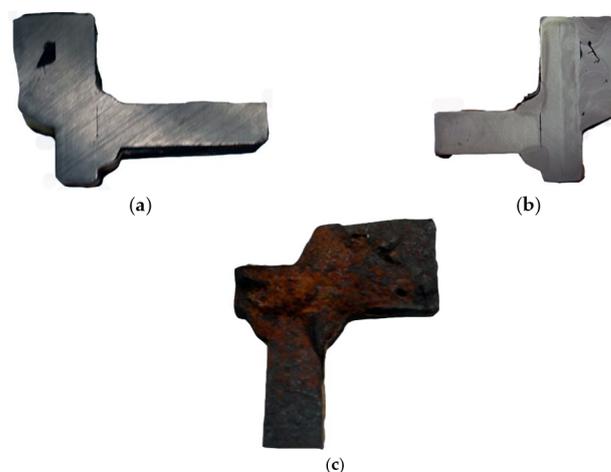
Figure 36. Macroscopic examination (handy-size bulk carrier 30185 DWT): (a) the lateral surface of the bar containing crack I; (b) view of the second side surface of the bar after etching; and (c) fracture surface.

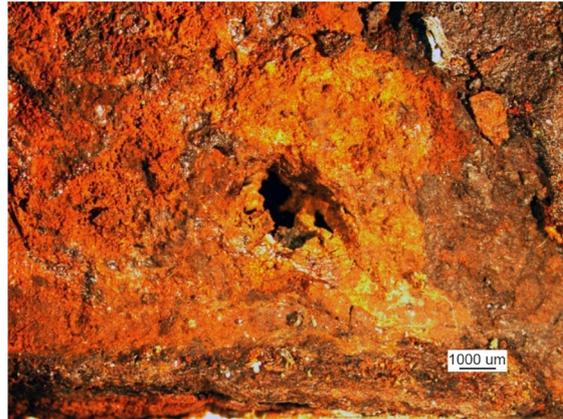
Figure 37. The deep corrosive pit is the presumed origin of the crack (handy-size bulk carrier 30185 DWT). Stereoscopic optical microscopy.

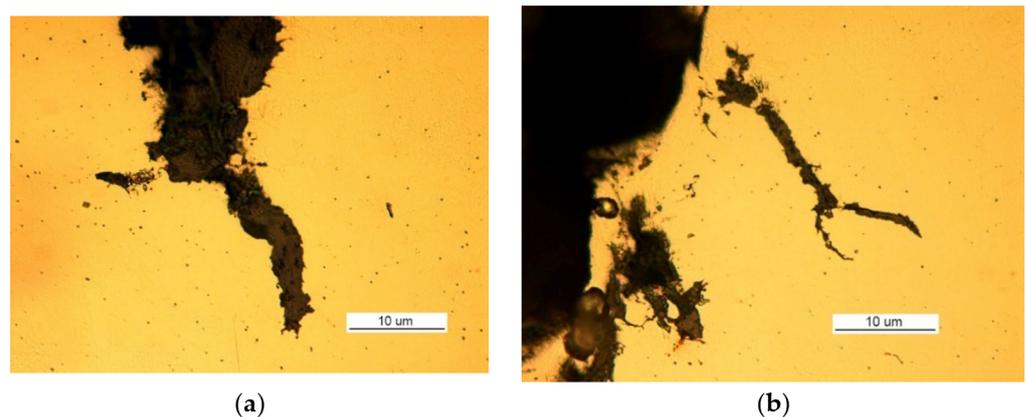
Figure 38. Optical microscopy views (handy-size bulk carrier 30185 DWT): (a) the front of the crack developing in part 1 and (b) secondary cracks filled with corrosion products.

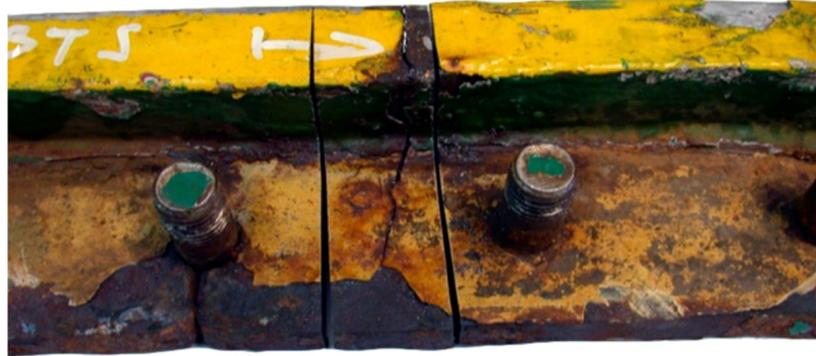
Figure 39. Crack II running through a bolt hole (handy-size bulk carrier 30185 DWT). Macroscopic examination.

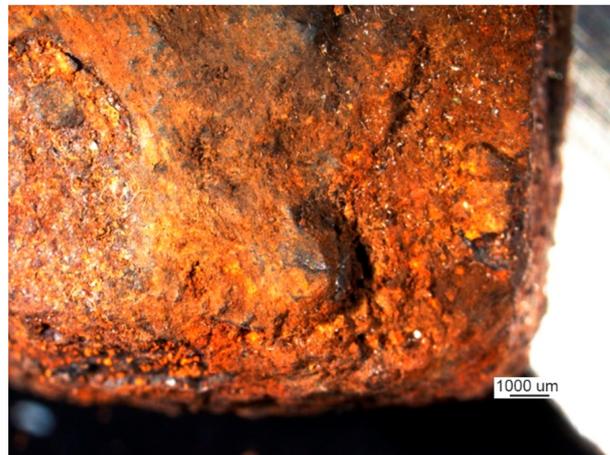
Figure 40. Corrosion pits at the edge of part 1 (handy-size bulk carrier 30185 DWT). Stereoscopic optical microscopy.

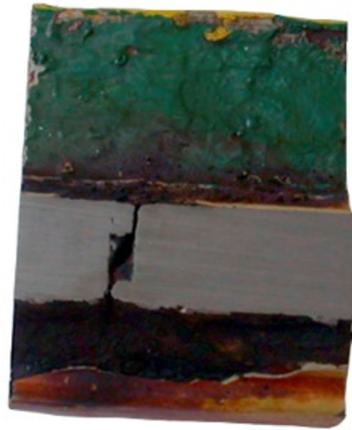
Figure 41. The merging of cracks previously branched at the bolt thread (handy-size bulk carrier 30185 DWT). Macroscopic examination.

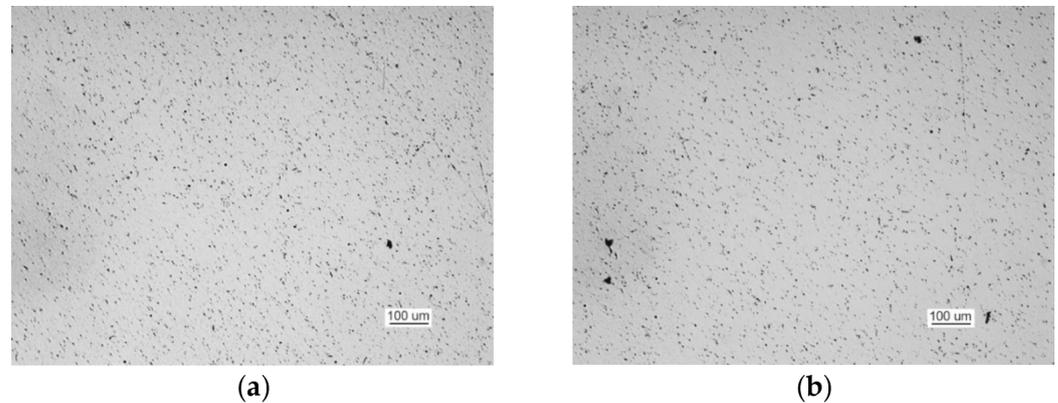
Figure 44. Optical microscopy views (handy-size bulk carrier 30185 DWT): (a) oxide spots in the material of part 1 (non-etched metallographic specimen) and (b) oxide spots in the material of part 2 (non-etched metallographic specimen).

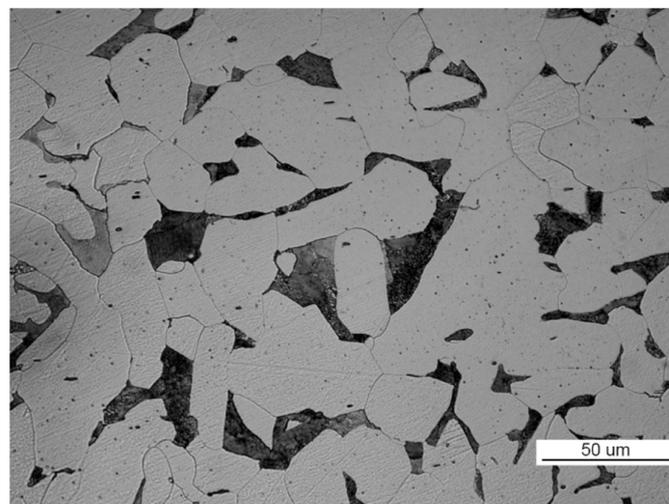
Figure 45. The structure of the steel in part 1 (handy-size bulk carrier 30185 DWT). Optical microscopy.

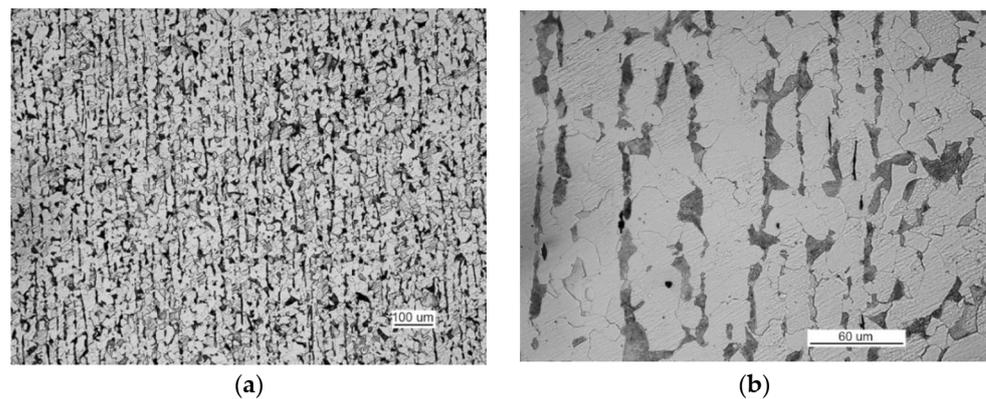
Figure 46. Optical microscopy views (handy-size bulk carrier 30185 DWT): (a) the band-like structure of part 2 and (b) material structure of part 2 with cementite, silicate, and sulfide precipitates.

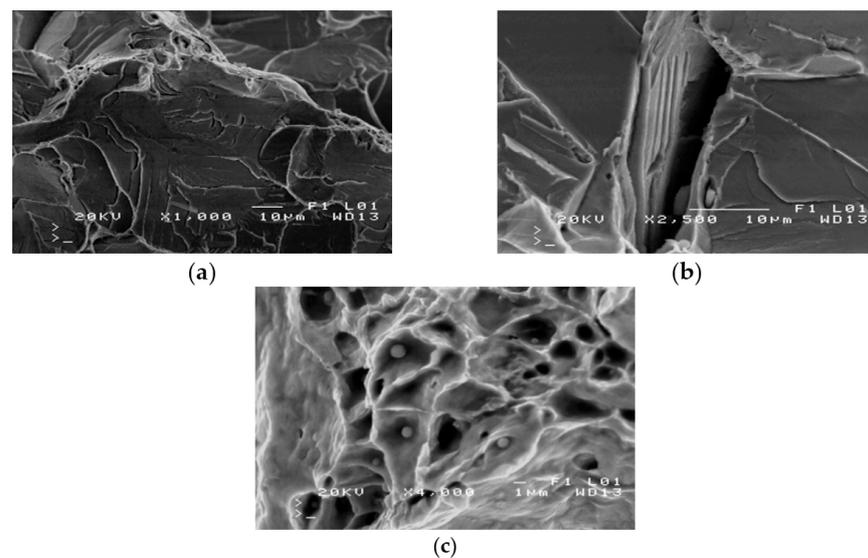
Figure 47. Scanning electron microscope (SEM) views (handy-size bulk carrier 30185 DWT): (a) brittle fracture produced after impact testing at $-20\text{ }^{\circ}\text{C}$; (b) fracture-based crack that runs through a pearlite grain; and (c) a fragment of crater-like ductile fracture (spherical precipitates of Fe and Si oxides are visible at the bottom of craters).
