Successful detection of a high-energy electrical short circuit and a “rescue” shock using a novel automatic shocking-vector adjustment algorithm

Masahiro Mizobuchi, MD,* Yoshihisa Enjoji, MD[†]

From the *Cardiovascular Center, Kyoto-Katsura Hospital, Kyoto, Japan, and [†]Tokyo Heart Center, Ohsaki Hospital, Tokyo, Japan.

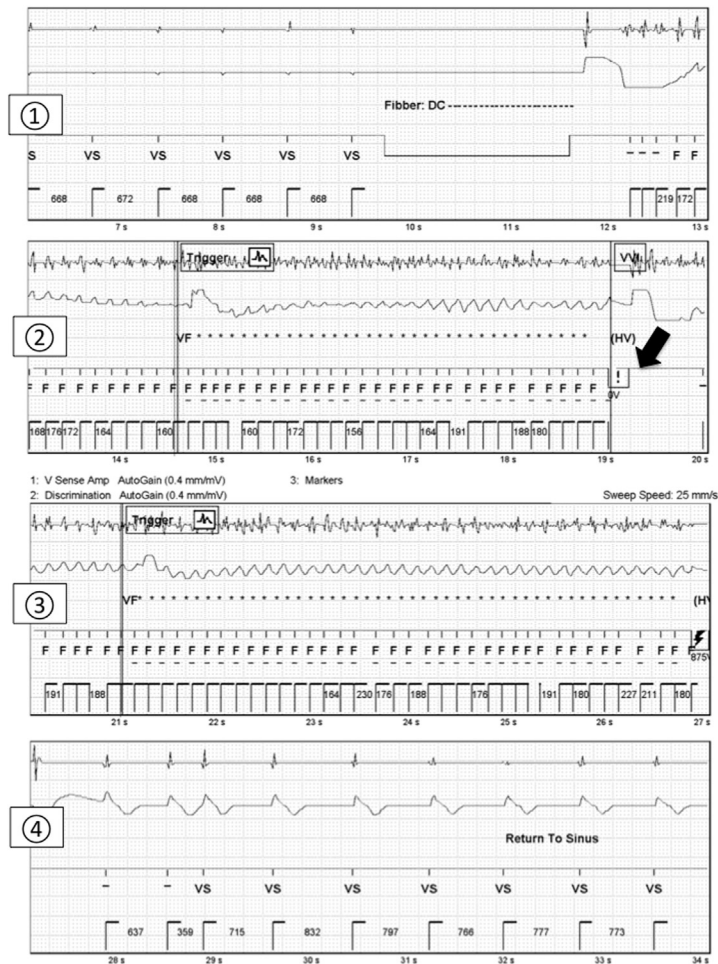
Figure 1 Intracardiac tracing during defibrillation threshold testing is shown. VF was induced ①. The first shock was implemented but failed to terminate VF. Note the exclamation point at the first shock. This mark denotes overcurrent detection. A high-voltage shock could not be delivered (“0 V”) ②. Subsequently, the next detection and charging sequence was executed. VF was successfully terminated using maximum shock delivery (875 V) of the “RV-CAN” shocking-vector configuration ③④. CAN = implantable cardioverter-defibrillator generator; DC = direct current; HV = high voltage; RV = right ventricle; VF = ventricular fibrillation.

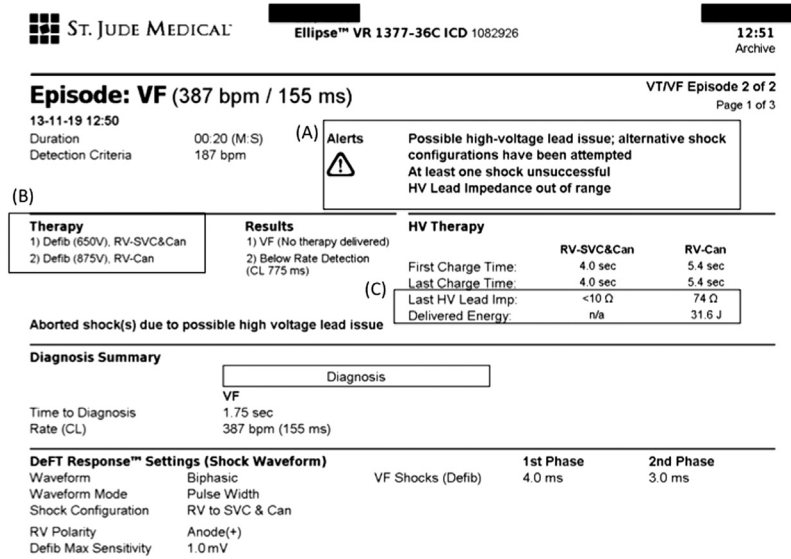
Serious adverse events, including deaths linked to Riata leads, have been reported.^{3–7} In these reports, the authors point to the risk of an HV short circuit caused by the inside-out abrasion underneath the shocking coils in the Riata lead family devices, though the incidence rate of internal abrasion short circuits underneath the SVC shock coil is quite low (0.06%).⁸ The concern is that an HV short circuit may not be detected during a routine checkup unless DFT is performed.^{4,5} Nevertheless, there are currently no recommendations or expert consensus regarding DFT during follow-up of Riata leads because of potential risks of compromised hemodynamics or failed rescue as well as overcurrent delivery, resulting in the destruction of the ICD system. Since we were concerned about the potential risk of unknown insulation break while no apparent defect was detected, DFT was performed after discussing the risk and benefit with the patient and among the device-care team. Consequently, we found that an apparently normal Riata lead had a fatal electrical failure demonstrating an HV short circuit and it occurred between the RV and SVC coils. The reasons are as follows: First, HV impedance between the RV coil and the SVC/CAN was below the detection limit, whereas during the second attempt, HV impedance between

the RV coil and the CAN was within normal limits (74 Ω ; Figure 2). Second, no physical defects (such as arc formation or burn injury) were found on the surface of the CAN and the RV shock lead or inside the subcutaneous pocket. These findings could not suggest that an HV short circuit occurred between the RV coil and the CAN because of an insulation break of the lead in the pocket. We expected that cables for the RV coil were electrically connected with the SVC coil because of an insulation defect and was short-circuited during the delivery of the first shock (Figure 3). However, strictly speaking, an arc could occur between the RV and SVC coils without physical contact at HV; therefore, it cannot be guaranteed that the RV coil cable and the SVC coil underwent a pure “electrical short.”

Figure 2 The analyzed data of defibrillation threshold testing are presented. **A:** Alert messages. **B:** The second shock vector was changed (RV-CAN), and the delivered shock was at its maximum energy (875 V). **C:** HV impedances and delivered shock energies are shown. CAN = implantable cardioverter-defibrillator generator; CL = cycle length; HV = high voltage; RV = right ventricle; SVC = superior vena cava; VF = ventricular fibrillation.

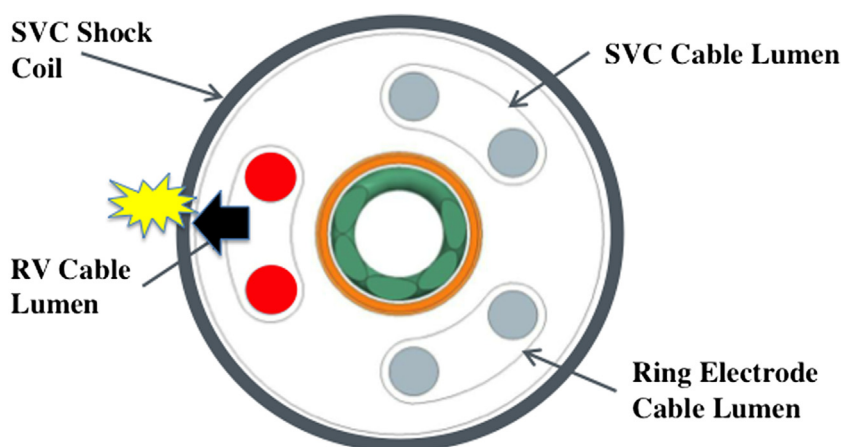
Figure 3 A possible mechanism of an HV electrical short circuit between the RV and SVC coils is demonstrated (courtesy of St Jude Medical). An internal abrasion of the lumen of an RV conductor cable could have occurred underneath the SVC coil. HV = high voltage; RV = right ventricular; SVC = superior vena cava.
