A case of Durata ICD lead coil externalization: Inside-out lead abrasion?

Ian E. Mann, MBBS, MRCP,^{*} Oliver R. Segal, MD, FRCP, FHRS^{*†}

From the ^{*}The Heart Hospital, University College London, London, United Kingdom, and [†]Barts Heart Centre, St. Bartholomew's Hospital, London, United Kingdom.

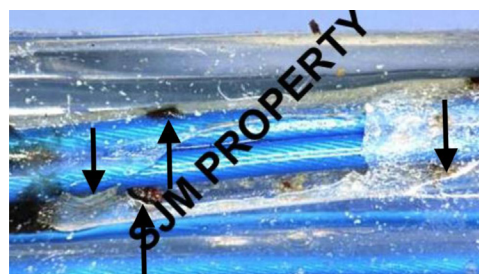
longer intact, and the intact blue ethylene tetrafluoroethylene (ETFE) insulated conductor cable can clearly be seen. The downward arrows show a crack at the distal and proximal end of the breached Optim coating. The upward arrows indicate several areas of discoloration underneath the Optim coating where biological material has collected.

The extracted Durata ICD lead was sent to St Jude Medical for detailed examination, and visual inspection, as reported by St Jude Medical, revealed “an external insulation abrasion due to friction to another device and/or feature of the heart breaching the ring electrode cable lumen. The ETFE cable coating was intact in this region. X-ray examination found no anomalies. Electrical measurements found normal coils continuities. No short circuits were found on any conduction paths.”

Figure 2 Appearance of externalization of the conductor cable 5 mm proximal right ventricular shock coil. The downward arrows show a crack at the distal and proximal end of the breached Optim coating. The upward arrows indicate several areas of discoloration underneath the Optim coating where biological material has collected.

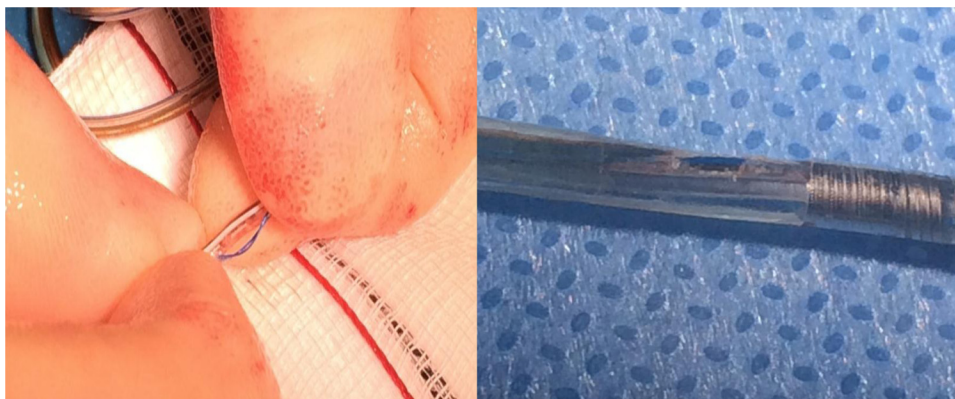
Figure 1 shows an intraoperative photograph of the Durata ICD lead taken immediately after extraction. There is a clear breach of the outer protective Optim coating, suggesting possible inside-out lead abrasion. Closer examination of the extracted Durata lead shows the appearance of externalization of the conductor cable 5 mm proximal to the RV shock coil (Figure 2). In this region, the silicone–polyurethane copolymer (Optim, St Jude Medical) is no

Figure 1 Images show a clear breach of the outer protective Optim coating, where the blue ethylene tetrafluoroethylene-coated conductor cables can be seen.

The leads in this case were explanted without laser or powered sheaths, requiring only simple traction after severing the distal portions of the leads and insertion of a locking stylet, meaning the presence of lead damage cannot be the result of the extraction process. The appearance of biological material that had collected under the breached outer Optim coating is indicative of a pre-existing insulation breach and supported by a previous study from Swedlow et al,¹⁰ who concluded that a longer duration of breach increases the likelihood of biological material collecting. They also found that in comparison with the postulated inside-out lead insulation failure of the copolymer coating, the unequivocal explant-related damage was at a different location on the lead, with a distinctive appearance (including linear tears and melting).¹⁰ In the present case, there is cracking of the proximal and distal ends of the breached Optim coating in the longitudinal plane of the lead with the appearance of the outer borders of the abrasion overlying the inner borders of the abrasion. This also supports an inside-out abrasion rather than outside-in, as well as reciprocal compressive bending. We believe the findings in this case point to inside-out lead abrasion of the Optim coating, causing ICD lead noise and sensing failure necessitating extraction.

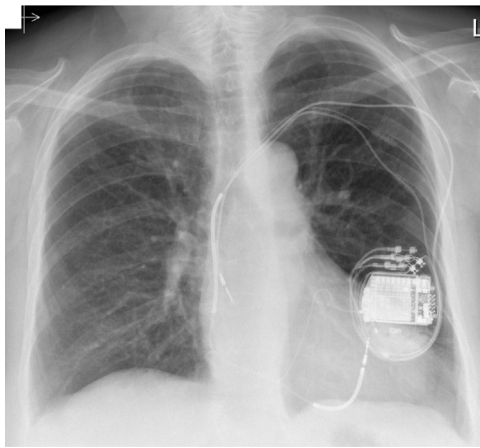
In contrast to this opinion, examination of the chest x-ray image prior to extraction (Figure 3) shows that the section of lead with the insulation breach was within the right ventricle and not in contact with another mobile structure or near the generator. The section of the lead with the abrasion is straight and not angulated. Furthermore, no independent movement of the leads relative to one another is seen on the fluoroscopic images, making external abrasion, in our opinion, impossible.

Figure 3 Plane film chest radiograph prior to the extraction procedure. The section of lead with the insulation breach was within the right ventricle and not within contact of another mobile structure or near the generator.
