Case report

Gross trunnion failure after a metal-on-polyethylene total hip arthroplasty leading to dissociation at the femoral head-trunnion interface

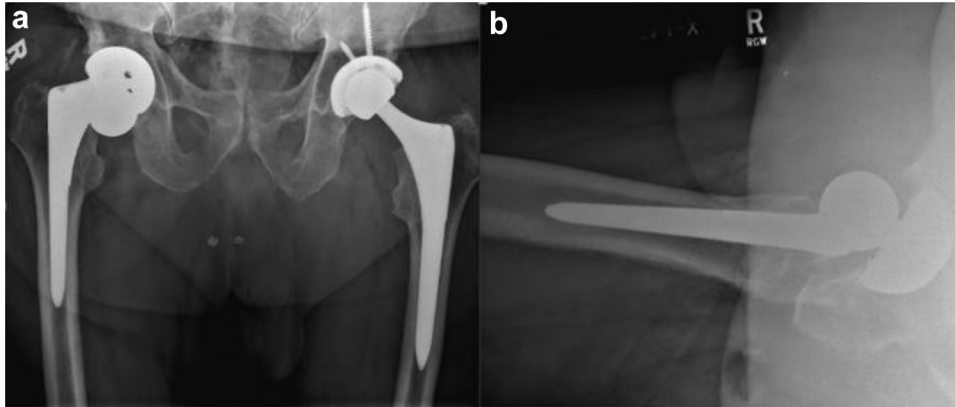
Our patient is a 77-year-old man who was 10 years status post right THA. His index procedure was performed with a Zimmer Trabecular porous proximally coated double-taper titanium primary femoral stem (Zimmer Orthopedics, Warsaw, IN), while the acetabular component used was a Zimmer Trabecular metal cup (Zimmer Orthopedics, Warsaw, IN). The base of both components was composed of Titanium, a proprietary Ti-6Al-4V titanium alloy. The femoral head component was a 36-mm CoCr alloy head. Femoral length and offset information could not be obtained. [Figures 1 and 2](#) are his preoperative and postoperative radiographs from 10 years before presentation. The patient was doing well without any prodromal symptoms for 10 years until he had an acute onset of right groin pain upon trying to rise from a seated position. He noted a “loud pop” with associated sharp groin pain during the incident. Immediately after the incident, he was only able to bear partial weight on his right lower extremity secondary to pain and weakness. He started using a walker to assist with ambulation. Clinically, the patient had a leg length discrepancy. His right lower extremity was 3.5 cm shorter than his left. The anteroposterior and lateral radiographs of the affected hip demonstrated what appears to be a GTF [[3,6,7](#)] ([Fig. 3](#)).

Figure 3. Anteroposterior pelvis (a) and lateral hip radiographs (b) from January 2018 demonstrating hardware failure consistent with dissociation at the right femoral head-stem interface. Left total hip arthroplasty was performed on 03/2017 by a different surgeon.

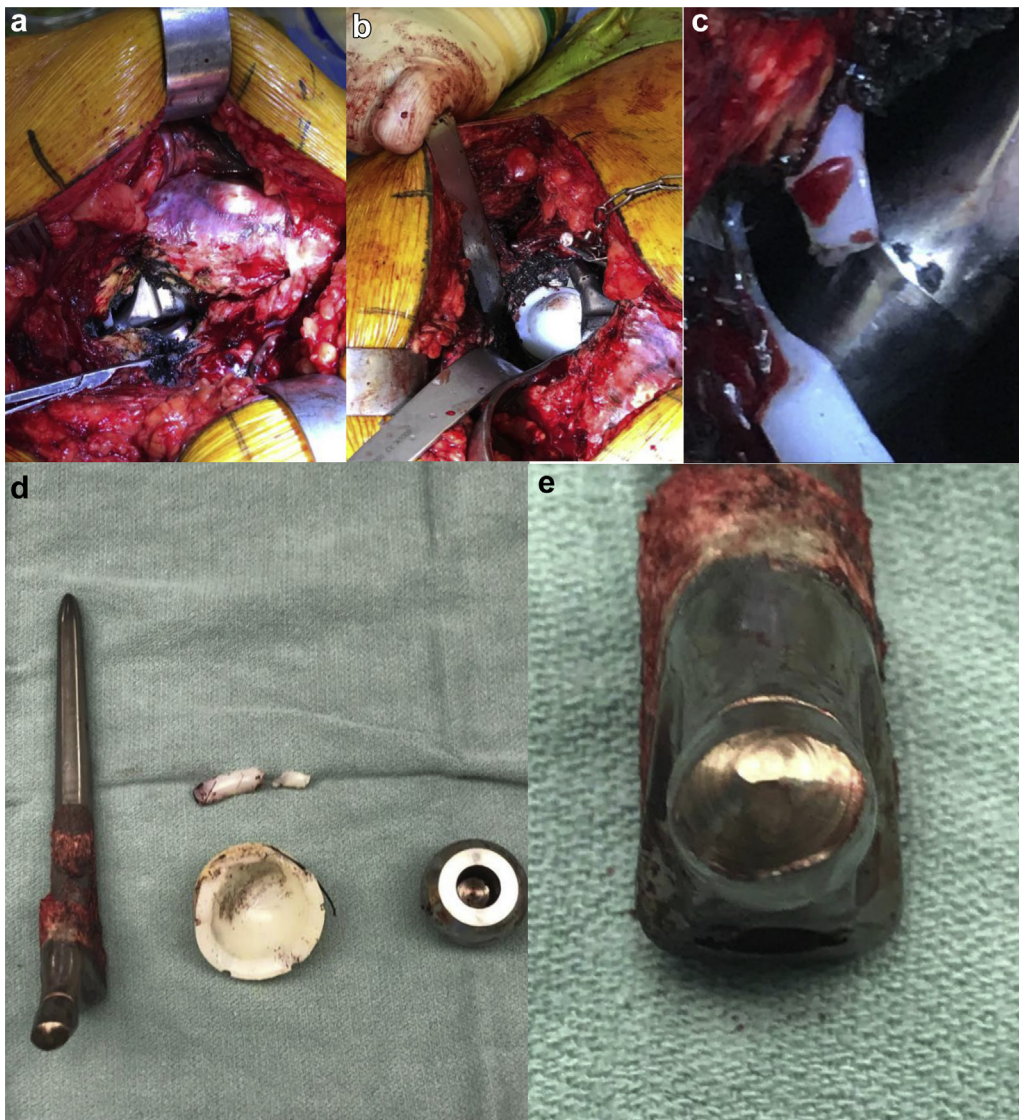
Informed consent for revision surgery and case report was obtained from the patient. At the time of revision surgery, a posterolateral approach to the hip was used using the prior incision from his initial THA procedure. After performing a capsulotomy, there was gross evidence of dark metal debris and possibly corrosion products within the hip joint ([Fig. 4a and b](#)). Multiple tissue cultures were negative. The femoral head was noted to have completely dissociated from the femoral stem trunnion. The polyethylene liner was fractured at the anterior superior edge ([Fig. 4c and d](#)), and the trunnion was severely worn to the point of being elliptical as opposed to cylindrical ([Fig. 4d and e](#)). Both the femoral stem and the acetabular component were well fixed without evidence of osteolysis. Excisional debridement of the dark-stained and necrotic soft tissue was performed, followed by irrigation and liner exchange with placement of a new highly cross-linked polyethylene liner in the original acetabular component because there was no damage to the locking mechanism. With regard to the femoral stem, the trunnion wear was so severe that the trial head would not stay in place on the femoral trunnion, so femoral revision was performed. We used an extended trochanteric osteotomy for

Figure 4. Intraoperative images from the revision right total hip arthroplasty in February 2018. (a) Posterolateral surgical approach to the right hip with obvious metallosis in the hip joint and the soft tissues surrounding the implants. Notable is the dislocated CoCr femoral head that the instrument is pointing to. (b) Evidence of wear on the polyethylene liner from the femoral stem after dissociation of the head. (c) Fractured polyethylene liner. (d) Explanted components with significant wear noted about the trunnion to the point that the trunnion was elliptical instead of cylindrical, and on the polyethylene with notable fracture of the liner. (e) End-on view of the worn trunnion.

Our case supports previously published literature as our patient had several identified risk factors listed above. Our patient is male, with a BMI of 33.8, and had an implantation time of 10 years. Our patient also had a 36-mm CoCr femoral head. We believe the cause of failure to be several years of MACC, leading to GTF and subsequent polyethylene damage related to the trunnion articulating with the polyethylene liner after the dissociation. It is important to note that we cannot definitively confirm MACC as the cause of failure because we did not obtain serum metal levels preoperatively, but given the similarities shared between our patient and previously published risk factors, MACC is likely cause of failure. MACC leading to GTF continues to gain awareness as a rare but

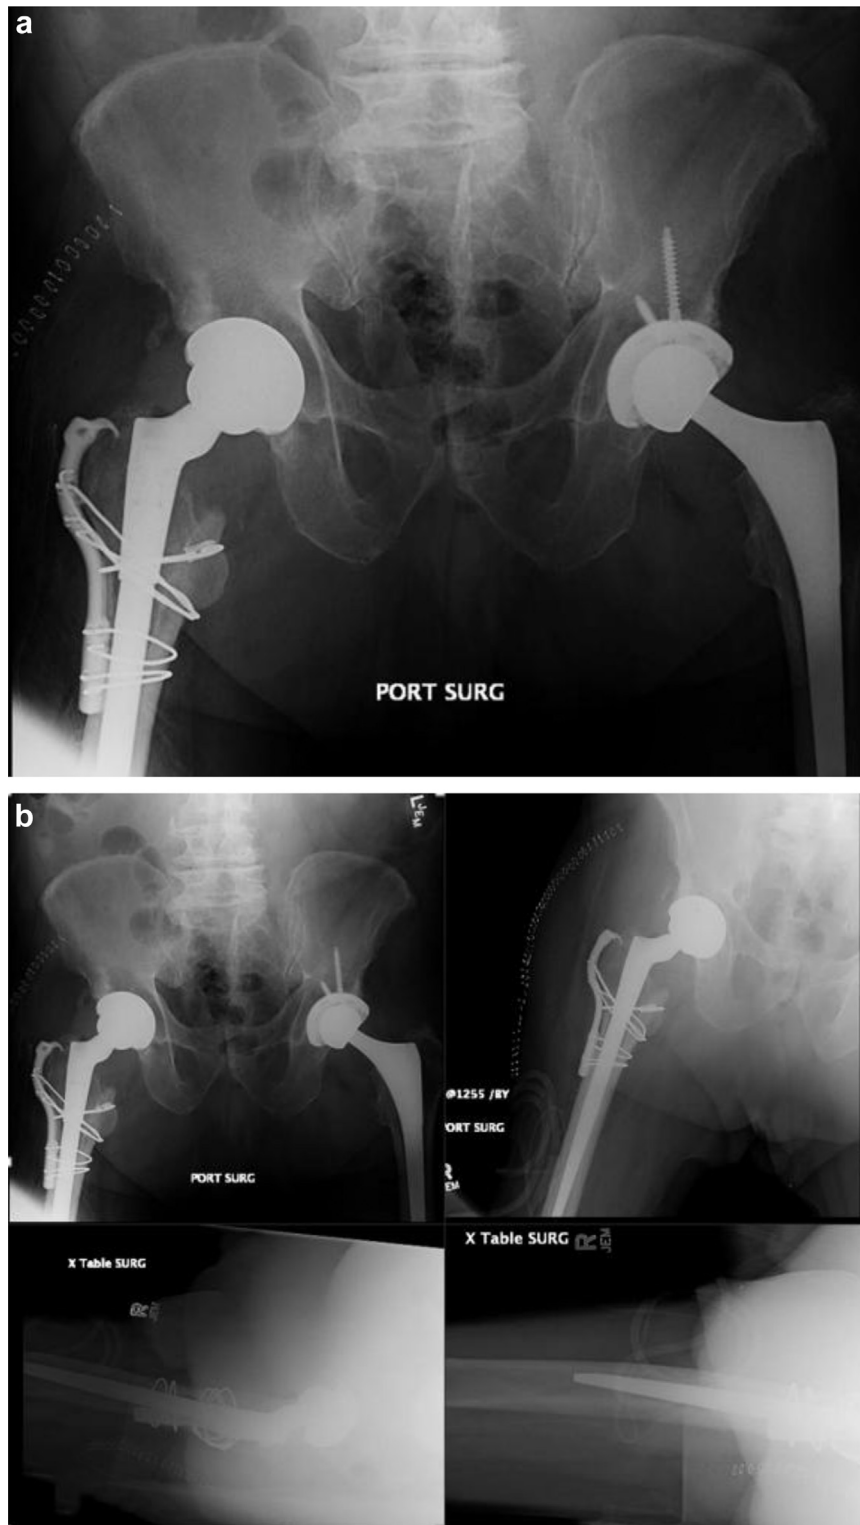
Figure 5. (a) Postoperative anteroposterior pelvis radiograph showing the reconstruction with a modular femoral stem, cables, and greater trochanteric hook plate. (b) Postoperative anteroposterior and lateral radiographs of the right hip from February 2018 after revision right total hip arthroplasty.

removal of the femoral stem. A Zimmer Biomet tapered modular cementless revision stem (Zimmer Orthopedics, Warsaw, IN) with a 36-mm ceramic head was placed ([Fig. 5](#)).

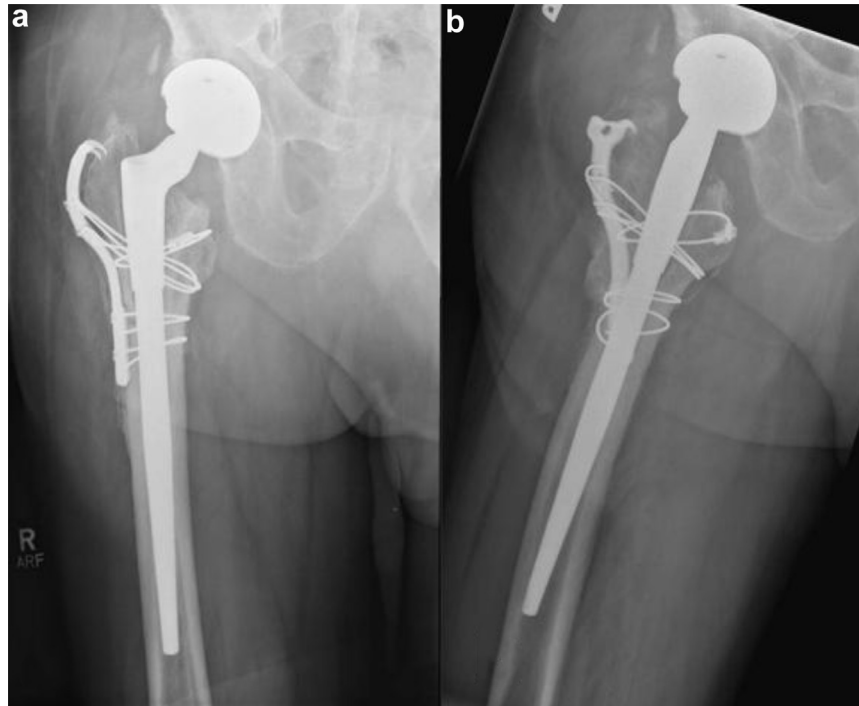
The patient’s postoperative course was uneventful and at the patient’s latest follow-up (8 months postoperatively), the osteotomy site had completely healed ([Fig. 6](#)). The patient was mobilizing pain free, without functional limitation, and had returned to his usual activities.

Figure 6. Anteroposterior (a) and lateral (b) radiograph of the right hip from August 31, 2018, showing maintenance of good alignment of all the hardware, good interval healing, and no complicating features.
