Case Report

Placement of the Internal Pulse Generator for Deep Brain Stimulation in the Upper Back to Prevent Fracture of the Extension Wire due to Generator Rotation: Case Report

Ankur Garg, Avinash L. Mohan, and P. Charles Garell

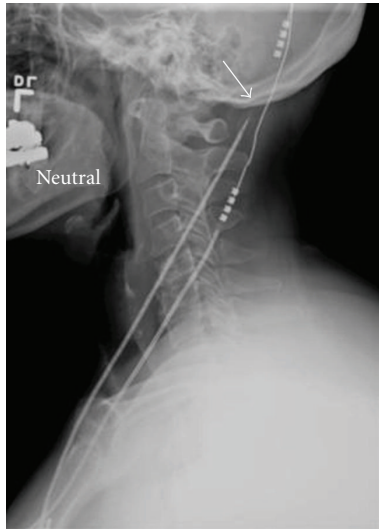
2.2. Second Operation. In April 2006, the patient reported that her symptoms were increasingly less well controlled and that she experienced occasional tingling-type sensations in the right retroauricular region. Interrogation of her DBS system revealed very high impedance (>2000 ohms) on all combinations on the right side, whereas impedance was within the normal range on the left side. An X-ray revealed a discontinuity in the integrity of the extension wire on the right (Figure 1). Elective replacement of the right-sided

FIGURE 1: Lateral X-ray showing discontinuity of the right extension lead (arrow). Note that both the right and the left connections are low relative to the skull.

extension lead and IPG and movement of the connection on the skull surface were performed in May 2006. The patient reported immediate improvement in her symptoms. Postoperative interrogation of the DBS system revealed the impedance to be less than 1800 ohms on both sides.

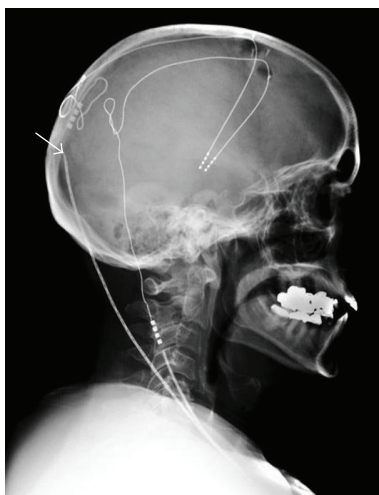
FIGURE 2: Lateral X-ray showing a new discontinuity of the right extension lead over the skull at the connection to the right DBS electrode. Note the braided appearance of the right extension lead.

2.3. Third Operation. In August 2006, the patient reported increased bradykinesia and speech difficulties. Her medications were increased, resulting in mild to moderate dyskinesias. Interrogation of the DBS system revealed that the impedance on the right was again >2000 ohms for all combinations, whereas it remained <1800 ohms on the left side. Followup X-rays revealed a braided appearance and a new discontinuity of the right extension lead (Figure 2). On

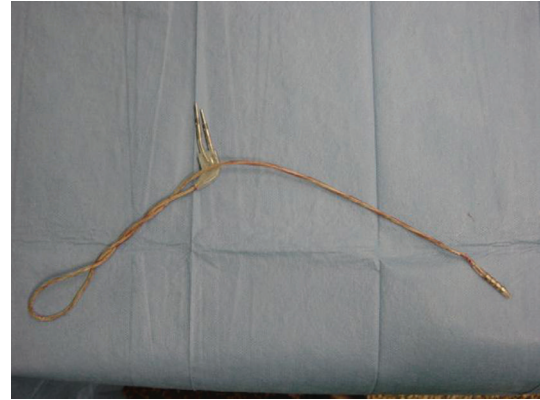
FIGURE 3: Appearance of the right extension lead during the third operation.

the basis of the clinical, electrophysiological, and radiological evidences, elective replacement of the right-sided extension lead was again performed in October 2006. At operation, the extension lead was extensively coiled on itself, presumably due to the rotation of the IPG in the loose connective tissue of the right subclavicular region (Figure 3). These rotational movements created an increasing mechanical strain on the extension lead, resulting eventually in its fracture at the more firmly attached connection site. To prevent recurrence, we created a smaller subclavicular pocket by obliterating the excessive dead space and sutured the IPG to the surrounding fascia through two suture holes in the IPG. The patient reported immediate improvement in her parkinsonian symptoms postoperatively.

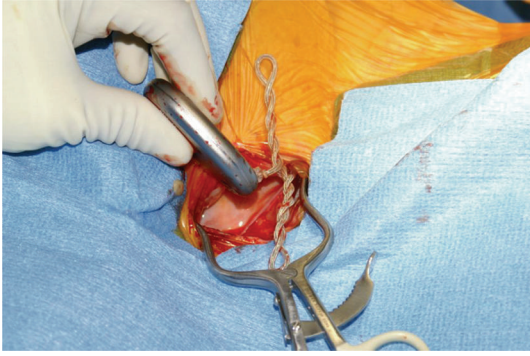
2.4. Fourth Operation. A followup X-ray in January 2007 revealed increased density in the right extension wire at multiple places that suggested new coiling. However, on interrogation, the DBS system was found to be electrically connected and functional. Followup X-rays in February 2007 revealed further increased coiling of the right extension wire. On interrogation of the right DBS system, the impedance was found to be high for all electrode combinations. At this point, we recommended placing the right IPG in the right suprascapular position. At revision surgery in May 2007, the IPG and extension lead were found to be extensively rotated (Figure 4). Postoperatively, the patient reported immediate improvement in her symptoms.

FIGURE 4: Appearance of the right IPG and extension lead during the fourth operation. Note the extensively coiled extension lead.

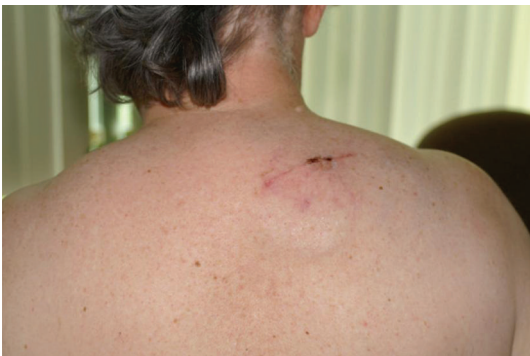
2.5. Followup. The patient has been followed for 12 months after the surgery and reports continued resolution of her symptoms (Figures 5 and 6). On interrogation on followup, the impedance was found to be within the normal range on both sides.

FIGURE 5: Postoperative appearance of the IPG implanted in the suprascapular region after the last surgery.
