Pacemaker Malfunction Due to Electric Blanket: A Rare Case of Electromagnetic Interference

Received Sept. 26, 2022; Accepted for publication Dec. 6, 2022; Published online Dec. 19, 2022
<https://doi.org/10.17161/kjm.voll5.18549>

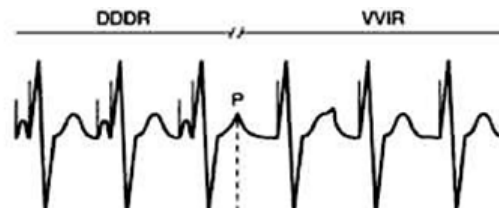
within device circuit which can cause reset of DDDR mode to VVI or VOO mode (Figure 1). Other causes of reset include electrocautery or external defibrillation. The reset mode does not revert to normal upon removal of EMI source (electric blanket in our case) and resolution requires programming by device.

Figure 1. Schematic illustration of EMI-induced conversion to VVI pacing from DDDR pacing mode after electromagnetic interference.

The pacemaker was reprogrammed to DDDR mode which resulted in resolution of symptoms. After discontinuing the use of the electric warming blanket, the recurrence of symptoms was not observed.
