## Case Report

# Fracture of the Tibial Baseplate 16 Years after Miller-Galante II Total Knee Arthroplasty

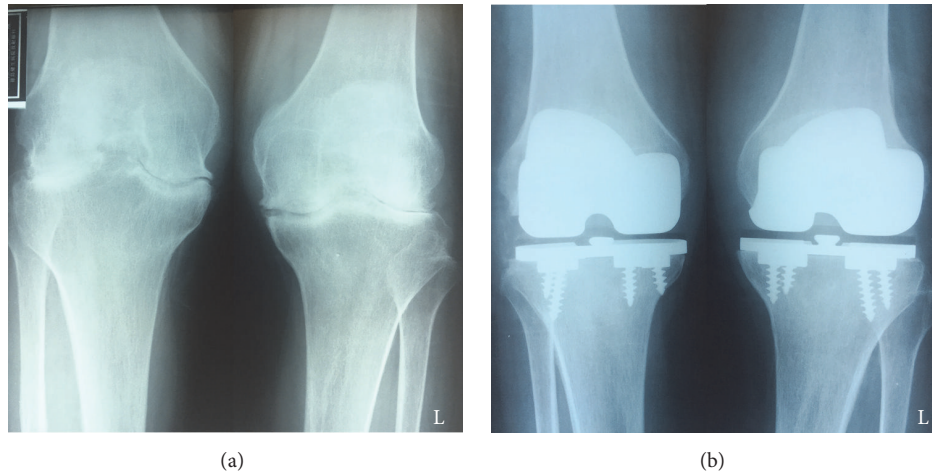
FIGURE 1: Plain radiographs of the bilateral knee of the patient with rheumatoid arthritis before and after Miller-Galante II Total Knee Arthroplasty performed 16 years earlier. (a) Preoperative plain radiograph shows bilateral rheumatoid arthritis of the knee categorized as Larsen grade 4. (b) Postoperative plain radiograph shows a femorotibial angle (FTA) of  $174^{\circ}$  on the right side and  $183^{\circ}$  on the left side. The left side shows varus malalignment.

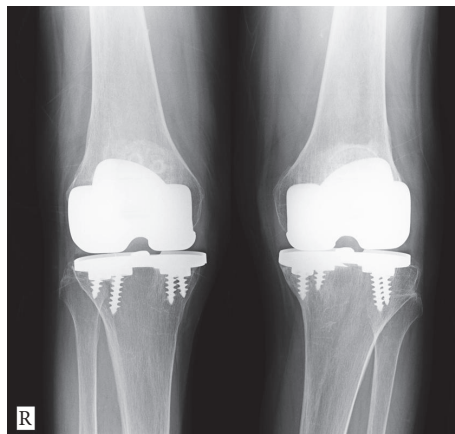
FIGURE 2: Follow-up plain radiograph obtained 15 years after surgery shows no change in the alignment of the right side and obvious deterioration of the varus malalignment (FTA of  $190^{\circ}$ ) of the left side.

A follow-up plain radiograph taken 15 years after arthroplasty revealed a deterioration of the varus malalignment of the tibia (Figure 2). However, the patient had no complaints about the left knee at this point, and we considered the problem was related to polyethylene wear. However, 16 years after arthroplasty, she presented to our department with a 3-month history of severe pain in the left knee. Clinically, she walked with a limp and a varus thrust. Examination of the left knee indicated joint effusion and tenderness along the medial joint line with localized warmth. There was a well-healed anterior skin incision over the left knee with no evidence of skin infection. Active and passive motions of the knee caused

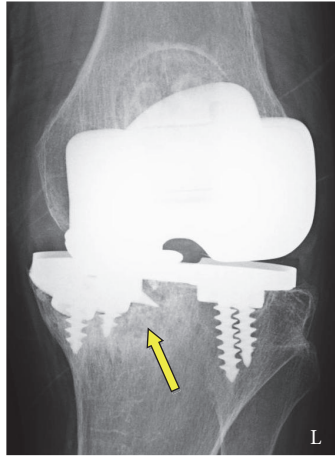
pain in the medial part of the knee. Plain radiographs taken at this time showed further distortion of the tibial component of the left knee with obvious fracture of the tibial baseplate and osteolysis under the broken component (Figure 3). She had not consulted us about the problem immediately because she had been undergoing conservative treatment for Graves' disease for 3 months. At the time of presentation, rheumatoid arthritis and Graves' disease were well controlled and all other laboratory values were in the normal range.

FIGURE 3: Follow-up plain radiograph obtained 16 years after the surgery shows disappearance of the medial joint space, subsidence of the broken baseplate, and osteolysis under the medial compartment (arrow).

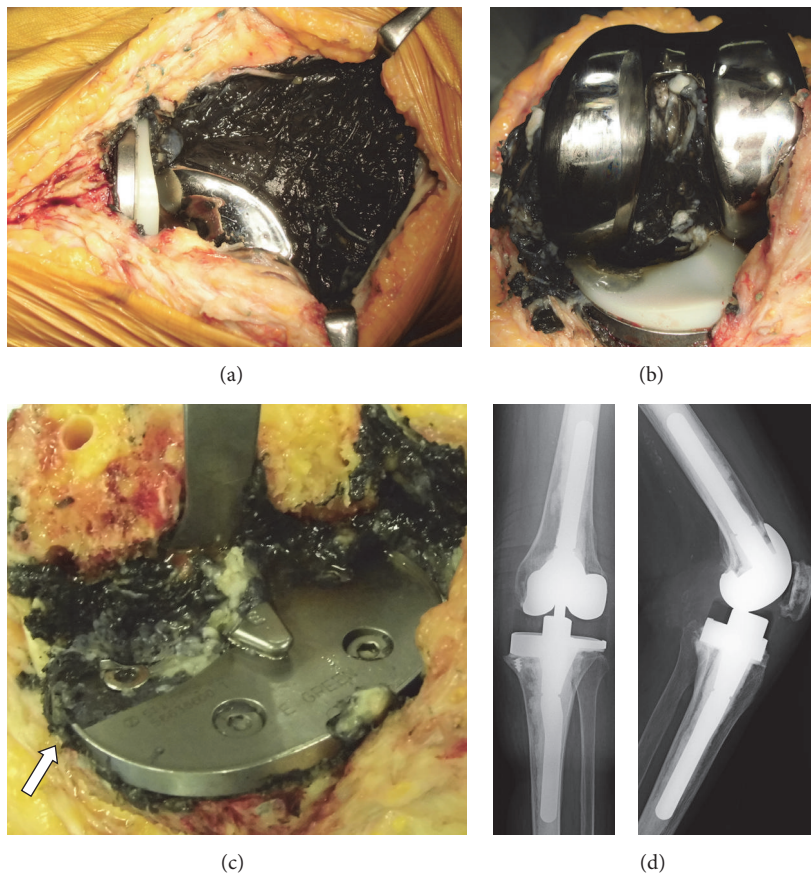
The patient underwent revision knee arthroplasty on the left side via the previous skin incision. Perioperatively, we observed severe metallosis within the knee joint (Figure 4(a)). The polyethylene insert was obviously worn and broken at the posteromedial site (Figure 4(b)). After the broken polyethylene insert was removed, a coronal fracture was found at the posteromedial portion of the tibial component and there was subsidence of the posterior metal tray fragment (Figure 4(c)). When the four screws were removed, we noted

FIGURE 4: Gross appearance at revision surgery. (a) Severe metallosis is observed within the knee joint. (b) Polyethylene insert is heavily worn and broken at the posteromedial portion. (c) Coronal baseplate is fractured from the posteromedial corner to the posterior cruciate ligament recess (arrow). Subsidence of the posterior broken fragment of the baseplate is apparent.

of the broken tibial metal tray, the medial aspect of the tibia showed cavitation of the cancellous bone under the medial weight-bearing surface. All metal and debris were removed and the revision prosthesis (LCCK, Zimmer-Biomet) was implanted. Medial augmentation was required to correct the

bony deficiency (Figure 4(d)). There were no postoperative complications, and the patient was ambulating with full weight-bearing on postoperative day 2. Significant pain relief and functional improvement was achieved based on early follow-up examinations (4 months). Remarkably, the MG II prosthesis on the right side was properly aligned, surviving for 17 years after primary surgery (Figure 5).

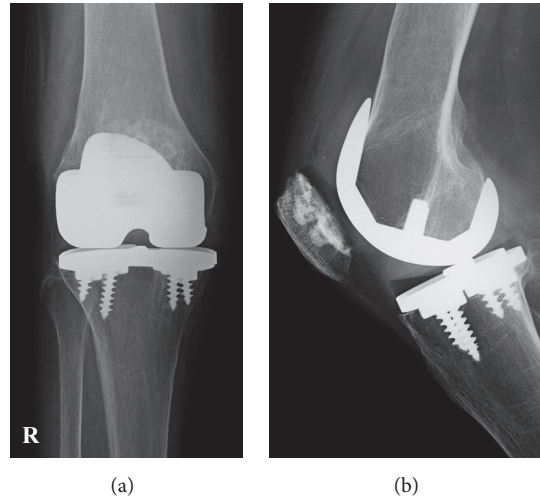
FIGURE 5: Follow-up plain radiograph obtained 17 years after initial surgery of the right-side implants shows normal alignment is maintained, with no evidence of stress shielding or loosening.

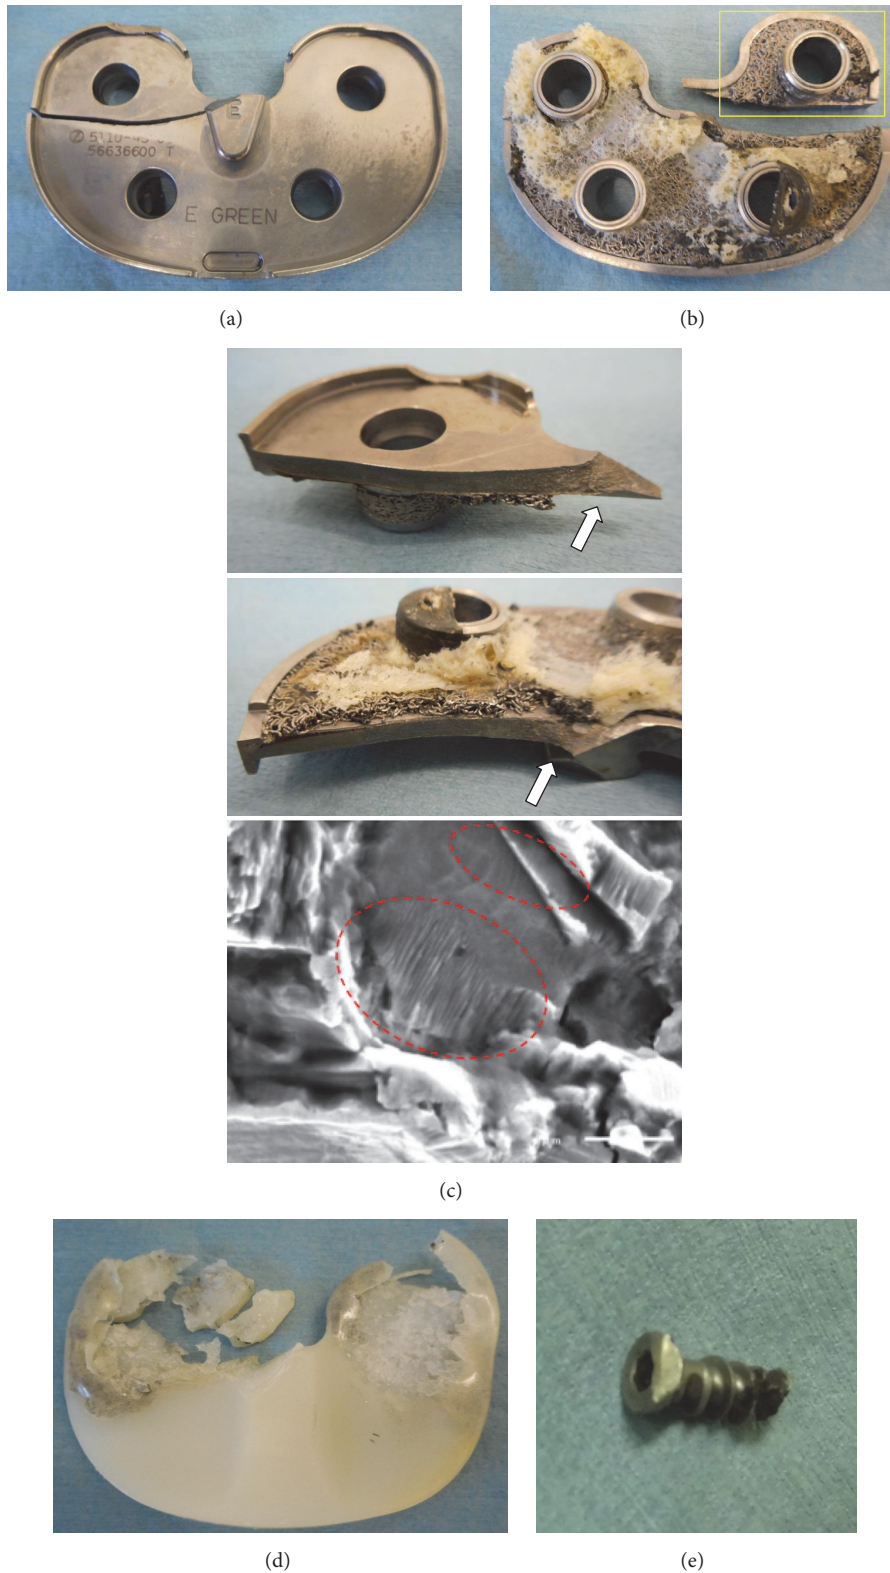
Gross observation of the retrieved broken tibial baseplate revealed that the fracture line extended in a coronal direction from the medial corner to the posterior cruciate ligament (PCL) recess (Figure 6(a)). There was no evidence of bone ingrowth at the undersurface of the posterior fragment of the tibial tray, although bone ingrowth was noted under the tray anterior to the fracture line (Figure 6(b)). The broken surface was complex, instead of showing regular fracture waves. A focal stair-step pattern could be observed on gross examination at the medial corner of the PCL recess, and scanning electron microscopy showed fatigue striations at this point (Figure 6(c)). This observation supported the possible development of a fracture line that had started at the medial corner of the PCL recess [6]. The retrieved polyethylene insert revealed that the heavily worn medial site corresponded to the posteromedial breakage area of the tibial baseplate (Figure 6(d)). The retrieved portion of the fractured screw demonstrated the severe load that had been exerted on the posterior fractured baseplate (Figure 6(e)).

FIGURE 6: (a) Gross observation of the retrieved broken tibial baseplate reveals that the fracture line extended in a coronal direction from the medial corner to the posterior cruciate ligament (PCL) recess. (b) Gross observation of the undersurface of the tibial baseplate shows uneven bone attachment surrounding the medial fracture line but even bone attachment at the posterolateral portion. (c) Surface of the break is complex rather than with regular fracture waves. A focal stair-step pattern can be observed grossly at the medial corner of the PCL recess (arrow), indicating a fatigue fracture. Scanning electron micrography shows fatigue striations (circle). (d) Retrieved polyethylene insert has severely worn medial sites that correspond to the posteromedial breakage area of the tibial baseplate. Polyethylene insert is also severely worn at the posterolateral area. (e) Retrieved portion of the fractured screw.

Gross observation of the knee during revision surgery and of the retrieved implants indicated another factor predisposing to the posteromedial coronal-type fracture observed in our case. On the undersurface of tibial baseplate, the fracture line passed through a region of uneven bone attachment. After removal of the fracture tray, we noted bone loss due to osteolysis, consistent with the radiographic appearance. In our case, the tibial baseplate was fixed inadequately due to osteolysis, resulting in cyclic cantilever bending that concentrated stresses at the junction of the supported and unsupported regions. This is a typical failure mechanism reported for tibial tray fractures [5, 15, 18, 19, 21, 22]. Cankaya et al. [18] reported polyethylene wear and osteolysis leading to tibial component fracture. We speculate that the malalignment of implants causes polyethylene wear and osteolysis, resulting in a bone deficit predisposing to this tibial component fracture. A review of 74 cases demonstrated 100% correlation between the site of the fractured tibial baseplate and the region of bone loss [5]. Gross observation of the surface of the fractured baseplate revealed a focal stair-step pattern at the medial corner of the PCL recess, indicating a fatigue fracture; this site was therefore considered to be the starting point of the fracture [15].
