## Case report

## Failure of Emperion modular femoral stem with implant analysis

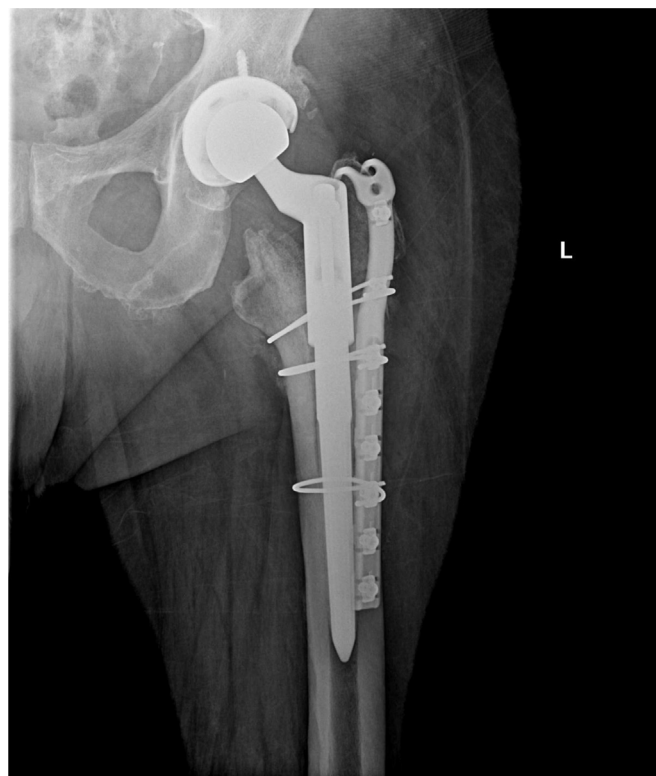
**Figure 2.** Left hip anteroposterior radiograph 6 months after revision left hip arthroplasty with the use of extended trochanteric osteotomy and revision modular femoral stem.

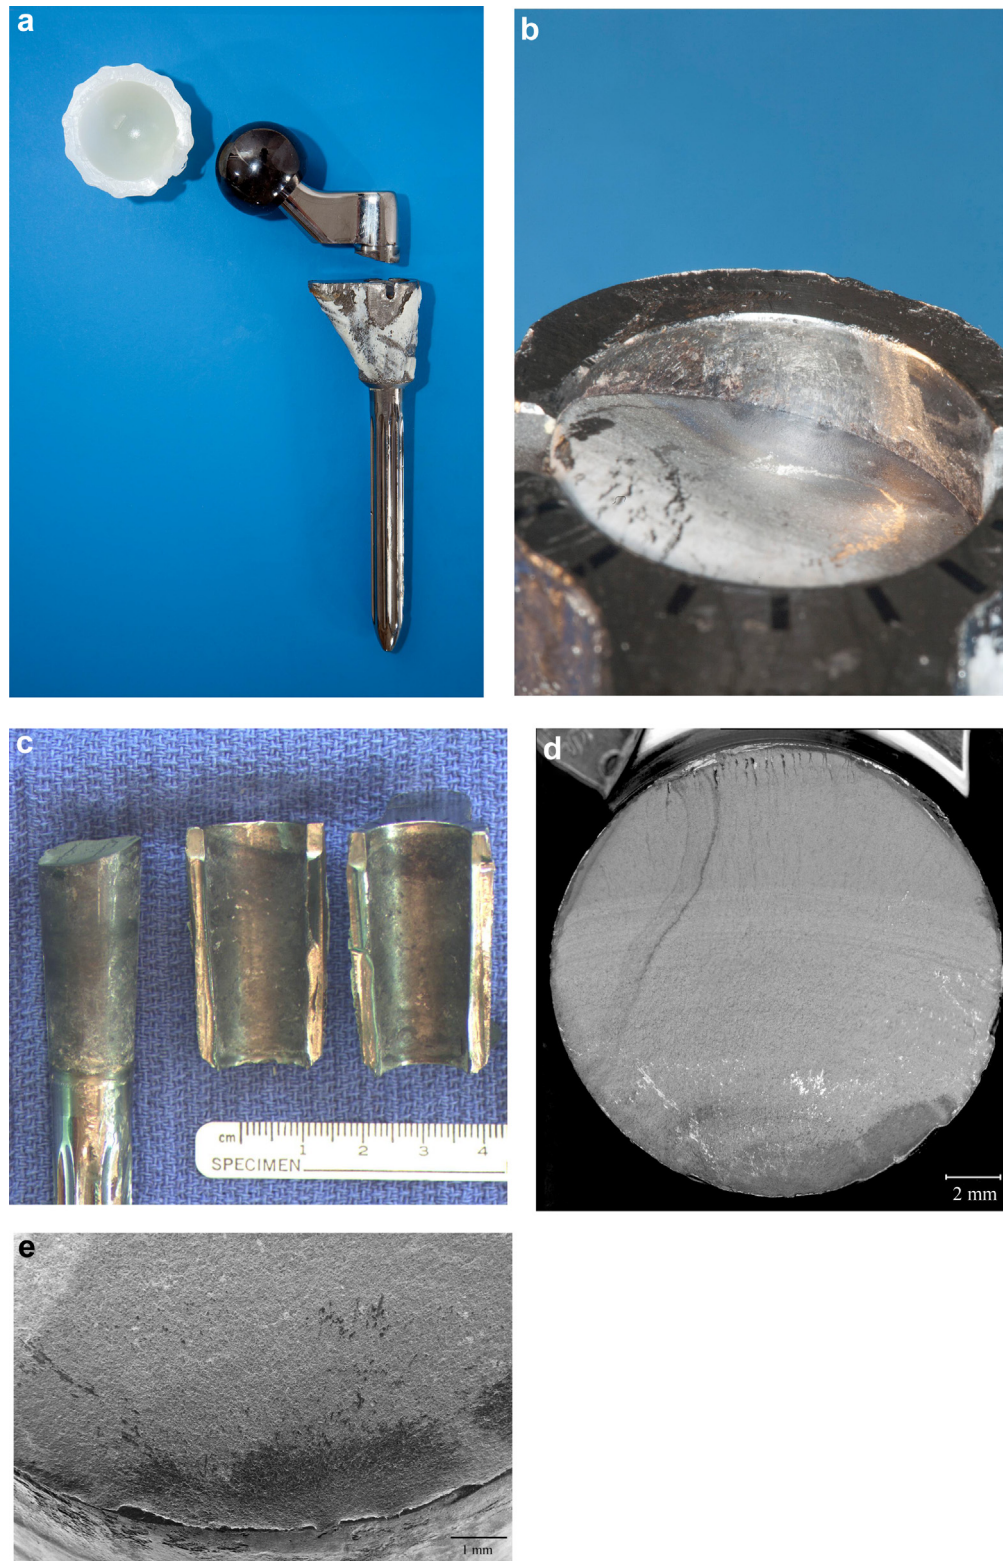
The hip stem in the present study experienced final overload failure suddenly as the patient rose from the seated position with no preceding pain or dysfunction. The fatigue crack that eventually led to this overload failure was initiated on the lateral side just below the proximal stem-sleeve taper interface (Fig. 3a). The interior lateral wall of the sleeve taper component above the distal stem fracture surface (Fig. 3b) and the interior taper sleeve (Fig. 3c) showed evidence of fretting and crevice corrosion on the opposing tapered surfaces to the area of fatigue crack initiation. In a previous retrieval analysis of 78 S-ROM stems (DePuy Synthes, Warsaw, IN), 88% had experienced corrosion and 65% showed fretting at the stem-sleeve interface [3]. Seven (9%) of the devices had experienced stem fracture near the proximal end of the stem-sleeve interface at an average of 111 months after implantation in a similar manner to this case in which failure occurred 74 months after the initial hip replacement. The findings of the failed S-ROM stems (DePuy Synthes, Warsaw, IN) are similar to the results of our analysis with a significant amount of corrosion identified at the taper surface (Fig. 3c).

We suspect the process leading to the catastrophic failure of the implant occurred over an extended period of time despite the patient being asymptomatic. Implant analysis revealed substantial corrosion noted on the lateral side of the fracture surface (lower portions of Fig. 3d and e), which may have accelerated fatigue crack initiation on the lateral side of the hip stem. The crack spread with continued fatigue loading but was temporarily arrested at each of

**Figure 3.** (a) Photograph of modular hip retrieval components. (b) Photograph of interior taper sleeve with distal stem fracture surface. (c) Photograph of the exterior lateral distal stem, interior lateral distal sleeve, and interior medial distal sleeve components. (d) Two-dimensional stitched X-Y light microscopy image of entire proximal stem fracture surface. (e) Scanning electron microscopic image of proximal fracture surface showing chevron marks indicating the fatigue crack initiation point emanating from the lateral surface.

the conchoidal markings (Fig. 3d). The propagating fatigue crack continued to reduce the area of remaining intact segment of the stem until it could no longer support the physiological loading cycles, eventually leading to overload failure. Fatigue cracks are

initiation likely stemming from crevice and fretting corrosion on the lateral side of the hip stem within the taper sleeve. The patient was morbidly obese which may have also contributed to increased stress and early device failure. The fatigue crack propagated across the surface, and the hip stem eventually failed because of ductile overload near the medial side of the stem. No evidence of manufacturing or metallurgical irregularity was found on the hip stem or sleeve components. The fatigue fracture of this modular hip stem represents an unusually early failure that was likely accelerated by crevice corrosion within the taper sleeve with the patient's morbid obesity identified as a potential contributing factor. We recommend caution with the use of modular femoral stems in morbidly obese patients because of increased cyclical loading across implant junctions. We would recommend being prepared to proceed with extended trochanteric osteotomy for stem removal when presented with a similar clinical scenario.
