Are asymmetric metal markings on the cone surface of ceramic femoral heads an indication of entrapped debris?

Sebastian Valet^{1*}, Bernhard Weisse¹, Jakob Kuebler², Martin Zimmermann³, Christian Affolter¹ and Giovanni Pietro Terrasi¹

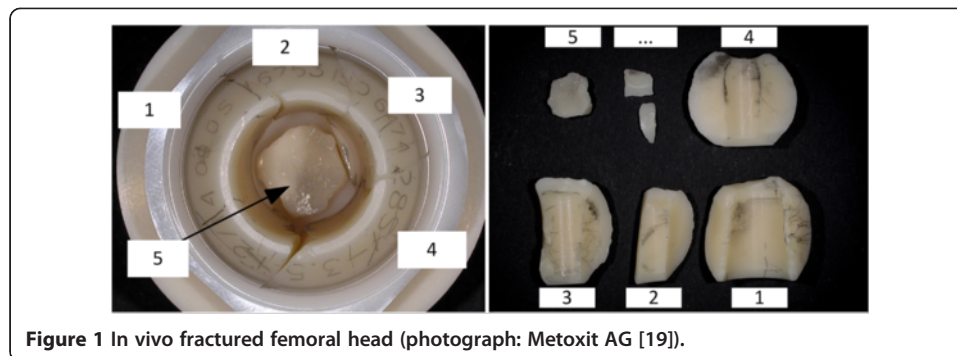
Analyses of in vivo fractured ball heads have repeatedly shown asymmetric metal markings on the conical surface of the ceramic fragments [15-18]. Figure 1 shows a typical case of an in vivo fracture of an alumina ceramic head [19]. Inspection of the fractured alumina ball heads typically showed asymmetric distribution of metal marking, resulting, presumably, from the motion in the taper fit interface between the titanium alloy stem and ceramic head prior to fracture (called primary metal marking). Additional metal markings (called secondary metal marking) can be caused by movement between fractured fragments and the stem as they are present on the fragments. Metal markings along fracture edges also appeared on fragments (Figure 1).

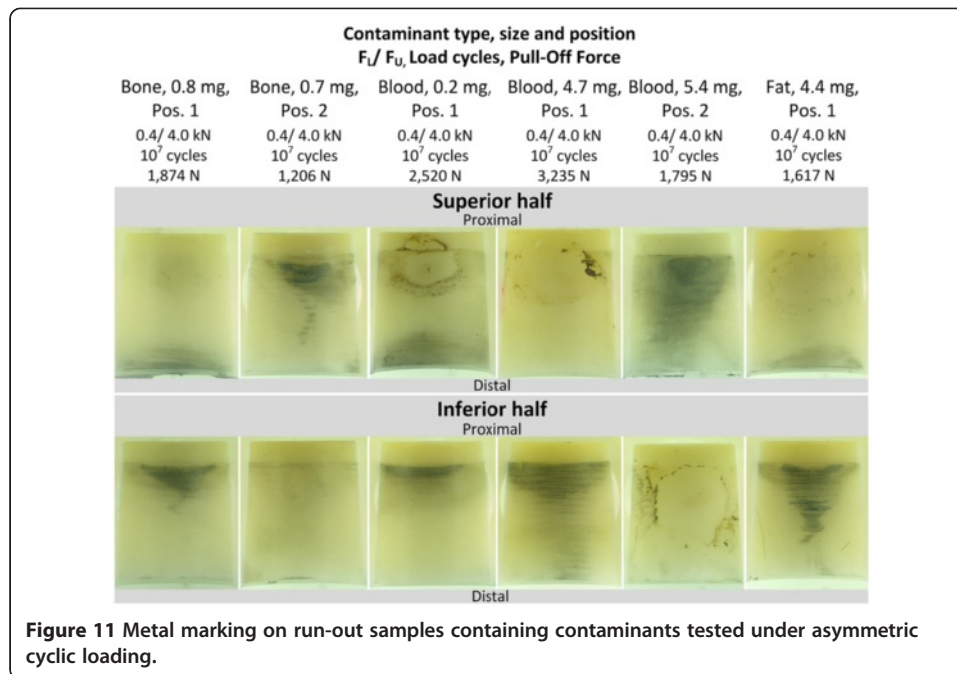
Figure 11 shows metallic marking on heads tested in a 40° configuration that had passed the run-out criterion (10 million load cycles) without failure. The average value of the force required to pull-off the heads from the differently contaminated taper was 2,041 N (n = 6, SD = 721 N, range = 2,029 N). The measured distance d_{GAP} was in a range of 2.5-2.7 mm.

- **Distribution of metal marking in circumferential direction:** A strongly asymmetric distribution of metal markings is present along the circumferential direction.
- **Distribution of metal marking along taper axis:** Two regions of increased metal markings are present. Most intense marking appear in the proximal area at the opposite cone half of the contaminant, whereas slight markings are visible in the distal area on the superior and inferior side of the head.
- **Influence of contaminant position:** If the contaminant was placed on the opposite side of the cone (from superior to inferior side) it did not significantly change the degree and distribution of the resulting metal marking.

The occurrence of asymmetric metal markings on the cone surfaces of fractured femoral heads can be an indication that either a biological residual was entrapped in the taper fit or the stem cone was damaged prior to fracture. The entrapment of contaminants in the taper fit surface introduces an increased risk of femoral head fracture. Therefore, particular care should be taken during surgeries to assure the cone surfaces of the

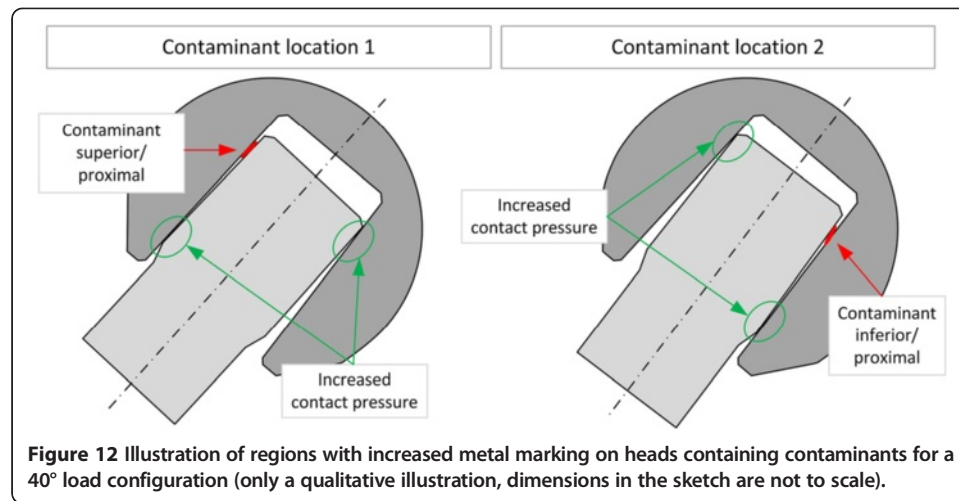
The presence of a contaminant introduces an eccentricity and misalignment between the taper axes of the stem and the conical hollow of the ball head. Thus, additional contact pressure on the distal end on one side causes a tipping of the ball, which then creates an increased contact pressure at the proximal end but on the opposite side.

Figure 12 qualitatively shows how the taper interface is affected by the presence of a contaminant. The illustrated schematic shows the taper-interface fit in a cross-sectional view along the cone axis and in the plane of the applied test load and contaminant position (Figure 12). Residuals concentrated on one position and side of the stem surface will, if not completely compressed, result in a slight tilt of the stem-cone against the cone of the femoral head. This situation increases local contact stresses in two regions as depicted in the sketch (Figure 12). As metal markings were predominant in the regions of increased contact stresses, it can be proposed that they were caused by the increase in local contact pressure in these regions.

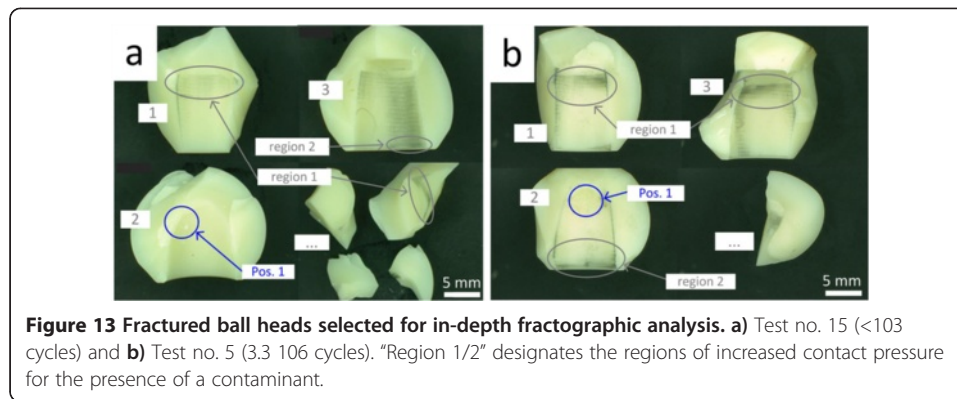
Seven of the total 18 femoral heads tested failed before reaching the test stop criterion of 10^7 cycles. Four of those seven heads (test no. 5, 7, 14 and 15) were selected for a first failure analysis which revealed that the heads had a common failure pattern. Independent of the contamination position (1 or 2) between stem and head bore and as a result of the loading configuration a main fracture fragment with spherical calotte shape was detached from the superior half of the heads (Figure 13a). For a more in-depth failure analysis the femoral heads with the lowest number of load cycles till failure (test no. 15, $<10^3$ cycles) and the one with the highest number (test no. 5, $3.28 \cdot 10^6$ cycles) were selected, Figure 14. Figure 13b and Figure 13e show the main fracture fragments of the two heads with arrows marking the fracture origins. On the main fracture fragment of test no. 15 two white spots could be seen in the bore and one covering the failure origin. The spots originated most likely from the salt in the Ringer-solution in which the tests were conducted at a temperature of 37°C and could be removed easily with lukewarm water. That femoral head failed from a large pore connected to a granule which had not been destroyed during pressing of the ceramic green body, Figure 13c and Figure 13d. The other head (test no. 5) failed from a porous region, Figure 13f. In the porous region loose, slightly necked or aggregated grains with a diameter in the range of 0.5 to 1 μm could be found, Figure 13g. In a back scattered (BS) electron microscope image almost no difference in the grey levels of the grains and the surrounding Al_2O_3 ceramic can be seen, insert in Figure 13g.

Therefore, the grains might be not properly densified Al_2O_3 particles or, more likely fine grained powder from a sintering additive to reduce grain growth, when sintering Al_2O_3 .

With the failure relevant defect size (depth) in test no. 15 which is, based on the fractographic images, roughly $a = 120 \mu\text{m}$ and the Griffith equation [34] it is possible to estimate that the relevant stress σ at failure had been about in the range of 280 MPa. For test no. 5 it was not possible to estimate a relevant failure size fractographically.

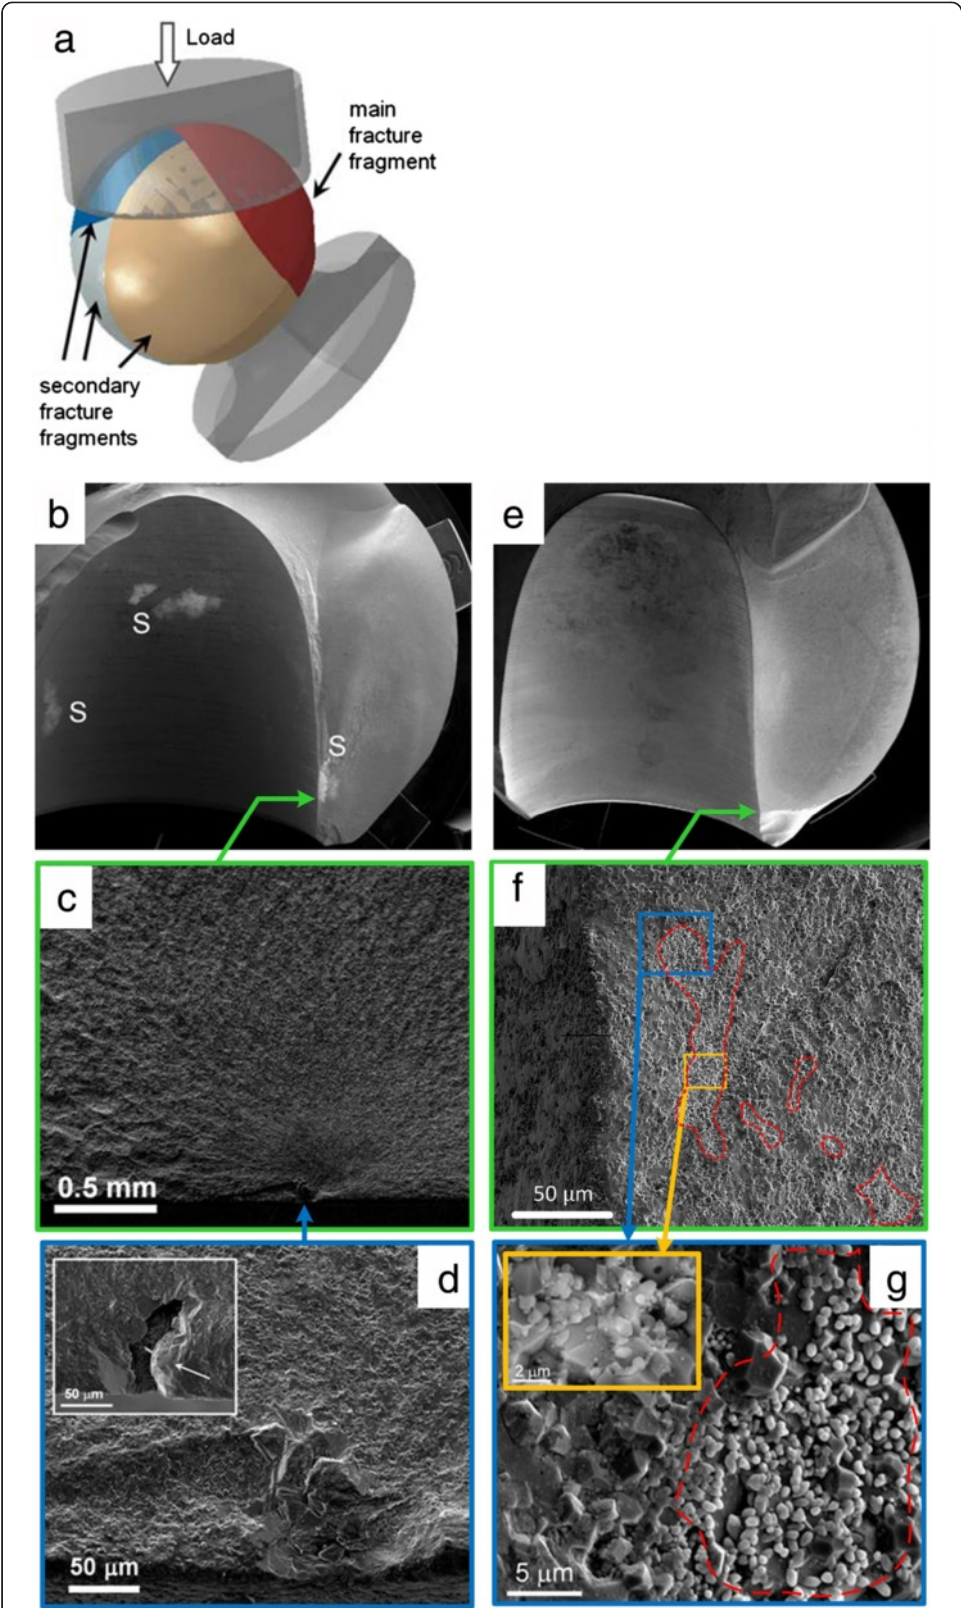
Figure 14 (See legend on next page.)

Fracture of samples at the beginning of the cyclic testing may be attributed to either static overloading during the increase of the cyclic test load or to low cycle fatigue due to subcritical crack-growth. In either case stress concentration induced by the contaminants are likely to have contributed to the failure. Asymmetric metallic traces found on the fragments of the in-vivo fracture as well as of the ball head fracture under asymmetric test conditions are an indication of an asymmetric contact pressure distribution. This asymmetry can be caused by the presence of contaminants resulting in locally increased contact stresses. In this study, all tested heads containing different types and sizes of contaminants exhibited significant asymmetric distribution of metallic marks on the conical surface. Contaminants such as bone chips, soft tissue or blood entrapped in the taper fit were reported to lower the fracture load in a test according to ISO 7206-10 by up to 90% [9,11]. The types of fracture observed in the failed heads of the present study were similar to the typical bore failure as reported for a static axisymmetric burst test [1].

Therefore, we suppose that the failure of the ball heads was caused by an increase of the maximum stresses in the ball head due to the presence of the contaminants. Additional analysis would be needed to quantify the increase of maximum stress if a contaminant is entrapped in the taper fit. This analysis may be conducted in a separate study.

Figure 14 Fractographic analysis. **a)** General fracture behaviour of ball heads failing before reaching 107 fatigue cycles. **b, c, d)** Test Nr. 15 (<103 cycles) and **e, f, g)** Test Nr. 5 (3.28*106 cycles) **b, e)** Main fracture fragment (fish-eye mode). Arrow marks fracture origin and S salt scales. **c)** Arrow marks fracture origin. **d)** Fracture origin magnified. Insert: opposite fracture surface. Arrow marks a granule, attached to large pore. The granule had not been destroyed during pressing the green body. **f)** Fracture origin magnified (circular line marks area in which porous regions were found). **g)** Magnified area showing a fine grained contamination. Insert: Magnified area BS shown in BSE mode.
