Article

## Surface Characterization of Retrieved Metal-on-Metal Total Hip Implants from Patients with Adverse Reaction to Metal Debris

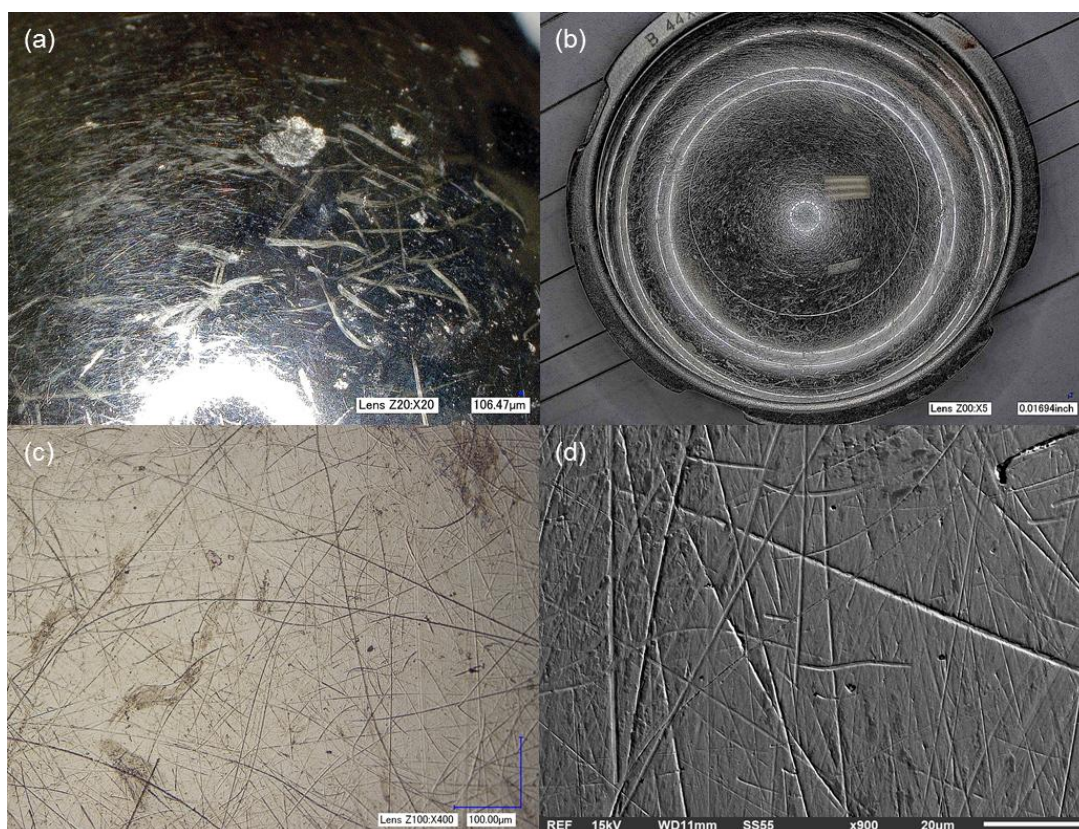
**Figure 1.** Severe scratching observed in specimen 1: (a) femoral head and (b) acetabular cup of Implant 1. Deep scratches were revealed during the analysis, which led to the hypothesis of a large amount of particle generation *in vivo*; (c) optical micrograph demonstrating scratch depth; (d) SEM micrograph showing no features other than scratching. The surface was clean of biological or corrosion products.

The level of scratching on the head was quantified using the depth up microscope technique (Figure 1c). The total area scratched was 671 mm<sup>2</sup> out of a total head surface area of 3926 mm<sup>2</sup>. This results in approximately 17% of the surface of the head affected by scratching. Using the clinical information, an estimated area of material lost from the scratches per year of implantation was approximately 152 mm<sup>2</sup>/year. Surface analysis, with the 3 different microscopy techniques, of the interfaces of this implant did not reveal any mechanisms other than scratching, as illustrated in Figure 1d. EDS analysis of areas that exhibited scratches showed similar composition to the areas of the implants with no characteristic damage ranging from 5% to 7% Carbon (C), 28% Chromium (Cr), 62% Cobalt (Co) and 3%–7% Molybdenum (Mo). Scratched and unscratched surfaces did not present a significant change in their elemental composition in all the specimens evaluated.

An individual analysis of each of the samples is necessary to characterize the different factors that lead to the formation of an ARMD. In the case of Implant 1, it was found that the cup had an abduction angle of 57 ° and a head of 44 mm in diameter. These characteristics classify the head as large and the cup abduction angle as outside of the *Lewinnek Zone* [17]. It has been reported that MoM soft tissue reactions are more likely to be found in hip prostheses with heads between 38 and 49 mm of diameter and with cup abduction outside of the *Lewinnek Zone*, which is defined between 5 °–25 ° for anteversion and 30 °–50 ° for abduction [17,21]. In a study of 2600 cases of hip resurfacings, Gross *et al.* [22] found a low incidence rate of pseudotumors, ranging from 0.1% to 1.8%. However, all of the failures that presented pseudotumors had small head components (less than 48 mm) and abduction angles greater than 50 ° [22]. Acetabular inclination is thought to be an important factor that contributes to increasing wear rates and metal particles, which increases the probability of developing a pseudotumor [21,23,24]. However, some studies have shown that there is not a significant correlation between metal serum levels and angle of cup inclination [25,26]. Thus, both studies acknowledge that accurate cup positioning lowers the possible risk of implant failure. The need for revision of Implant 1 was most likely due to its high cup abduction angle, which led to an uneven distribution of forces and stresses on the implant, inducing the observed scratching. The estimated surface area loss due to scratching (17%) is significant and may indicate that a high amount of metal ions and debris was released from this interface. Such an influx of foreign metal ions into the body may have led to the formation of an ARMD.

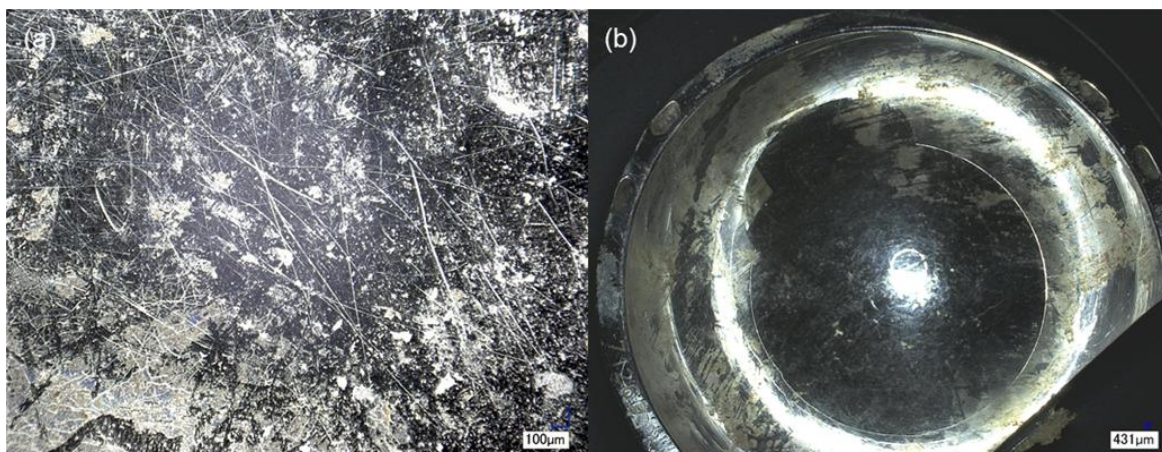
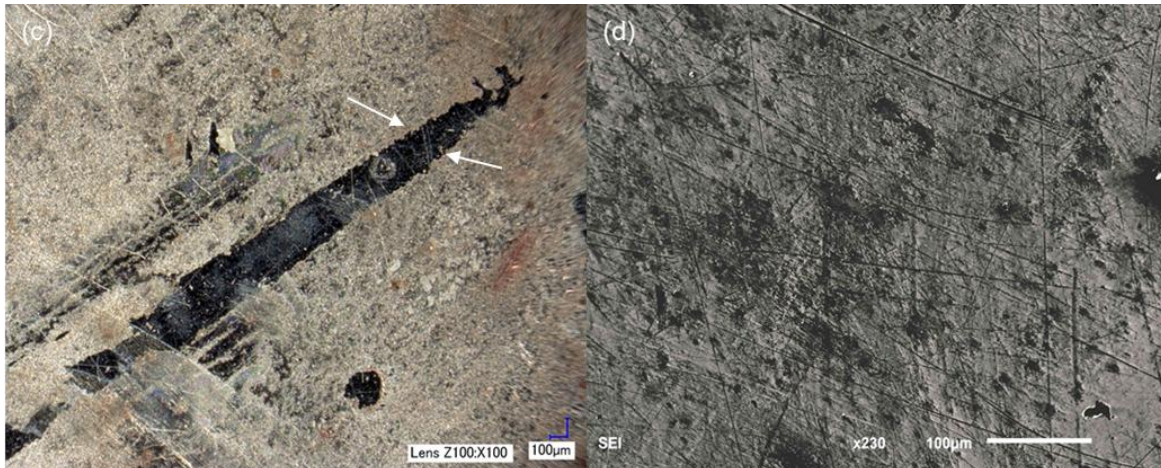
Implant 2 was recorded as having *in vivo* corrosion upon revision. Similarly to Implant 1, microscopic inspection, showed no evidence of corrosion features. However, this sample did present a large amount of debris on its surface, which appeared to be of biological origin and from wear of the top surface (delamination), as illustrated in Figure 2c,d. The level of debris was such that the head-cup ensemble was fixed in a non-rotational position. The nature of the debris was studied under SEM and EDS. A control section of the implant head with no deposition on its surface showed presence of 60% Co, 28% Cr and 5% C with traces of Mo and other trace elements. The analysis of a debris covered section of the implant showed 47% C presence, 8% Nitrogen (N) and 8% Oxygen (O); with only 23% Co and 12% Cr. In addition to these features, a large amount of scratching was observed in both the head and the cup. The results of the microscope analysis found a scratched area of the head of approximately 1309 mm<sup>2</sup> in a total surface area of 7971 mm<sup>2</sup>. This resulted in an approximate total area loss of 350 mm<sup>2</sup>/year from the head-cup interface. The percentage of surface scratched on the head was 17.5%. No etching or discoloration of the interfaces of the implant was noted.

**Figure 2.** Surface condition of Implant 2: (a) optical micrograph of the scratched and debris covered surface of the head; (b) optical micrograph of the scratched surface of the cup; (c) optical micrograph showing areas of the head with high degree of biological deposition on the surface and delamination of top layers (arrows). A large amount of metal debris could be expected from this area of the implant; (d) SEM micrograph showing surface irregularities, scratches, and debris covering the surface of the head of Implant 2.

From studying the surface of Implant 2, the nature of the debris covering the surface of the prosthesis was likely biological, a probable result of bodily fluids entering the rotational areas of the implant. The reason for revision of Implant 2 is similar to the mechanism observed with Implant 1, likely related to its highly scratched surface (Figure 2) that released metal particles into the surrounding soft tissues, causing an inflammatory reaction and the development of ARMD. The scratching in this implant was characterized and resulted in a 17.5% of area scratched.
