Rupture of an Industrial GFRP Composite Mitered Elbow Pipe

Abstract: This paper examines the immature rupture of glass fiber reinforced plastic composite (GFRP) mitered elbow pipes. The GFRP composite mitered elbow pipe's lifespan was twenty-five years; however, the pipes in question experienced immature failures, resulting in the reduction of their lifetimes to seven, nine, and ten years, respectively. The GFRP cooling water mitered elbow pipe's service conditions operate at a pressure of up to 7 bar and temperatures between 15–36 °C. The root cause of failure was determined using visual inspection, analytical, microstructural, mechanical characterizations, and chemical analysis. The initial visualization inspection revealed an improper joint between the composite overwrapped and the straight pipe sections. Mechanical properties along the axial, hoop and 45° from the axial direction were obtained. The results from the analytical analysis indicated that the elbow might withstand the operating pressure depending on the quality factor, which was confirmed to be low due to the elbow joint's improper fabrication process. As evidence of this, the numerical analyses' results indicated t

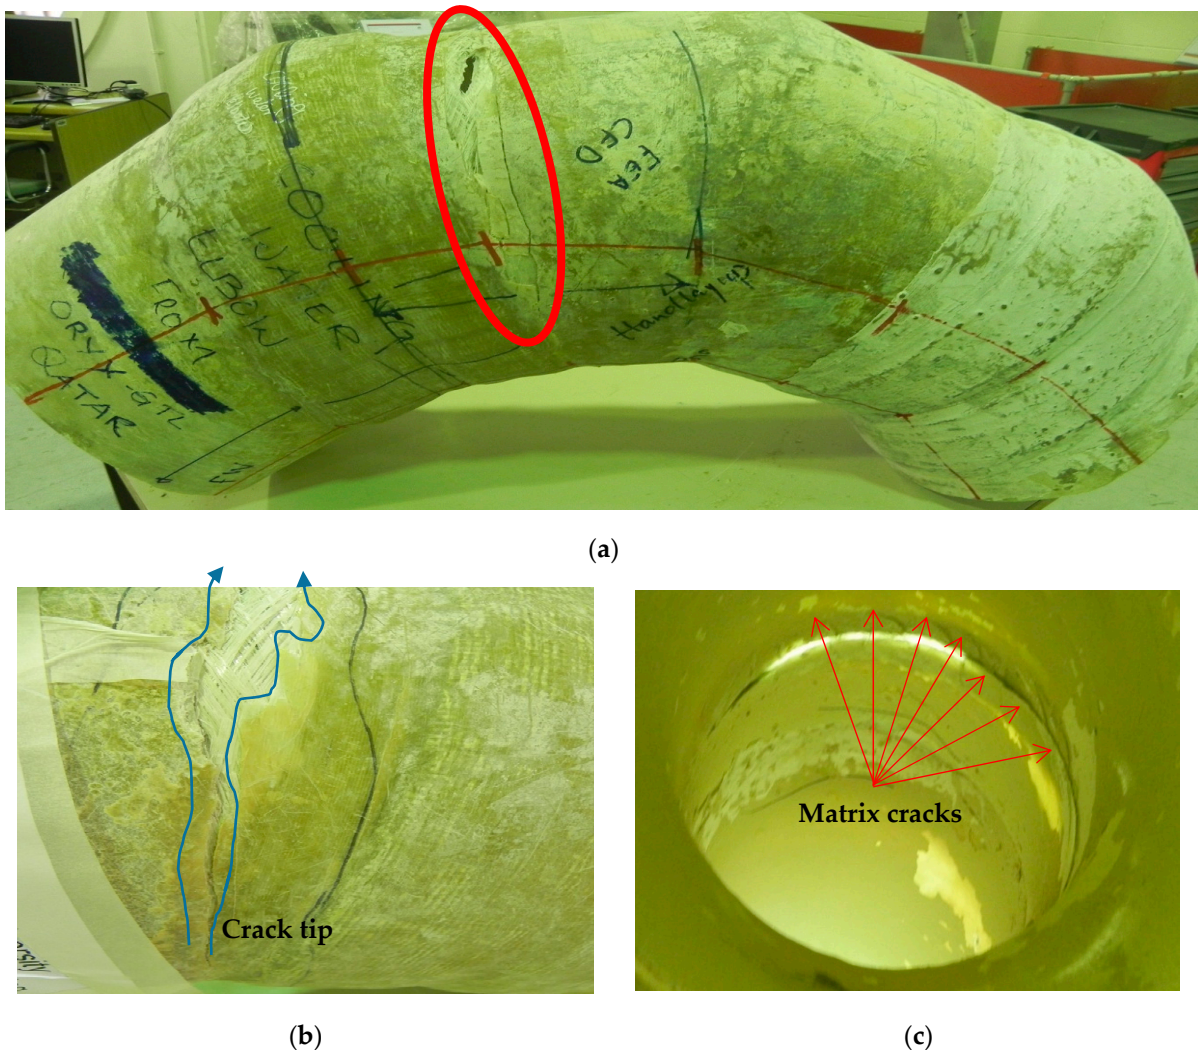
A GFRP cooling water mitred elbow pipe has experienced a structural failure at a ninety-degree mitred bend elbow, as shown in Figure 1a. The crack is circumferential on the elbow's extrados approximately in the middle of the bend angle. The technical details are summarized below in Table 1. The pipe was reported to be S-glass fiber/polyester. Figure 1b shows the crack initiation and propagation, while Figure 1c shows transfer matrix cracks at the crack tip. Figure 1c shows the typically mitred elbow. The curing process was reported to follow the gelation stage, hardening stage, and maturation stage. The curing process took 12 h at a temperature between 32 °C and 47 °C. Table 1 also lists the mechanical properties of the polyester resin as provided by the supplier.

Initial inspection of the crack revealed that the fibers in the elbow pipe wall's center were dry and very brittle (as seen in Figure 1b), indicating a poor fiber–matrix interface. When the component was cut in half longitudinally, it was also observed that the wall thickness varied significantly in the axial, radial, and hoop directions. An internal ridge was observed at the elbow entrance and exit, where the straight section was joined to the elbow. A visual analysis of the damaged composite proved that leaking results in through-thickness cracks within each ply, together with delamination, thereby forming a convoluted path through the pipe wall. An improper joint throughout the elbow was observed, as can be shown in Figure 2. Figure 3a–d show very poor bonding between the composite overwrapped and the straight pipe sections arranged to form the elbow section.

Figure 1. (a) Failed elbow; (b) a radial crack showing matrix cracking and fiber breakage; (c) transverse matrix cracks.

When composite materials are loaded in the fiber orientation direction, they will exhibit the best mechanical properties [12]. The fiber-reinforced composites must be able to withstand tensile load pull out, fiber bridge, fiber–matrix debonding, and matrix crack [13]. It is visualized that the elbow pipe is wound with the fiber orientation of $\pm 45^\circ$. Based on this finding, the generated strain due to the service load is not principally in the axial and hoop direction. In this case, a maximum strain failure theory does allow cracks in the matrix before cracks in the fiber. The mechanical test indicated that the maximum Ultimate Tensile Strength (UTS) and maximum strain are on the hoop direction specimen, whereas the axial direction showed knee at low stress and low strain, which indicates the formation of the first microcrack in the matrix; the bond between the matrix and the fibers breaks at a microlevel. These observations agree with the work published by [13]. It is observed that micromatrix cracking started at the inner surface of the elbow pipes, and the size and quantity of these microcracks increased with time (see Figure 1c).

- It is recommended that sections with a thickness of less than 15 mm be reinforced using overwrapped composites. During the remedy process, enough tension must be applied to the overwrapped composites to achieve a better wetting of fibers by the resin. It is well-known that high fiber tension levels in the fiber-reinforced pipes increase the load-carrying capacity and the stiffness of composite pipes.

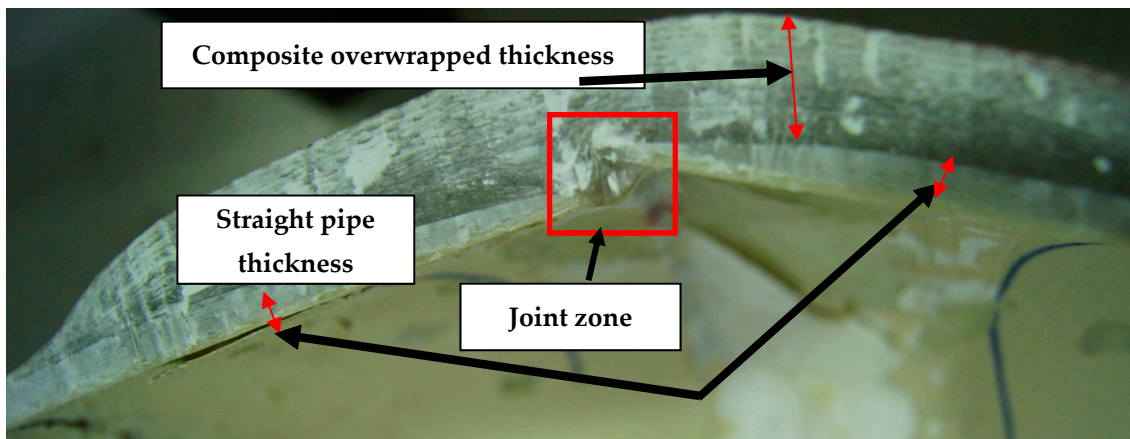
Figure 2. Elbow cross-section shows an improper joining between the composite elbow sections.

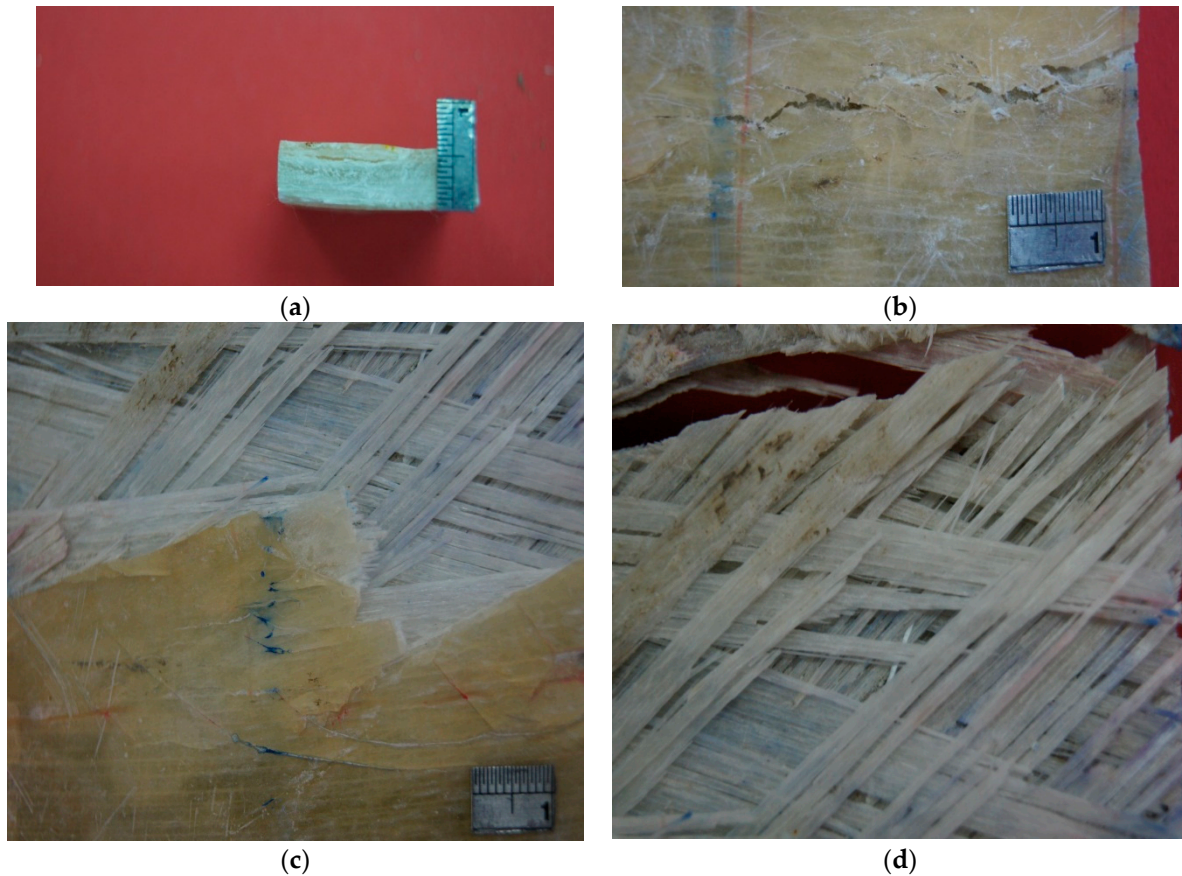
Figure 3. Fractured surface of (a) Interlaminar cracks throughout the elbow wall; (b) Interlaminar cracks at different magnifications; (c) Circumferential crack was observed to be initiated by matrix cracking; (d) Close up of crack revealing, matrix cracking, poor fiber-matrix interface, fiber debonding, and delamination at tip crack.

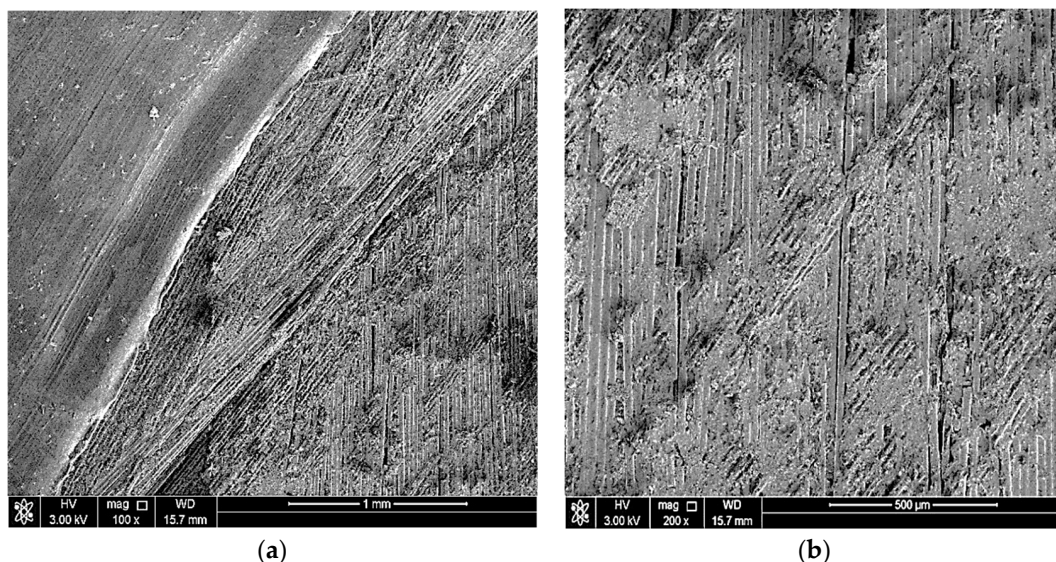
The objectives of conducting a scanning electron microscope (SEM) examination on the elbow-joint were to identify the surface's condition, examine in more detail the cracks in the material, and spot defects in the material, if present. Two of the three parts were scanned at five magnifications (100X, 500X, 1000X, and 2000X) using the scanning electron microscope. Figures 4–6 show the SEM results. The fractured surface was undulated with some bundles of loose and broken fibers (fiber bridging). The matrix fracture was quite brittle, exhibiting only brittle features fracture morphology in the matrix. At higher magnifications, such as 1000X and 2000X, the delamination between layers is very clear and indicates an improper fabrication process of the elbow-joint. Note that the matrix crack initiated the cracks, and with repeated loading, the crack eventually reached the surface and caused the reported leakage.

Figure 4. SEM images of the fractured region at (a) 100× and (b) 200×.

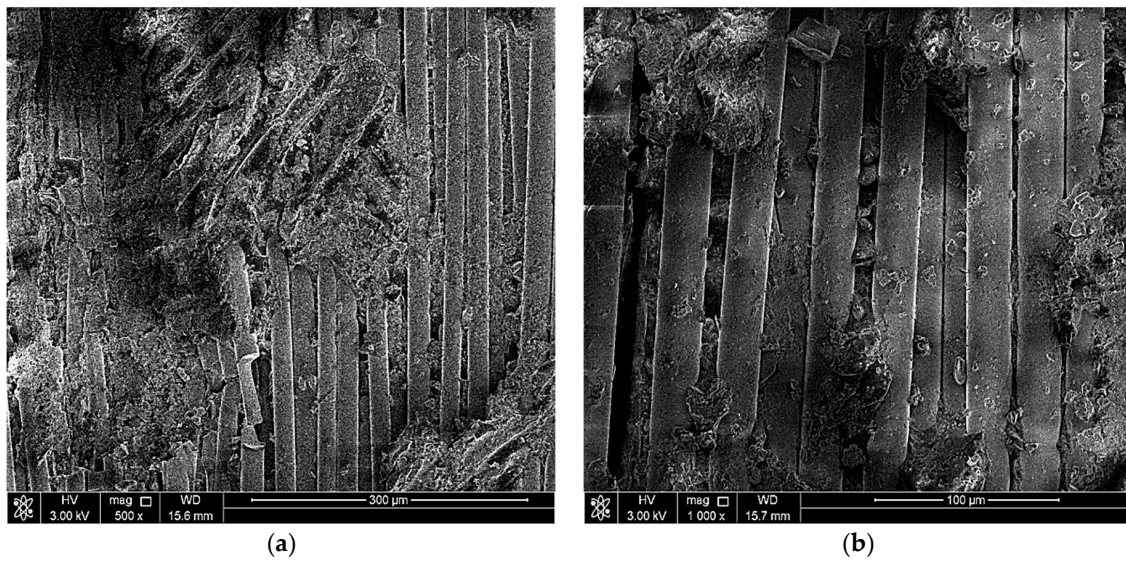
Figure 5. SEM images of the fractured region at (a) 500 \times and (b) 1000 \times .

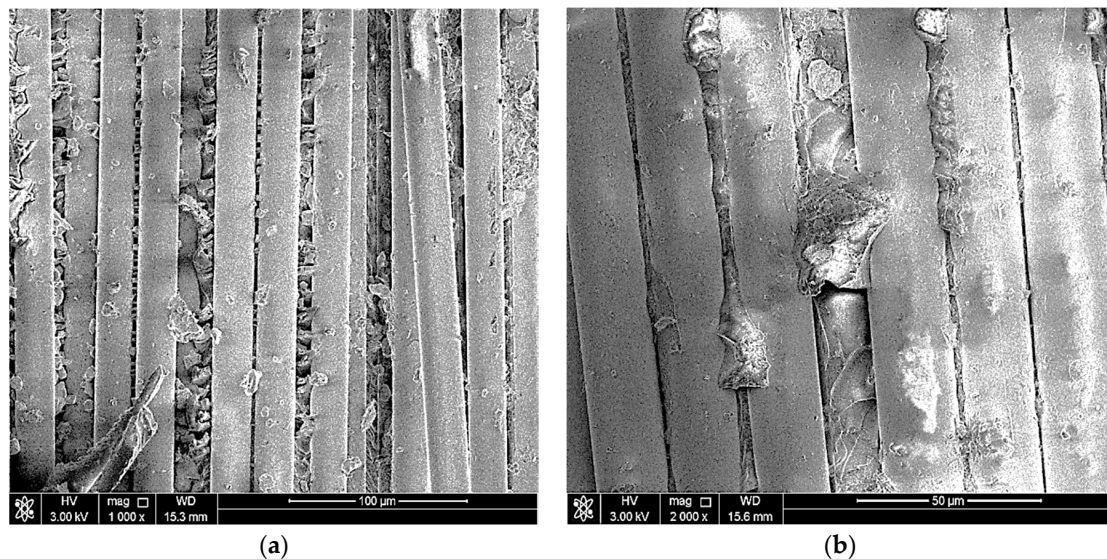
Figure 6. SEM images of the fractured region at (a) 1000 \times and (b) 2000 \times .

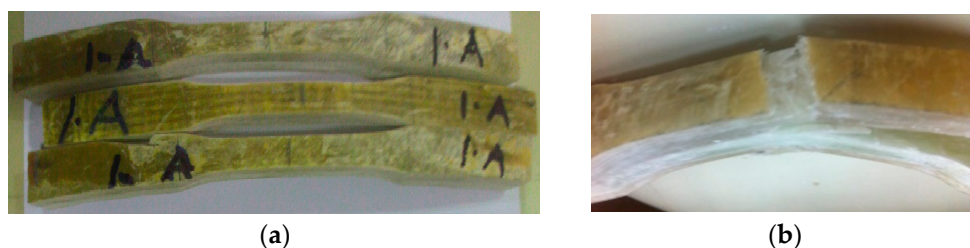
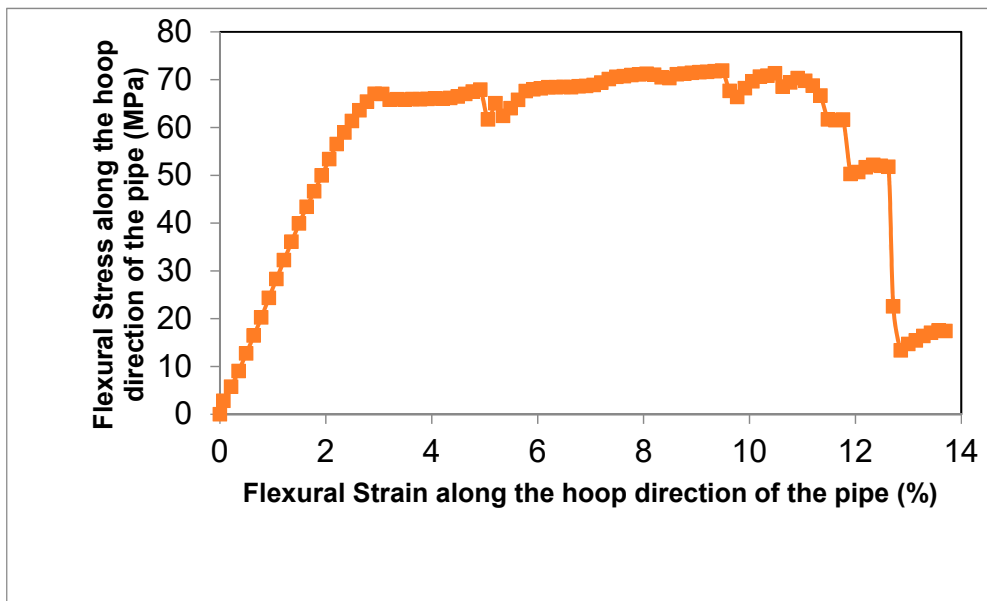
Figure 8. (a) Prepared specimens machined along the hoop direction; (b) Failed specimen showing matrix cracking, fiber debonding, and huge delamination between the straight pipe and the overwrapped fiber breakage; (c) Flexural stress–strain curve of hoop specimens.

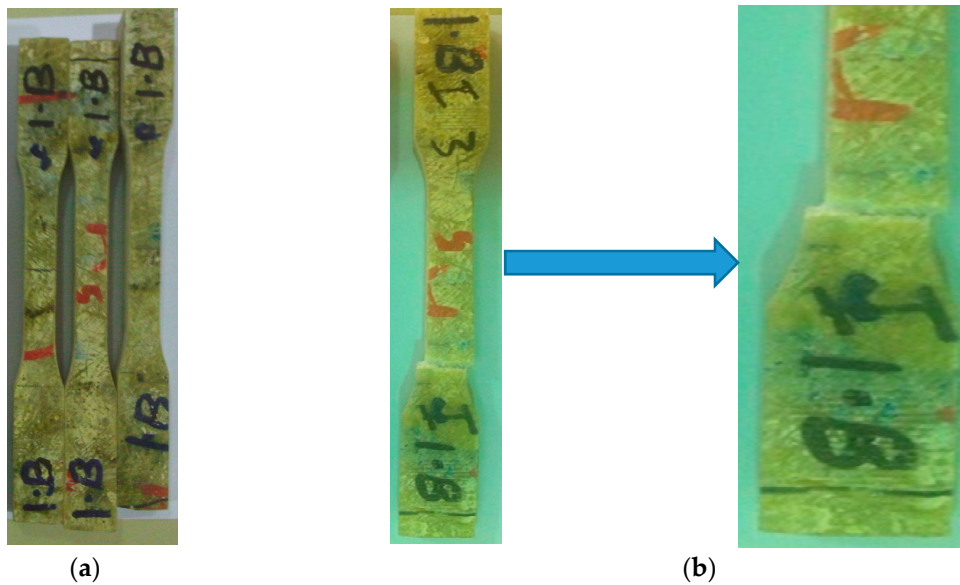
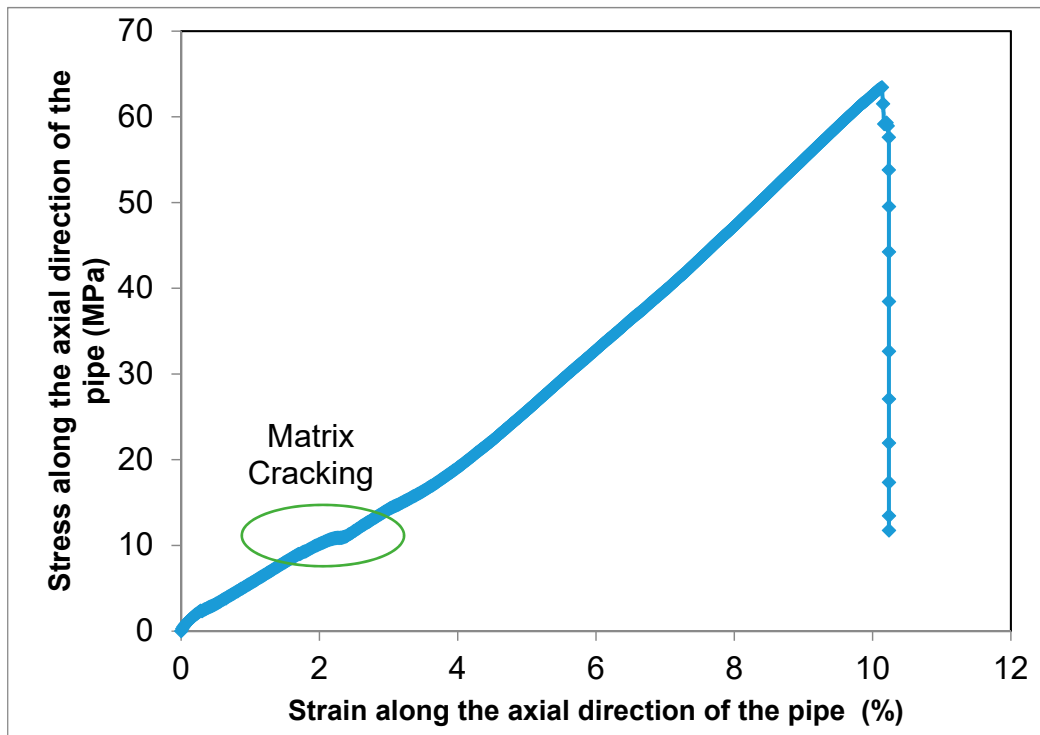
Figure 9. (a) Prepared specimens machined along the axial direction; (b) Failed specimen showing matrix cracking, fiber debonding, and huge delamination between the straight pipe and the overwrapped composite; (c) Stress–strain curve of axial specimens.

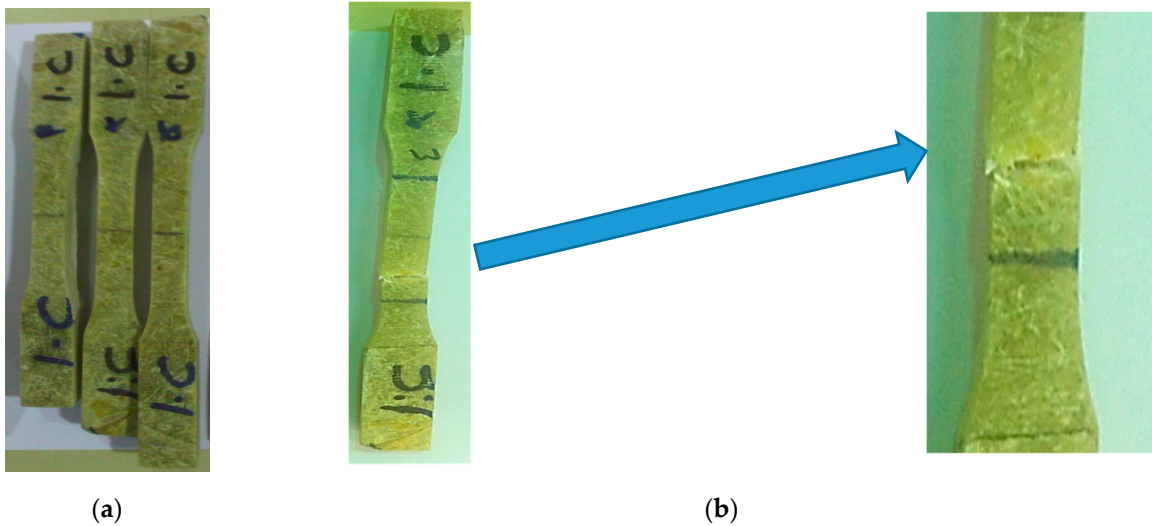
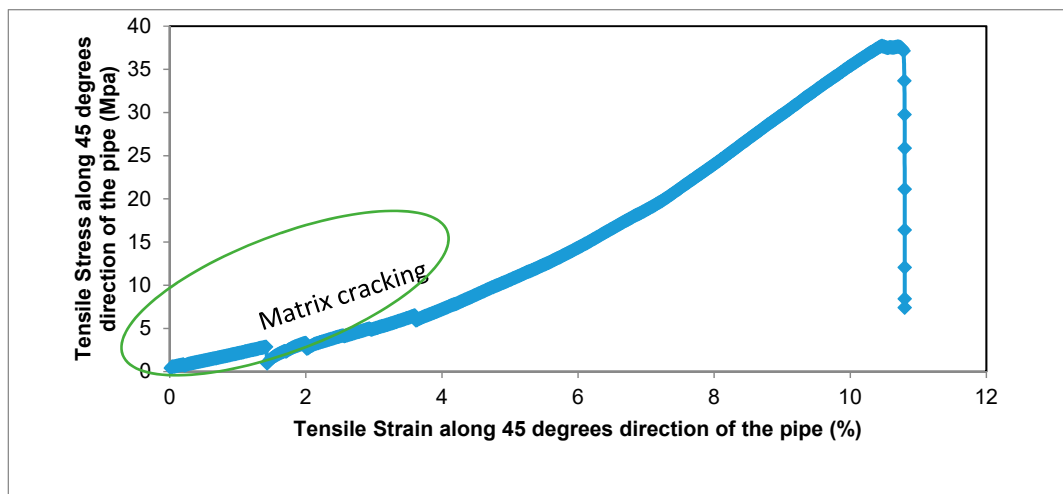
Figure 10. (a) Prepared specimens machined along the 45° direction; (b) Failed specimen showing matrix cracking and fiber breakage; (c) Stress–strain curve of 45° direction specimens.

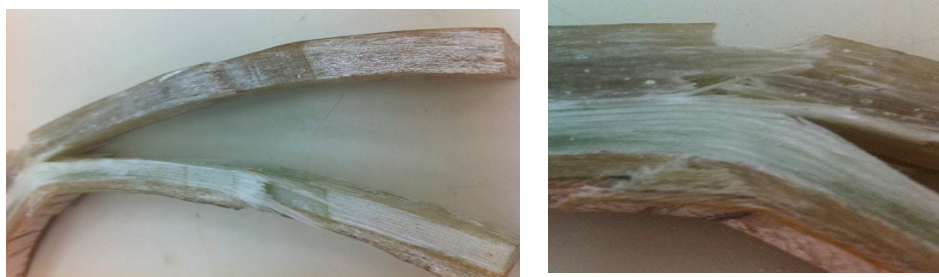
Figure 11. A severe delamination between the composite overwrapped and the joined straight pipes sections.

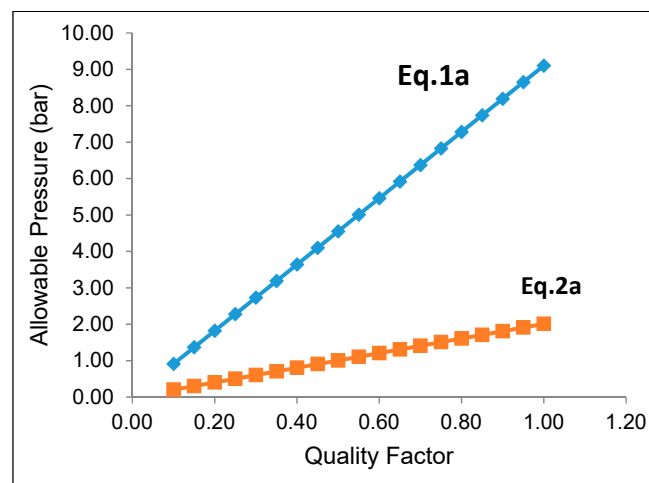
Figure 13. Allowable internal pressure as per ASME B31.3.

For calculations using equation 1a, the miter angle (θ) is idealized as 22.5° . The results indicate that the elbow may withstand the operating pressure depending on the quality factor (E). However, when actual geometric values are input into equation 1b, the allowable pressure calculated is significantly reduced. The result is that the maximum calculated allowable internal pressure when the quality factor E is taken as 1 is only 2 bar. These calculations show that the component’s irregular geometry severely affects the elbow’s load-carrying capacity. The irregularity appears to have contributed directly to the elbow’s premature failure. This is because the elbow wall thickness significantly dominates the axial stress at the center of an elbow. Therefore, it is an inferior design to make the elbow center the thinnest part, as shown in Figure 14. The analytical analysis conclusion is evident in the fact that the elbow was not designed correctly.

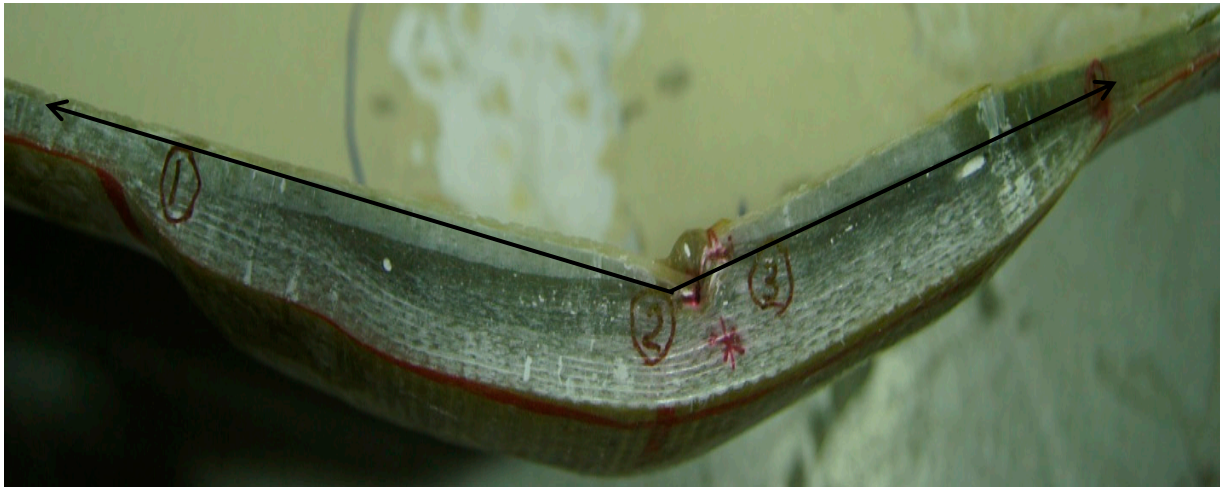
Figure 14. Thickness variation of composite elbow.

To further investigate the component's pressure capacity, it was modeled and analyzed using computational fluid dynamics and finite element analysis techniques. Geometry drawing was performed using Solid Works, and the CFD and FEA analysis was completed using Ansys Workbench. The GFRP elbow dimensions and detailed coordinates were measured using the 3D Computerized Measuring Machine (CMM). Measurements taken included section lengths, bend angles, inner diameter, and wall thickness. These dimensions were then used to draw the real geometry to model the GFRP elbow for numerical evaluation using computational fluid dynamics and finite element analysis. The failure zone was carefully modeled using a fine mesh to accurately compute the pressure profile and stress-strain contours. The measured outer dimensions showed a significant variation through all the directions. The dimensions at the inner side of the failure zone were carefully measured to examine any erosion possibilities. Dimensional analysis eliminated erosion and proved the presence of tiny matrix cracks. It is also interesting to note that based on the developed geometrical profile, the GFRP elbow has a poor profile that includes many internal ridges, as shown in Figure 15. A measured failure zone thickness was 8.3 mm, as highlighted in Figure 14.

- The fiber–matrix interface was poor.
- Irregular thickness: the joints between the straight pipe sections received a more significant amount of reinforcement. This increase in thickness caused the areas of lesser thickness to become inherent weak spots.

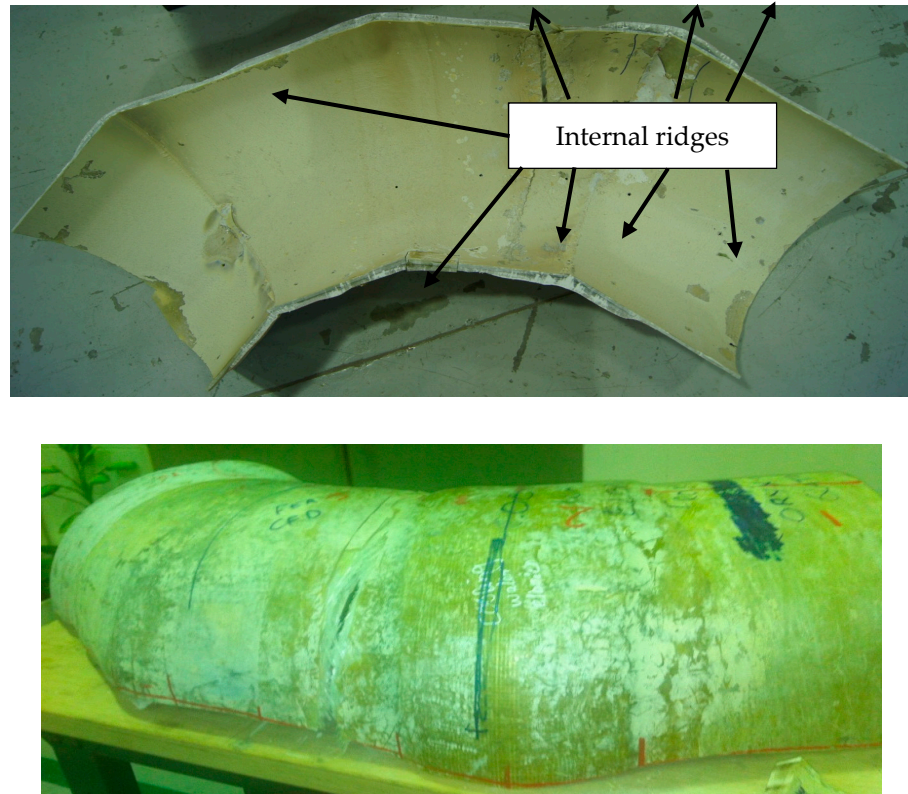
Figure 15. Internal surface of GFRP elbow showing internal ridges.

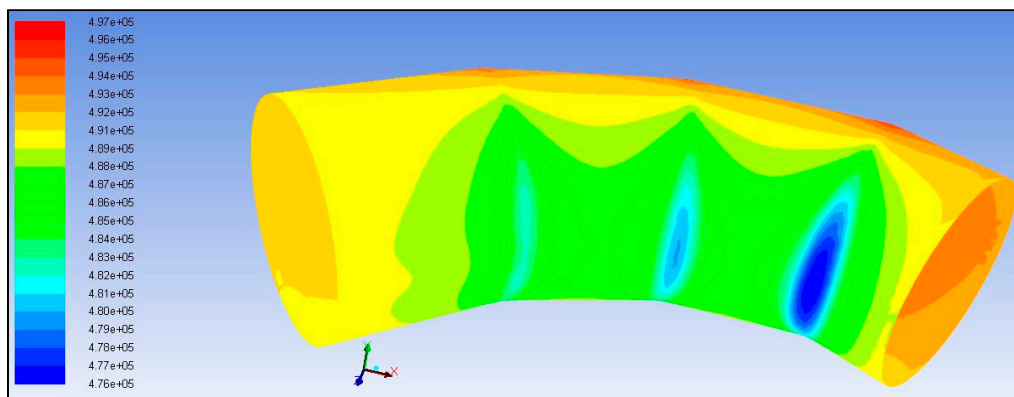
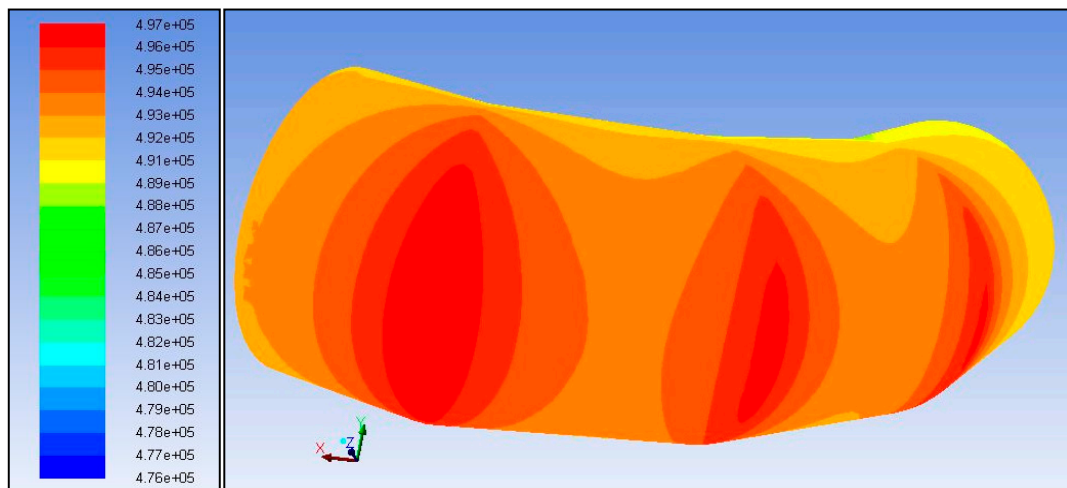
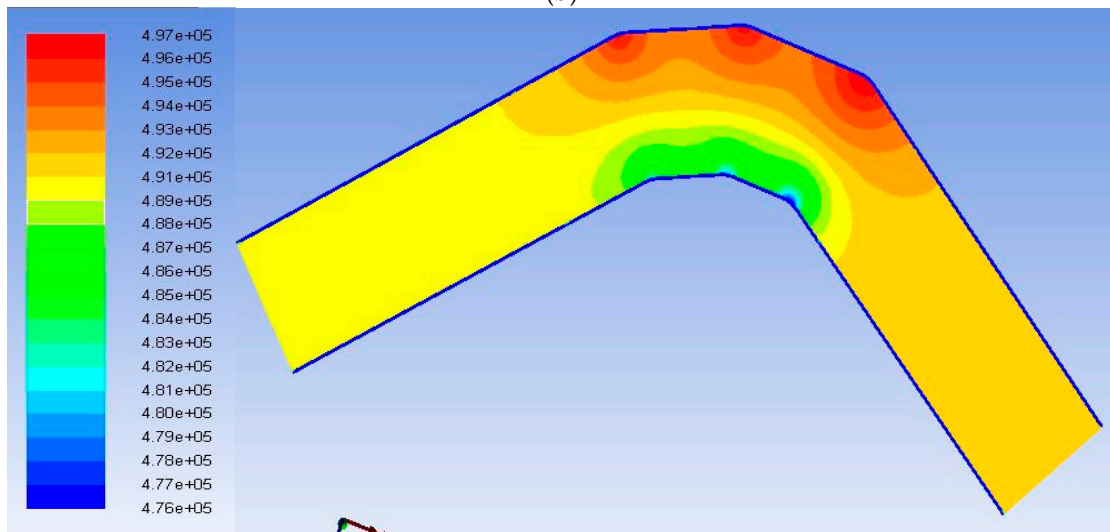
The final mesh was transferred to FLUENT CFD software for analysis. The realizable K-Epsilon model was used to solve the model with a pressure drop of 0.1 bar applied (i.e., 5 bar at the inlet, 4.9 bar at the outlet). The solution was then initialized and iterated until residual values dropped below $1E-3$, when they are considered converged for this analysis. After the solution converged, the results could be plotted. The main area of interest was the magnitudes of pressure at the wall. The contours of this pressure were plotted, and the results at the inside of the bend and the outside of the bend are shown in Figure 18a,b, respectively. As seen in Figure 18a, a substantial pressure drop occurs at the first change in direction. This pressure drop causes inefficiency and adds unnecessary head loss in

Figure 18. Contours of pressure obtained from CFD analysis.

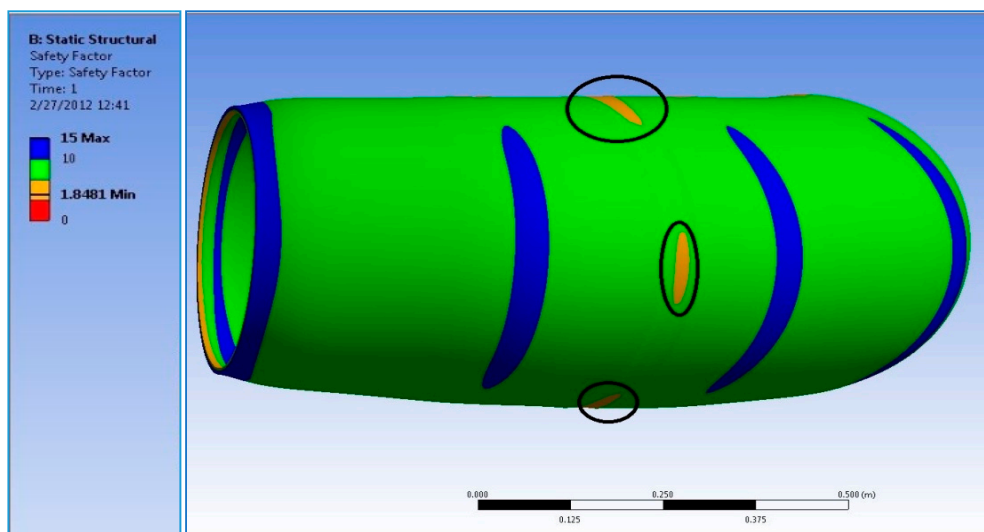
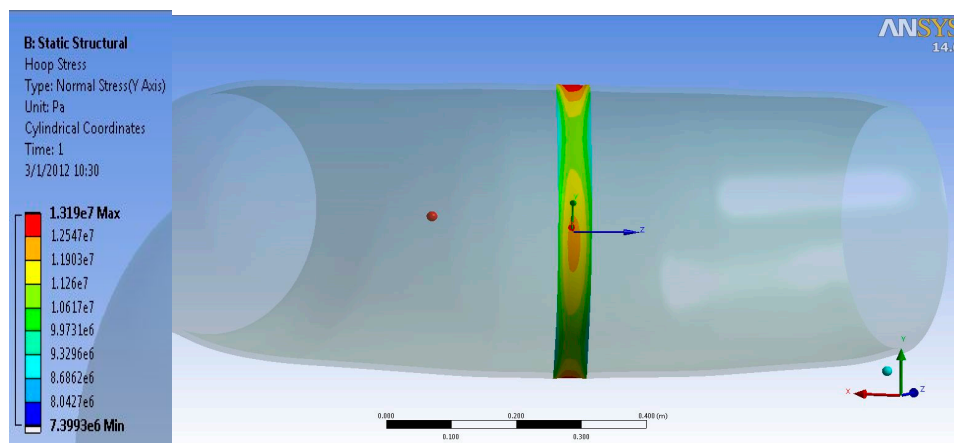
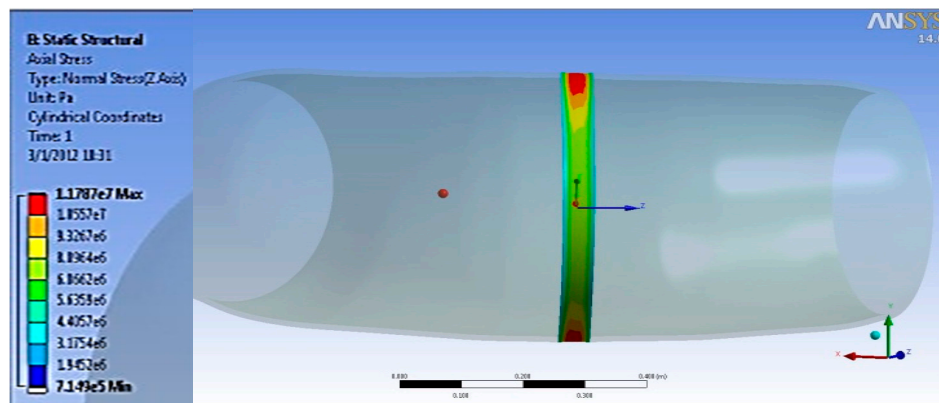
the system, and highlights the component's geometric irregularity. Using the Ansys Fluid Solid Interaction system, the CFD analysis's pressure results can be ported into the FEA analysis to study its effect on the material. The data obtained from mechanical testing of the specimens was combined with properties common to glass fiber composites, and was modeled in Ansys. The internal pressure load was imported from FLUENT; fixed supports were applied at either end of the elbow. After the solution was completed, the safety factor's contours were plotted to determine the component's ability to withstand the applied pressure load of 5 bar. The results can be seen below in Figure 19. As can be noted from observing the figure, the safety factor dropped to a minimum of 1.8 in the radial region, where the thickness was reduced to simulate the failure zone. A static safety factor of only 1.8 is not enough to give the elbow a lifetime of 20 years under the operating load applied.

Figure 19. Contours of static safety factor and hoop stress and axial stress at the center of the elbow-joint.
