CASE REPORT

The CT gap sign, a case of failure to seat the polythene component in total ankle replacement (infinity)

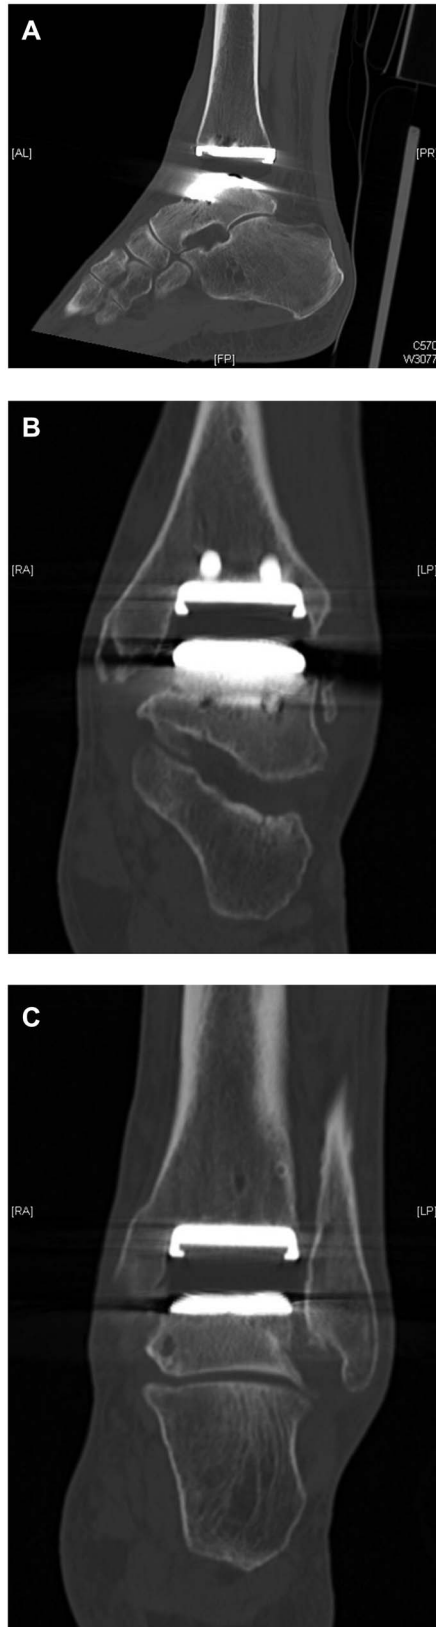
All inflammatory markers were within normal limits. Upon suspicion that the talar component might be irritating the tibialis posterior tendon, he underwent an ultrasound which was normal. His computed tomography (CT) was reported as normal by the radiologist. Symptoms suggested possible impingement of a slightly oversized talar component on medial malleolus. On close scrutiny, it was apparent that the CT postoperatively showed the poly to be seated anteriorly with a failure to engage posteriorly, leaving a void in the socket. We describe this as a

Figure 1: CT demonstration of the poly liner sitting slightly outside of its groove 'the gap sign' (A) Lateral view showing ct gap sign (B). AP view showing gap (C). AP view showing poly seating.

'CT GAP sign' (Fig. 1A–C), and he was offered a revision ankle replacement.

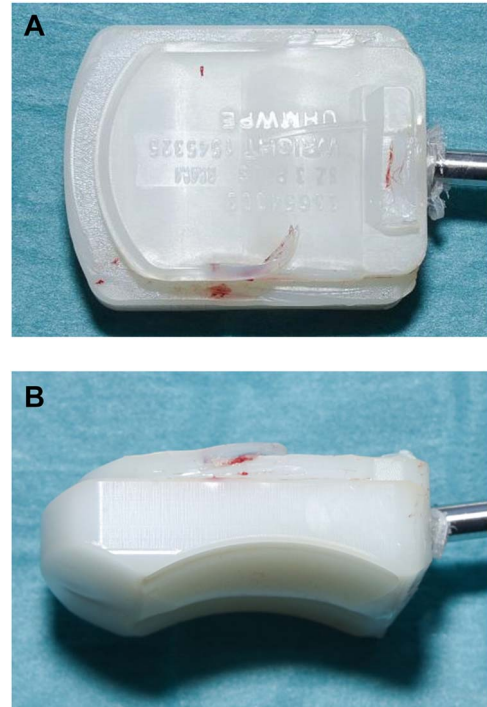
Figure 2: (A, B) Intraoperative pictures of polyethylene liner demonstrating incomplete seating into replacement.

Revision ankle surgery was undertaken by anterior approach through the previous incision. Intraoperative samples were taken which ruled out infection. The tibial component was well fixed to bone and showed no evidence of loosening, subsidence or rotational malalignment. Macroscopic examination of the retrieved insert showed grooves on its side. The poly was not fully reduced in its groove and had dislodged from the groove subsequently on the posterior aspect of the implant (Fig. 2A and B). He had a revision of the talar component to size 2 and change of polythene with good clearance of his medial gutter.

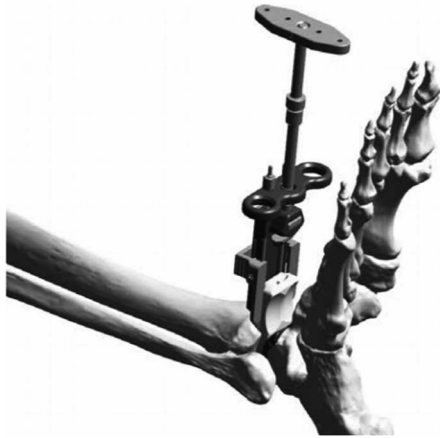
Figure 3: Inserter assembly.

The cause of inadequate seating may be due to technical error, failure of the poly inserting mechanism or failure of design of the locking mechanism in the INFINITY implant. It may also be possible to postoperatively dislodge the poly component. The poly inserter does not give a visual confirmation of seating as it is not possible, in the INFINITY replacement, to visualize the back of the component using the standard anterior approach. Incorrect seating of poly may lead to eccentric overloading of joint space, eccentric poly wear and mechanical pain.

The polyethylene inserter assembly consists of the poly inserter, a guide rail and attachment screw (Fig. 3). The guide rail inserts onto the poly inserter, and the handle is pulled back and locked into a start position. Whilst inserting, the dovetail feature of the implant slides into the guide rail ensuring correct antero posterior orientation of component. Then, the assembly slides over attachment screws and flush to the surface

of the tibial tray after securing the attachment nut. Incorrect technique, unmatched tibial and talar cuts or inadequate ligament balancing can lead to incorrect seating. There is, unfortunately, no radiological marker to confirm poly position in this implant.

We would advise adequate exposure, clearing of soft tissue and thorough lavage along with attention to detail whilst preparing the poly insertion assembly. Addition of a radiological marker as in the knee would help early recognition. Infinity is the most commonly used implant in TARs in the UK and gaining more popularity; surgeons should keep in mind this rare complication, and early CT should be considered in cases with persistent pain postoperatively. In conclusion, incorrect seating of poly component is a rare complication, which can be a cause of persistent pain in ankle replacements. This can be easily missed by the untrained eye even on CT scans. Prompt revision is needed to prevent late consequences.
