CASE REPORT

Inappropriate shock delivery as a result of electromagnetic interference originating from the faulty electrical installation

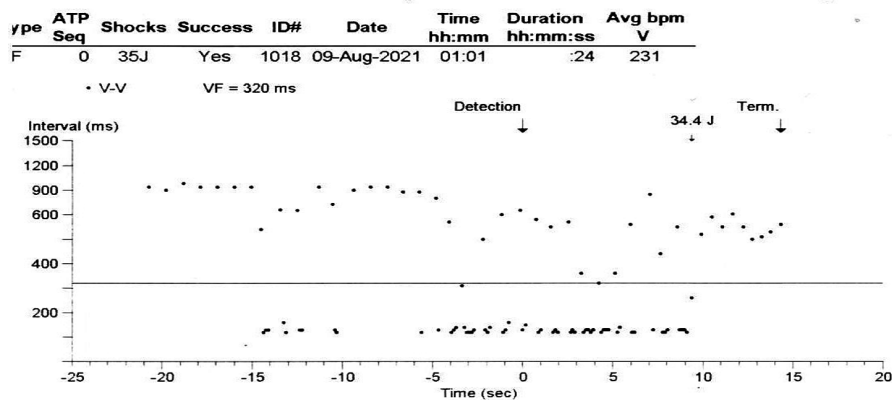
ICD interrogation revealed inappropriate ICD shocks due to electromagnetic interferences during bathing in the tub (Figure 1). The intracardiac electrograms showed a clear sinus rhythm, where R waves are visible and RR intervals were approximately 940 ms. However, at one point the electrocardiogram showed a sudden onset of a 50 Hz electrical artifact mimicking fast ventricular tachycardia which the device misinterpreted as such. The device then delivered a 34.8 joules shock while the patient was actually in sinus

FIGURE 1 Plot diagram demonstrates typical oversensing pattern, inappropriate VF detection and cessation following the delivery of the shock (due to patient dislocation from EMI source)

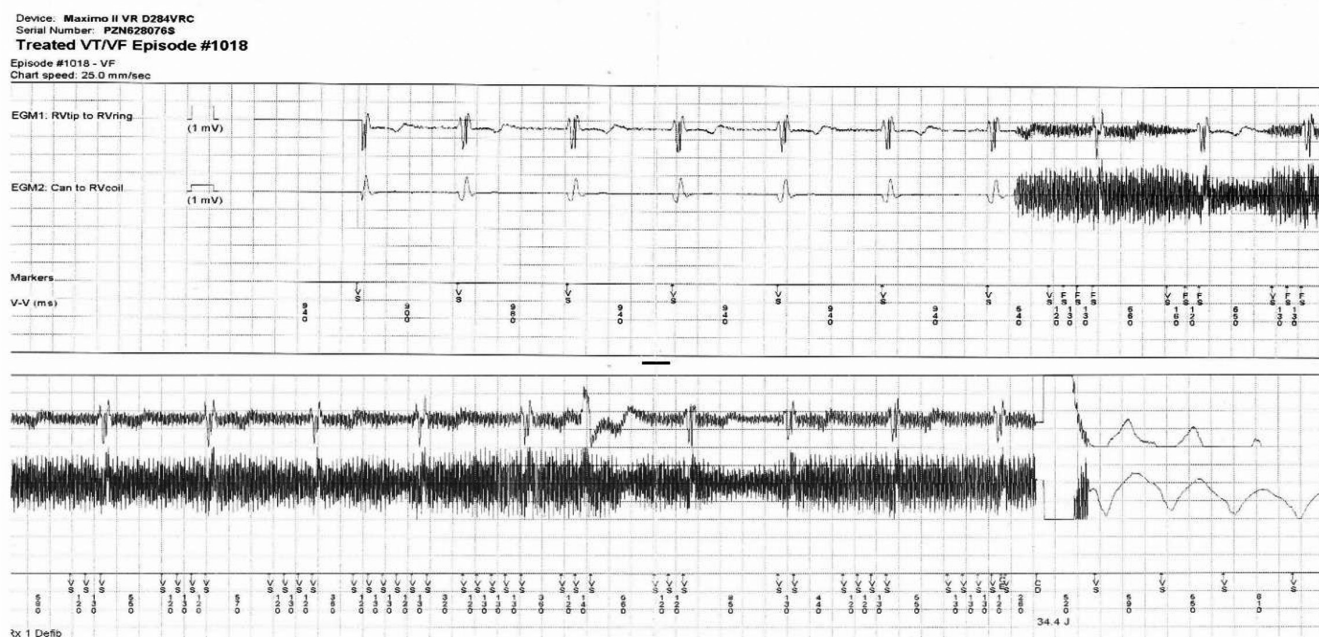
FIGURE 2 Intracardiac electrocardiogram at 25 mm/second, clearly shows a sinus rhythm with EMI detected as ventricular fibrillation, resulting in delivery of an inappropriate shock. Notice that external EMI usually has lower amplitude on channels recorded from small, closely spaced electrodes ("RV tip to RV ring") than on those recorded from widely spaced electrodes or those that include a large defibrillation electrode ("Can to RV coil")

rhythm. Despite the constant amplitude of the EMI source, oversensing may vary because of automatic adjustment of sensitivity and postural variation in the orientation of the sensing bipole relative to the electric or magnetic field. (Figure 2). The patient was not injured. The ICD function was correct except suboptimal sensing value of 2.4mV to 4mV.

After this event, the maintenance workers investigated the electrical installation in the bathroom and found that there indeed was leaking voltage between the electrical installation and the metal pipes. The electrical installations were subsequently repaired and there were no significant changes in the ICD parameters after the event. The patient has not experienced any further ICD shocks, nor ICD noise reversion episodes.
