# The Effect of Tropical Environment on Fatigue Failure in Royal Malaysian Airforce (RMAF) Aircraft Structure and Operational Readiness

**Abstract:** The environmental condition in which the Royal Malaysian Airforce is currently operating its aircraft is prone to corrosion. This is due to the high relative humidity and temperature. With most of its aircraft being in the legacy aircraft era, the aircraft's main construction consists of the aluminium 2024 material. However, this material is prone to corrosion, thus reducing fatigue life and leading to fatigue failure. Using the concept of either Safe Life or Damage Tolerance as its fatigue design philosophy, the RMAF adopts the Aircraft Structure Integrity Program (ASIP) to monitor its structural integrity. With the current problem of not having the structural limitation on corrosion-damaged structure, the RMAF has embarked on its fatigue testing method. Finite Element (FE) studies and flight tests were conducted, and the outcome is summarized. The conclusion is that the longeron tested on the aircraft can withstand the operational load, and its yield strength is below the ultimate yield strength of the material. These research outc

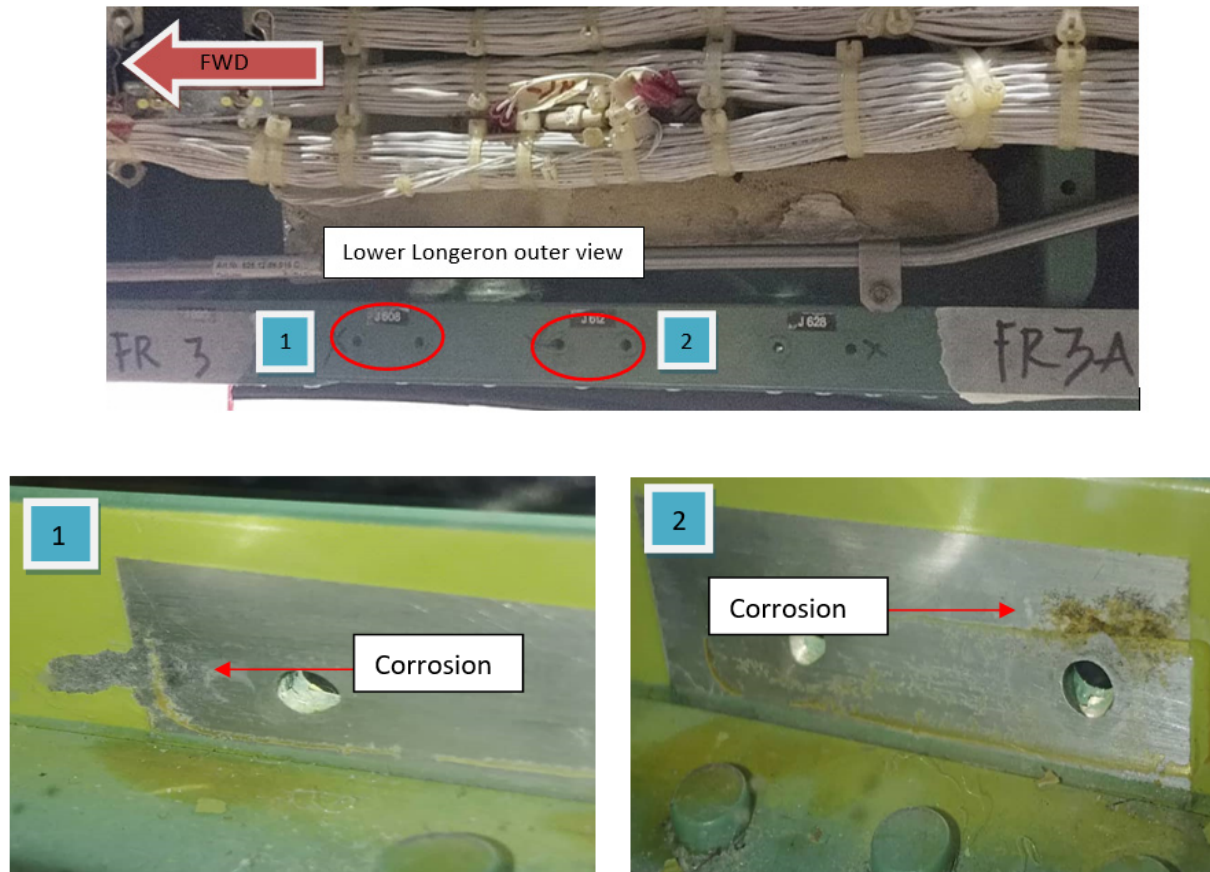
The RMAF is currently using the PC-7MkII aircraft as its trainer fleet. The PC-7MkII aircraft, a turboprop trainer type aircraft, is manufactured by Pilatus Aircraft Ltd. This aircraft is used for basic flying training or fighter conversion training and is intended for student pilots. Its airframe and avionics are similar to those of the PC-9M, which has a modular design [15]. Severe corrosion was found at the upper longeron, lower longeron, and wing spar when undergoing structural maintenance. These areas are listed as Primary Structure Element. The corrosion on the upper longeron is depicted in Figure 5 while the corrosion on the wing spar is shown in Figure 6.

Figure 5. Intergranular corrosion on upper longeron.

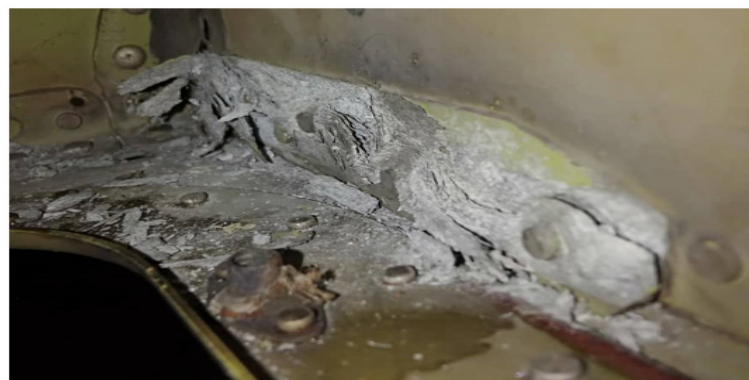
Figure 6. Corrosion on Wing Spar.

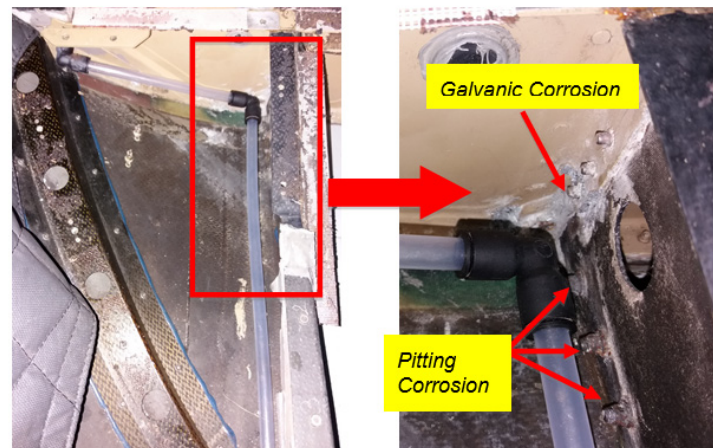
The EC725AP is the helicopter that is serving the RMAF. These helicopters based at Kuantan and Labuan airbase serve as tactical and search and rescue aircraft. Most of their structure is built from composite, however, there are some parts manufactured from aluminium alloy. Based on the depot-level maintenance carried out on one of the aircraft, it was found that the area of Frame X7225 till X7725 as shown in Figure 7 had been affected by severe corrosion [16].

**Figure 7.** Corrosion at Frame X7225 till X7725.

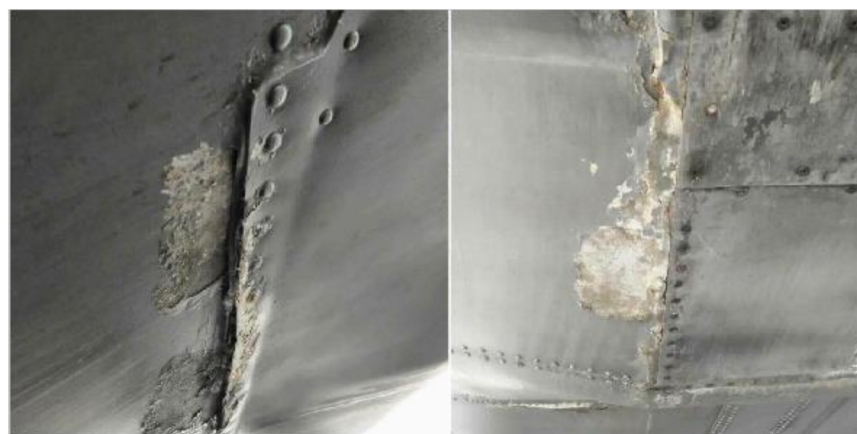
The Lockheed C-130 Hercules, also known as C-130H, is a military transport aircraft operated with a four-engine turboprop. Produced by Lockheed Martin, the aircraft was designed for troop, medevac, and cargo transport. Furthermore, this aircraft has many more capabilities, such as cloud seeding and air-to-air refueling. With its multirole capabilities and robust operating condition, this aircraft is subjected to corrosion and fatigue damage. It is currently located at Subang and Labuan Air Base. Based on the findings during its primary structural inspection, corrosion was found at the ramp and lower skin area as shown in Figure 8.

**Figure 8.** Corrosion at Lower Skin area.

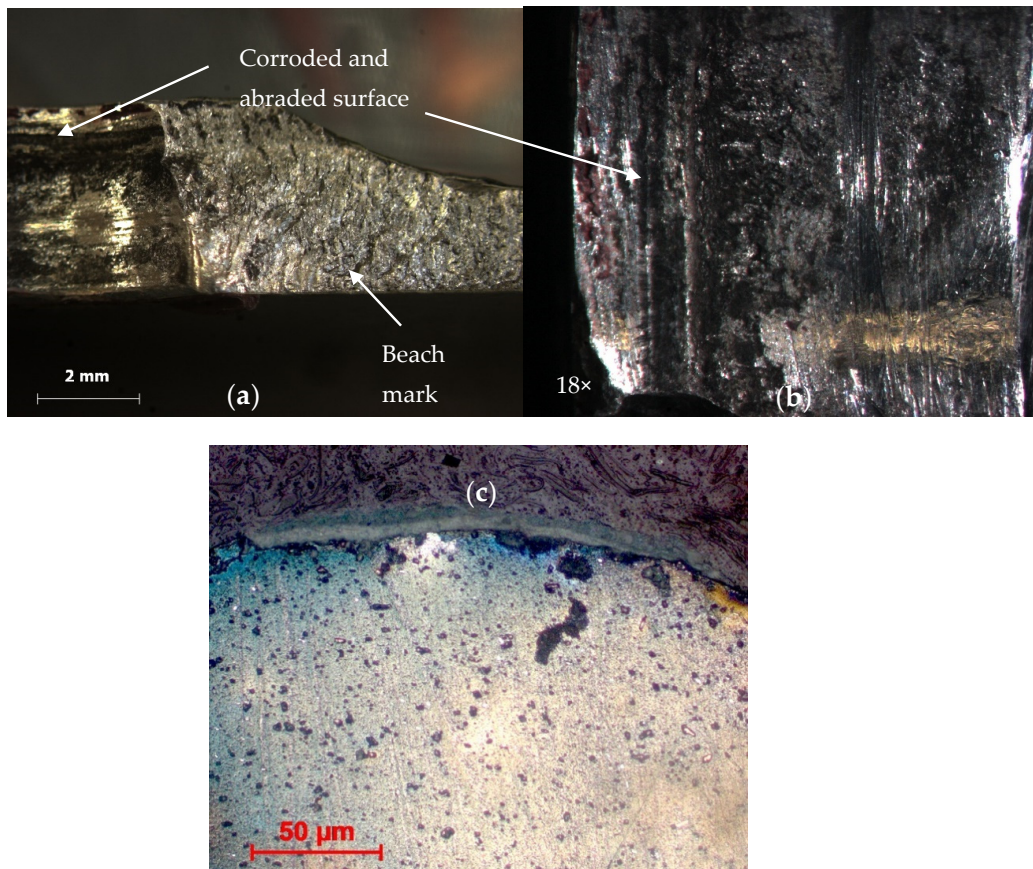
Examination at low magnification using an optical stereo microscope on the fracture surface on most of the structure revealed a beach mark, as shown in Figure 9a. A closed-up view on the surface found it was severely corroded and had abraded, as shown in Figure 9b.

**Figure 9.** Fracture surface due to corrosion and fatigue. (a) Beach mark and corrosion of frame X7225 of EC725. (b) Close up image (18×) on the specimen. (c) Close up image of C130H lower skin area.

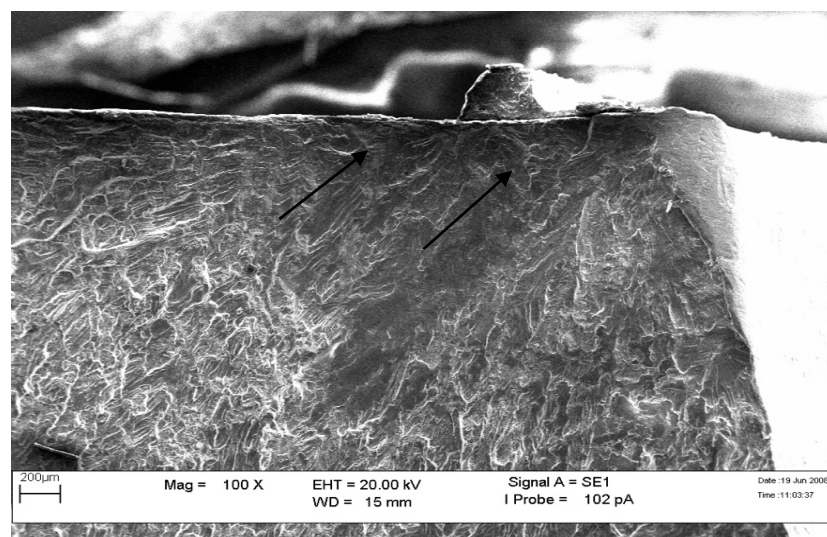
The fracture surface's crack initiation and beach mark region were examined using Scanning Electron Microscope (SEM) (Zeiss, Oberkochen, Germany). The presence of fatigue striation shown in Figures 10 and 11 indicates that the primary structure assembly had failed due to fatigue failure.

**Figure 10.** SEM image; arrow shows the fatigue striation (100×).

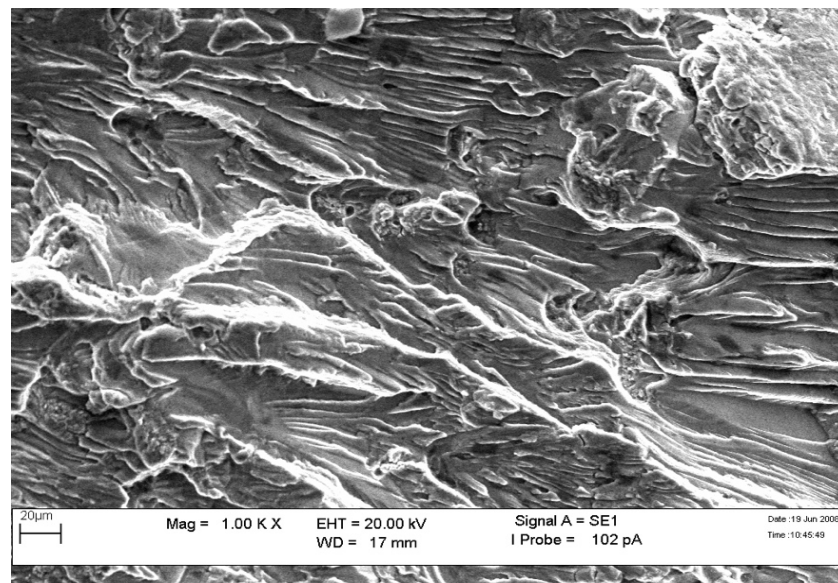
**Figure 11.** SEM image shows the fatigue striation (1000×).

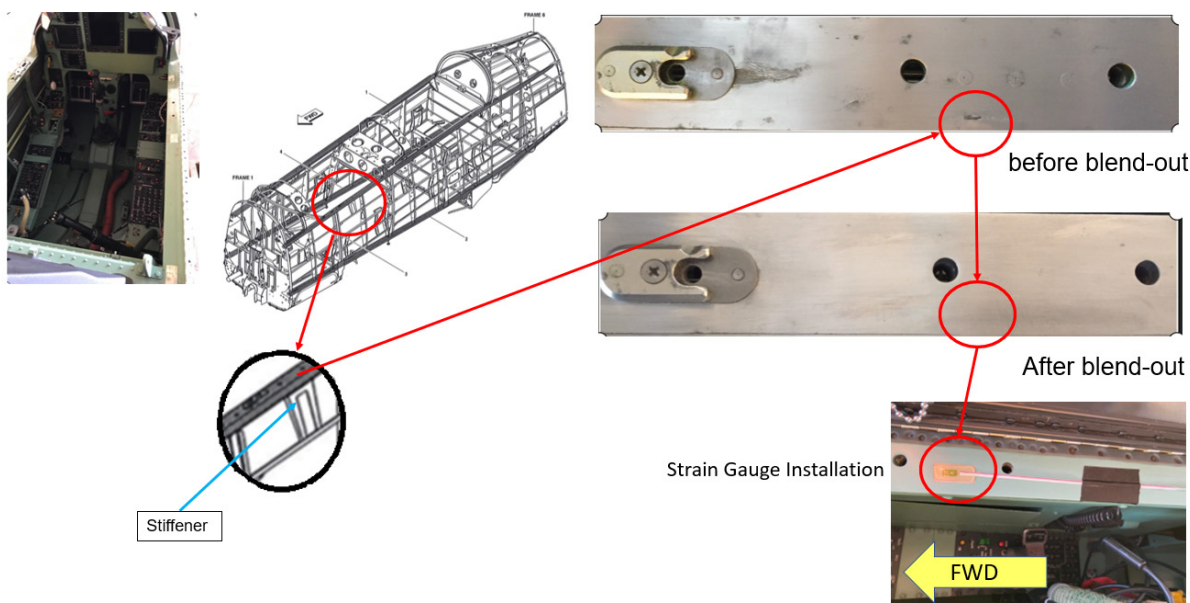
The left-hand (LH) and right-hand (RH) longeron were segmented based on Figure 14 for corrosion inspection. Upon blend of the corrosion, a strain gauge was installed at Section C on the RH longeron and Section B on the LH longeron as shown in Figure 15.

Figure 15. Blend out of corrosion and strain gauge installation.

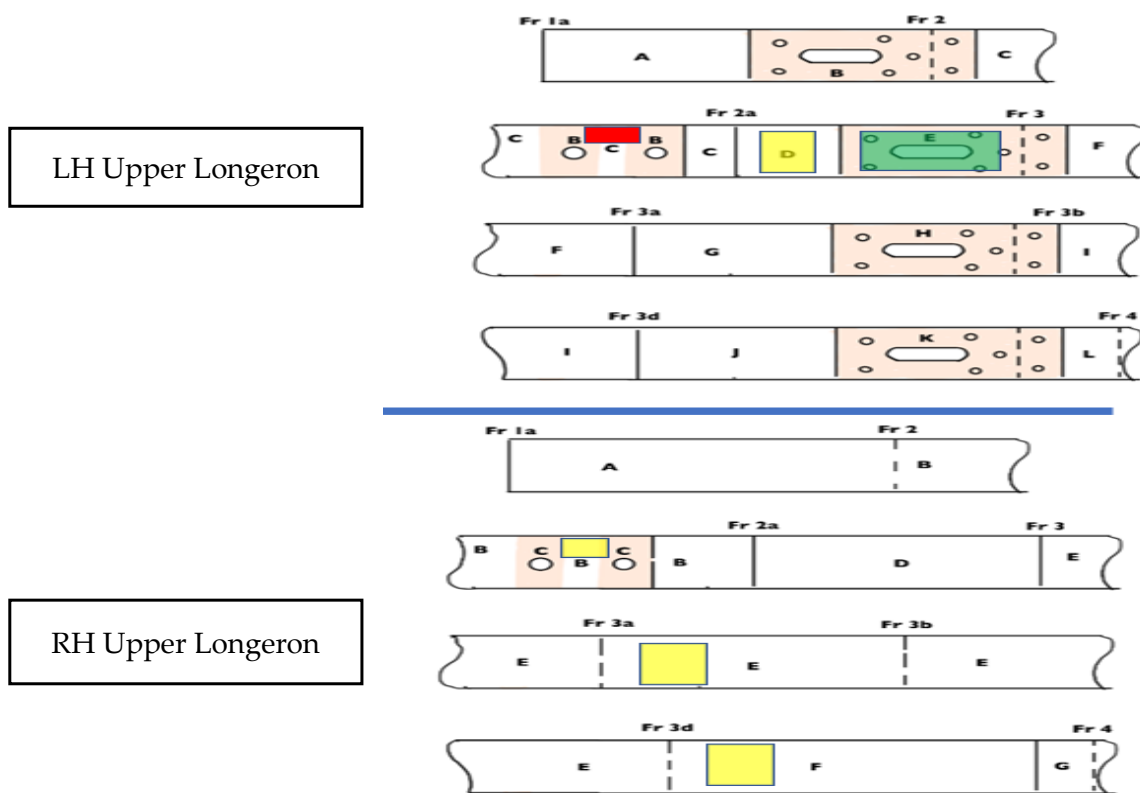
There were a few corrosion spots on the LH and RH longeron. Corrosion treatment work was carried out, which in return reduced the thickness of the longeron. The longeron has a thickness of  $2.7 \pm 0.2$  mm. Considering that the longeron's initial thickness (datum) is 2.7 mm, the structural area was treated and segmentized. Based on Table 2 and Figure 16, there was a thickness loss of 0.36 mm on the LH longeron. It is located between the two-lifting point. The detailed inspection and treatment result is depicted in Table 2.

Figure 16. Inspection result for the RH and LH upper longeron.
