Case report

Taper fretting corrosion with Stryker Anato stem after hip replacement

David M. Freccero, MD, Kenneth J. McAlpine, MD^{*}, Eric L. Smith, MD

Department of Orthopaedics, Boston Medical Center, Boston, MA, USA

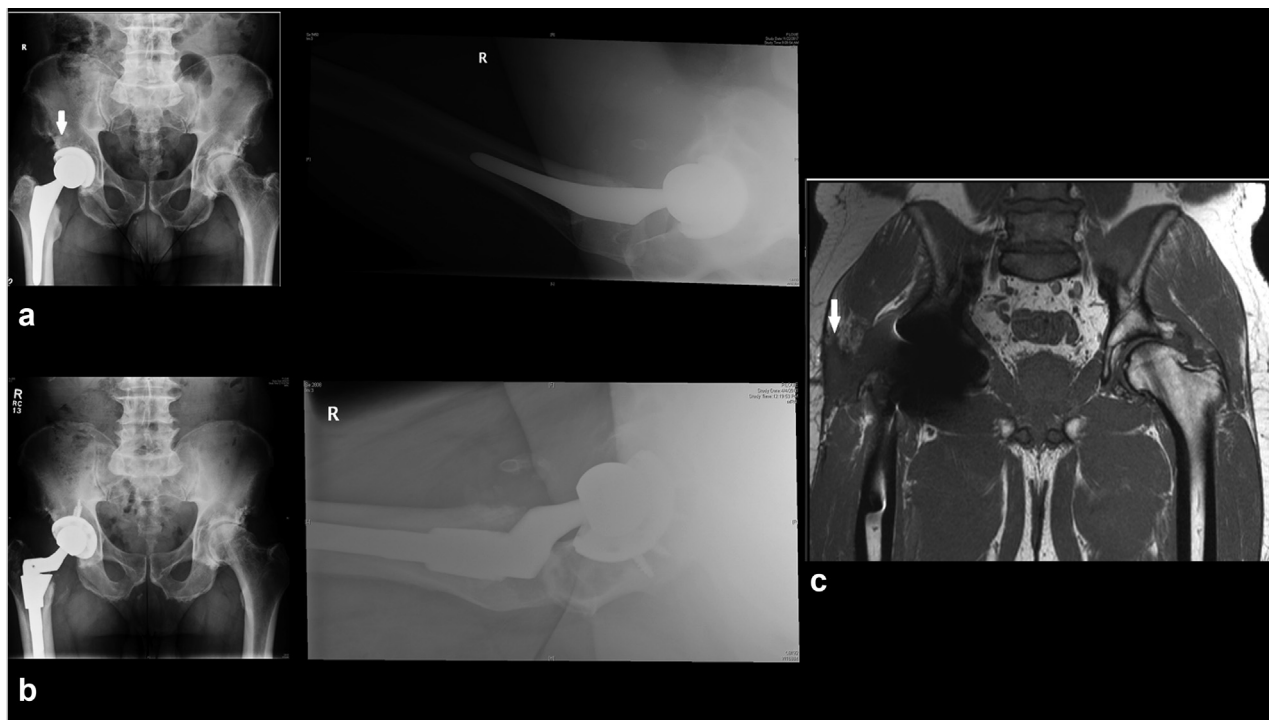
Figure 1. AP and lateral radiographs of the pelvis and right hip. The white arrow indicates an area of lucency (a). AP and lateral postoperative radiographs (b). MARS MRI with fluid collection indicated by a white arrow. MARS, Metal artifact reduction sequence (c).

Radiographs included an anteroposterior (AP) pelvis, a cross-table lateral of the right hip, and an AP view of the right hip (Fig. 1). Radiographs revealed a well-fixed femoral component in mild varus alignment. The acetabular component was in good alignment, but there was lucency noted in the superolateral aspect of the acetabular bone-implant interface in zone 1 [5], potentially concerning for loosening. There was no osteolysis of the femur or acetabulum noted. No periprosthetic fractures were noted, and there was no evidence of polyethylene wear. Workup included serology testing including sedimentation rate (ESR), C-reactive protein (CRP), and white blood cell (WBC) count. The ESR was 23 mm/hr (0–20 mm/hr), the CRP was 26 mg/L (normal < 5 mg/L), and the WBC count was 6000 cells/ml³. Right hip arthrocentesis was performed. The synovial fluid WBC count was 700 total nucleated cells (automated count), with no differential completed, and the synovial fluid cultures were negative after 14 days. Cobalt ion levels were 6 ppb (normal < 1.8 ppb), and chromium ion levels were 0.7 ppb (normal < 3.6 ppb), fitting the pattern of cobalt greater than chromium elevation for trunnion-related failure [6]. Metal artifact reduction sequence MRI of the pelvis was ordered. It revealed an encapsulated fluid mass measuring 240 cm³, extending from the greater trochanter to the hip joint. This fluid collection was consistent with an ALTR. The operative report documented use of a size 6 Stryker Anato femoral stem with a V-40 taper, a Stryker 40 mm + 0 mm cobalt-chromium metal femoral head, and Stryker Tritanium 58 mm hemispherical acetabular socket with an X3 highly cross-linked polyethylene liner (Stryker, Mahwah, NJ, USA).

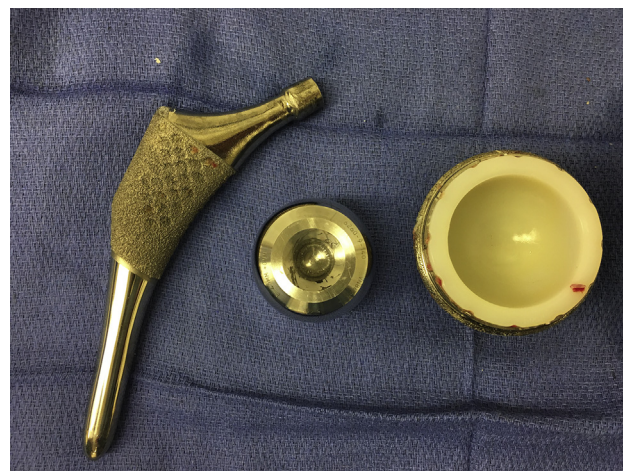
Revision surgery was performed using a posterior approach. Intraoperatively, there was dark-pigmented staining of pericapsular tissue with whitish cottage cheese fibrinous material dispersed adjacent to the hip capsule as well. There was significant MACC visible on the femoral neck with notching and mechanical defects of both the femoral neck and inner taper of the prosthetic metal head (Goldberg classification and Goyal classification) [1,7]. The abductor musculature was viable, beefy red, contractile to electrocautery stimulation, and intact. The femoral stem was well-fixed and was removed using a combination of flexible osteotomes, Kirschner wires, and a looped femoral stem extractor. The acetabular component was loose and was removed uneventfully with the Zimmer Explant Acetabular Cup Removal System (Zimmer, Warsaw, Indiana, USA) (Fig. 2). Debridement of the pigmented and

Figure 2. Explanted femoral stem, femoral head, and acetabular component. Damage to the trunnion is noted as well as metal residue.

To our knowledge, this is the first report of MACC resulting in ALTR involving the Stryker Anato stem. There are reports of the Stryker Accolade stem and Stryker Meridien stem developing head-neck taper corrosion and ALTR [1–4,8]. These stems are Ti-12Mo-6Zr-2Fe (TMZF) alloy stems with a V-40 taper. The Stryker Anato stem is also a TMZF alloy stem with a V-40 taper. It is a double-wedge, metaphyseal-engaging stem. Based on the previous reports of MACC involving TMZF stems with a V-40 taper, [2–4,8,9] along with this report of the Stryker Anato stem MACC and ALTR, particular design features including TMZF alloy and small V-40 tapers may be contributing factors to head-neck taper corrosion.

fibrinous ALTR tissue was performed. The wound was irrigated with copious irrigation, including use of dilute povidone solution. Frozen sections revealed no acute inflammation, but showed multiple lymphocytes characteristic of aseptic lymphocyte vasculitis-associated lesion (Fig. 3). Revision right total hip replacement was performed with DePuy/Johnson & Johnson Pinnacle Sector multi-hole acetabular component and a highly cross-linked polyethylene liner, and an S-ROM femoral stem with a Biolog Delta ceramic femoral head (DePuy, Warsaw, Indiana, USA). Postoperatively, the intraoperative cultures were positive for *Staphylococcus epidermidis* (1 specimen of 3 sent was broth-only positive). Infectious disease consultation was obtained and postoperative IV antibiotics were recommended for 6 weeks. A peripherally inserted central catheter (PICC) line was placed, and he received a 6-week course of IV Ancef (2 g every 8 hours), followed by 6 weeks of PO rifampin (300 mg daily). Postoperatively, he recovered uneventfully in the hospital and was discharged to home. At 1 year postoperatively, he had no right hip pain, and his ESR and CRP levels were normal. The cobalt level decreased to undetected levels, and the chromium level decreased to undetected levels (Table 1). He was able to use the exercise bicycle and ambulate without pain and resume physical fitness activities without pain.

Treatment for ALTR requires removal of the metal ion generator. Frequently, this involves retention of the femoral stem with femoral head exchange to a ceramic head with a titanium sleeve over the trunnion. There have been good results with this technique reported, with low rates of ALTR recurrence [2–4,7,11,17–19]. Alternatively, treatment may also require complete femoral stem revision and/or acetabular component revision if the components are loose. Complete femoral stem revision may also be required if there is gross trunnion failure or severe deformity or etching of the trunnion surface [1,16,19]. Complete femoral stem revision may also be indicated for malpositioned components or recalled implants. In certain clinical scenarios, the femoral head may be cold-welded to the trunnion, requiring complete femoral stem revision as well. In the case of complete femoral stem revision, advanced techniques may be required to remove a well-fixed femoral stem. These techniques may include use of Kirschner wires or Steinman pins or motorized burs to disengage bone in-growth or ongrowth areas from the stem, as well as the use of special device extractor tools to forcefully extract a well-fixed stem from the femoral canal. The extended trochanteric osteotomy may be a useful technique to facilitate access to well-fixed noncemented diaphyseal-engaging stems [20,21].

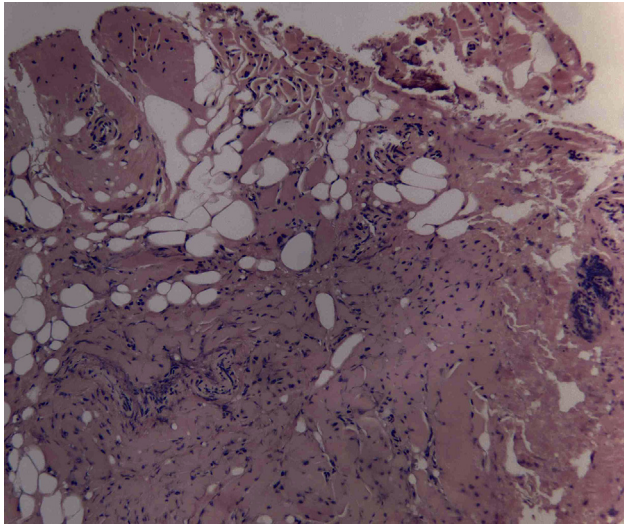
Figure 3. Representative pathologic specimen with hematoxylin and eosin staining. Multiple lymphocytes are seen representative of adverse local tissue reaction.
