Novel Method for Failure Modes Detection in UV-Cured Clear Coated Polymer for Automotive Interior Mechatronic Devices

Abstract: Plastic parts used in automotive interior are difficult to coat, due to their low surface energies as well as their sensitivity to temperature and solvents, rendering the development of coating systems for such substrates challenging. Automotive customer requirements are explicit and clear, mainly focused on functional and surface defects. A new failure modes detection methodology of UV clear coated polymers for automotive interior, obtained by a multi-step manufacturing process, is proposed. The polymer complex parts analyzed in this paper are manufactured in various steps as follows: two components plastic injection molding, primer coating, laser engraving, and UV-cured clear coating. The failure modes detection methodology of the parts within each process step is investigated using different tests and analyses as follows: surface tension test, painting adhesion test, optical 3D measuring, energy dispersive X-ray analysis (EDX), and microscopy. A design of the experiments (DoE) based on the Taguchi technique with the aim to detect the influence of the m

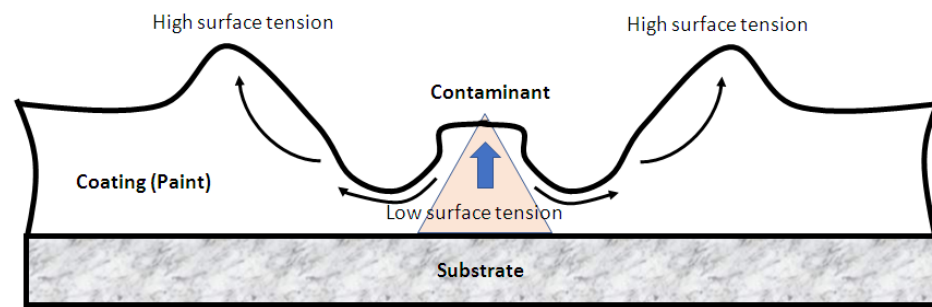
Based on the proposed methodology, one very rarely occurring failure mode was detected as very important and at a high level of scrap, the so-called fish-eyes defect. This defect is caused by a contaminant with low surface energy, from which the applied coating is displaced, as shown in Figure 3 [30,31].

Figure 3. Contamination defect called as fish-eye defect.

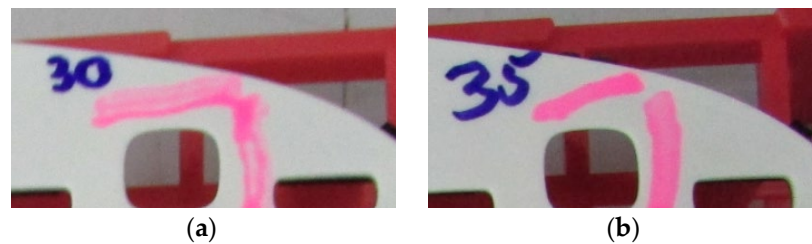
The surface of the parts resulted from the injection molding process were analyzed by Dyne Pens, and the results about the surface tension test are shown in Figure 4. The affected areas of the parts are determined for a 30 mN/m surface tension related with the

coated parts which present the fish-eye defect. The parts coated without the fish-eye defect have been the one measured at 35 mN/m surface tension.

Figure 4. Surface tension value is (a) 30 mN/m for bad parts; (b) 35 mN/m for good parts.

To improve the adhesion of the surface by using corona discharge or low-pressure plasma treatments [32] cannot be an affordable industrial solution in case of injected plastic parts due to expensive processes designed to handle the parts between process steps. A possible solution to increase the adhesion by surface preparation could be the cleaning with a solvent [33] or even cleaning with dry ice CO₂ blasting [34].

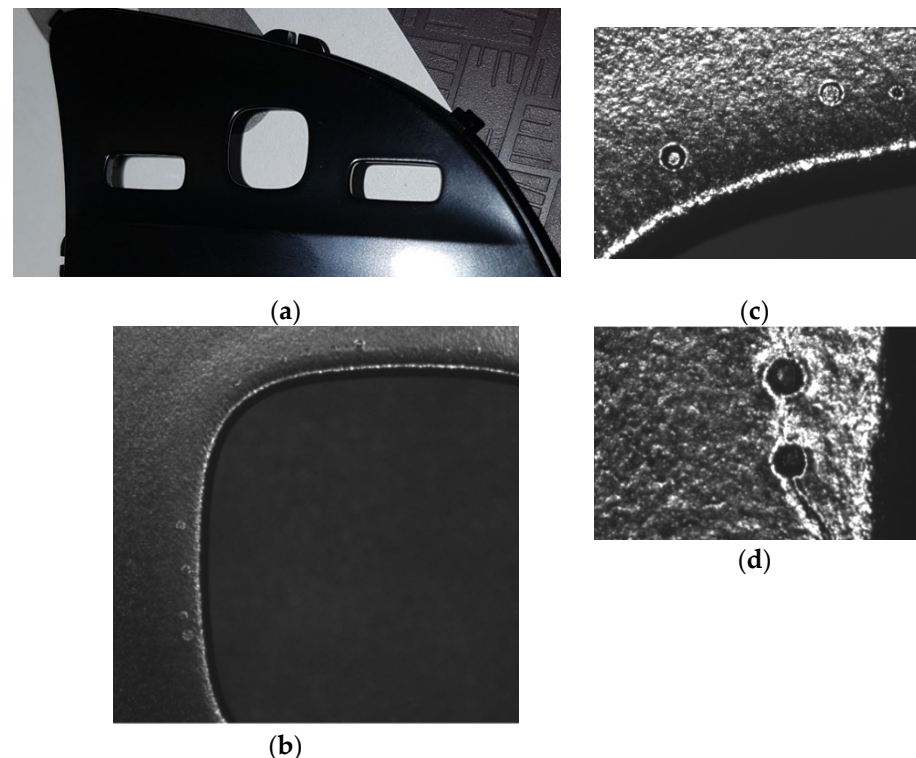
The optical microscopy investigations of the coated parts, used to understand the mechanism of the failure, have shown the occurrence of the defects on the plastic parts first layer coating, on the nearest area of the rectangle windows from the parts. Investigation led to fish-eye defect on the primer painted parts (Figure 7b–d).

Figure 7. Coated parts analysis: (a) Visual test; (b) Optical microscopy analysis of the rectangle window of the part; (c) Optical microscopy analysis on the upper zone of the rectangle window; (d) Optical microscopy analysis on the right zone of the rectangle window.

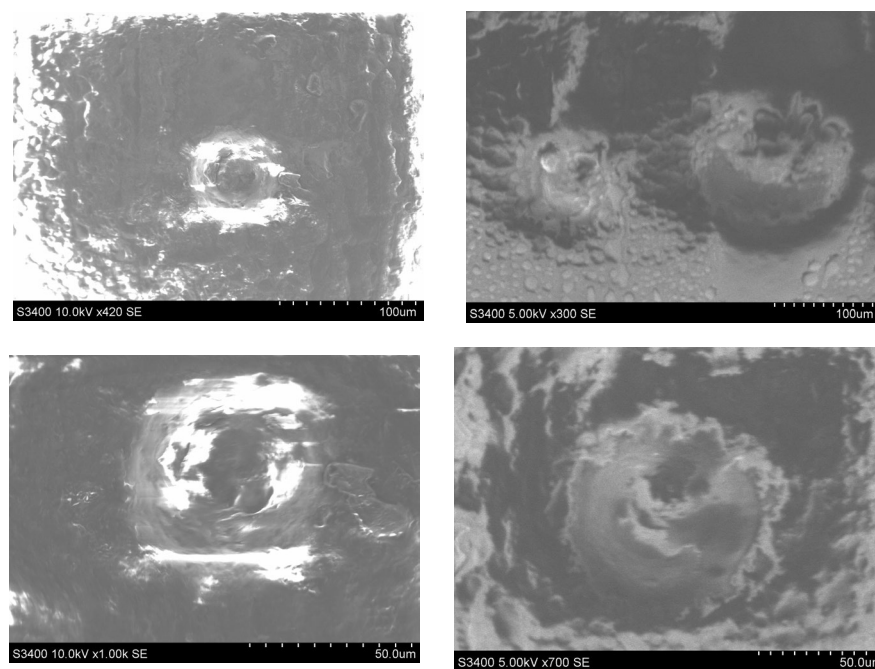
A SEM microscopy analysis study was performed in different four areas to deeply analyze the fish-eye defects on the nearest area of the rectangle windows of the part, as is shown in Figure 8. This defect is characterized by circular voids or crater-like openings. The size of the circular shape defect was in the interval 50 to 178 microns.

Figure 8. SEM microscopy analysis study in different four areas of the part.

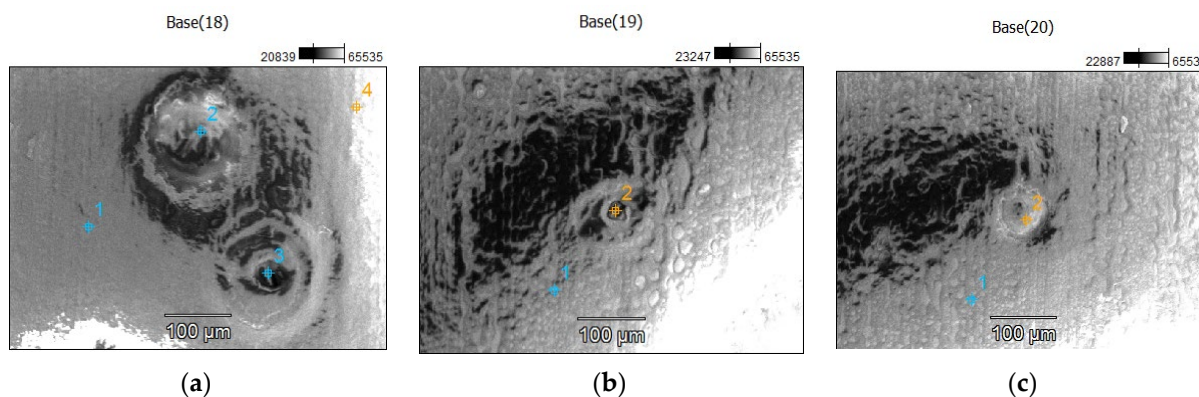
A number of three EDX analyses were performed within different areas which contain defects of the part, as shown in Figure 9. Four points were chosen for the first EDX analysis on the SEM image (Figure 9). Based on the results shown in Figure 10, only two EDX points are relevant (Point 1 and 2) for the following analysis. The results of the EDX analysis for the first area are presented in the Table 3. Similar EDX results, within only two points, were obtained for the other two interested areas from Figure 9. A possible contamination with a material such as oil or demolding spray during the injection process of the plastic part was checked by EDX analysis, and the results are shown in Figure 10.

Figure 9. Choosing the analyzed EDX points (1, 2, 3 or 4) in three different zone with defects of the part: (a) EDX points in Base(18) area; (b) EDX points in Base(19) area; (c) EDX points in Base(20) area.

The EDX analysis did not reveal any clear element that should not be present, because in the plastic substrate mainly hydrocarbons are present [16], and the base layer is also a hydrocarbon, so that the presumption of oil or release agent contamination was maintained.

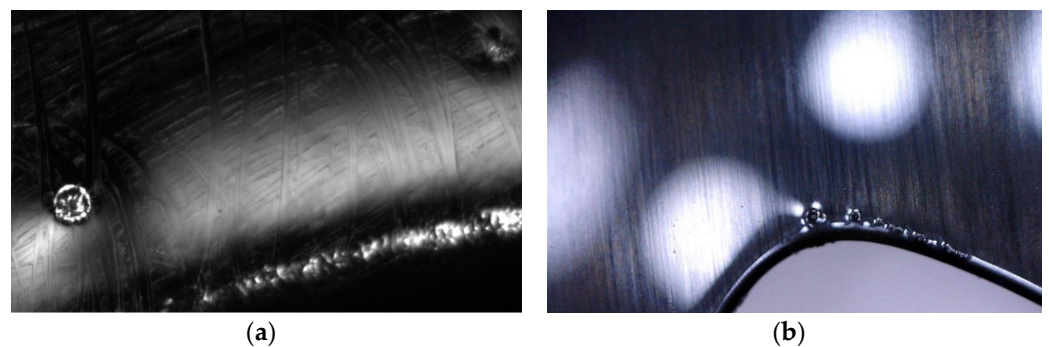
The thickness of the UV-cured clear coating has been measured, similar to the coating with primer. The result shows that they are not related to the “fish-eye” defects that appeared on the plastic pieces, as in the case of the primer, the thickness is in the specified tolerance with an average of 27 microns [5]. The “fish-eye” defects were detected on the UV-cured clear coating parts by the optical microscope, both in the area of square windows, but also at a distance from their edge (Figure 12a,b).

Figure 12. The issue (fish-eye) detected on the final clear coated parts: (a) in the area of the square windows; (b) at a distance from their edge.

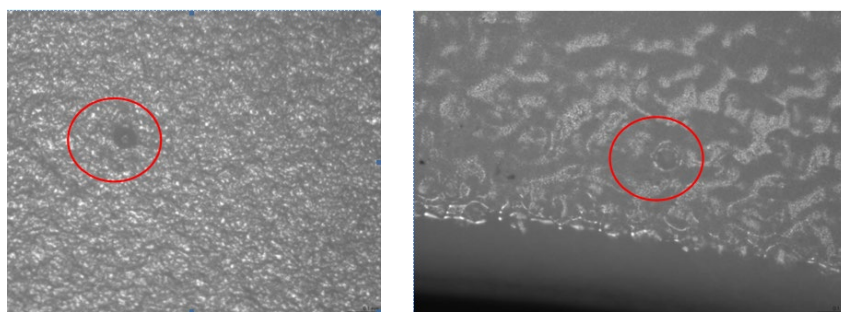
Figure 15. Optical microscopy inspection of the parts resulted using an increased mold temperature.

Some solutions to reduce then to eliminate the occurrence of the failures were found as follows. A defect rate indicator was used to measure the results of all counter measures and improvements actions, based on the report between the number of parts that contain one or more fish-eye defects and total parts checked, in percentage. As a short-term improvement action, the tempering step was implemented at 80 to 85 degrees Celsius during 2 h of the injected parts before the primer painting process. It leads to reducing of the defect rate from 80% to 50%. Furthermore, the changing of the cooling system of the injection molding tool from oil to water led to reducing of the defect rate from 50% to 0.9%. Variation of the defect rate of 0.9% generates the need to investigate the plastic parts, and new parameters in injection molding reduced the scrap rate from 0.9% to 0.05%.
