# Defibrillation failure with an electrical short circuit caused by internal insulation breach

Takuo Tsurugi, MD, PhD,\* Junjiroh Koyama, MD, PhD,\* Kazuhisa Kodama, MD, PhD,\* Hiroshi Nakajima, MD, PhD,<sup>†</sup> Tomohiro Sakamoto, MD, PhD,\* Ken Okumura, MD, PhD\*

From the \*Saiseikai Kumamoto Hospital, Kumamoto, Japan, and <sup>†</sup>Chiba Nishi General Hospital, Chiba, Japan.

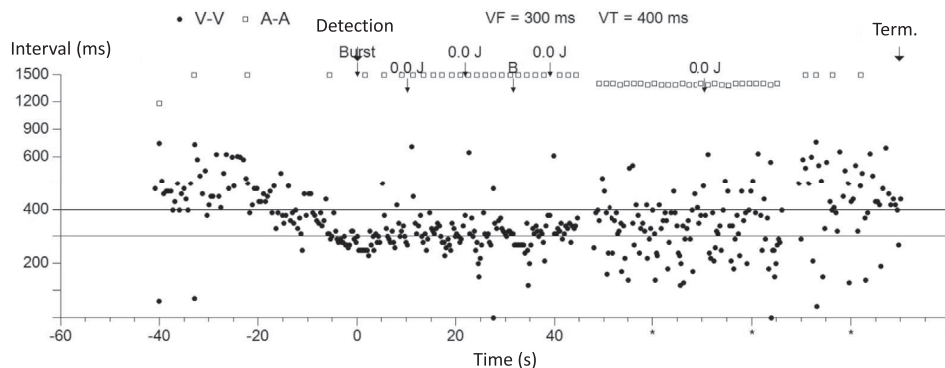
To the best of our knowledge, this is the first report of unsuccessful defibrillation in a Riata ST Optim lead owing to aborted shock delivery as a result of a decrease in impedance. Recently, Hauser and colleagues<sup>6</sup> reported lead failure and adverse clinical events of Durata, in which lead construction is similar to that of the Riata ST Optim, from the 2008–2018 FDA Manufacturer and User Facility Device Experience (MAUDE) database. Of Durata lead failures, 93% were associated with insulation failure, which was at a significantly higher rate than the Sprint Quattro Secure (16%) and Endotak Reliance leads (38%). Moreover, Durata internal insulation breaches contributed to 11 failures of VT/VF termination, and all cases were caused by a lead short circuit. Ten of the 11 lead short circuits occurred between the SVC and RV coils. Since the Durata and Riata ST Optim leads had no coating with Optim under the SVC shocking coil, a distal

**Figure 2** Ventricular fibrillation (VF) could not be terminated by a 0.0 J shock and burst pacing (black arrows), which continued for 20 minutes.

RV shocking coil could abrade through the inner silicone from inside to outside and ethylene tetrafluoroethylene would then be damaged, allowing that coil to shortcut to the SVC shocking coil.

We experienced a case of ICD shock delivery failure, which was likely caused by a short circuit in the Riata ST Optim lead. Exclusion of the SVC coil from the defibrillation system may be one of the measures to prevent a short circuit between the SVC coil and RV conductor.
