Field Investigation of Clay Balls in Full-Depth Asphalt Pavement

The \$19.6 million interchange improvements and roadway reconstruction at the intersection of US-31 (two lanes in both directions) and SR 38 in Hamilton County, Indiana, were built in summer 2012. The amount of hot mix asphalt (HMA) was 63,818 tons for mainline, shoulders and ramps. The Average Daily Truck Traffic (AADT) was recorded as 24,814 in 2011.

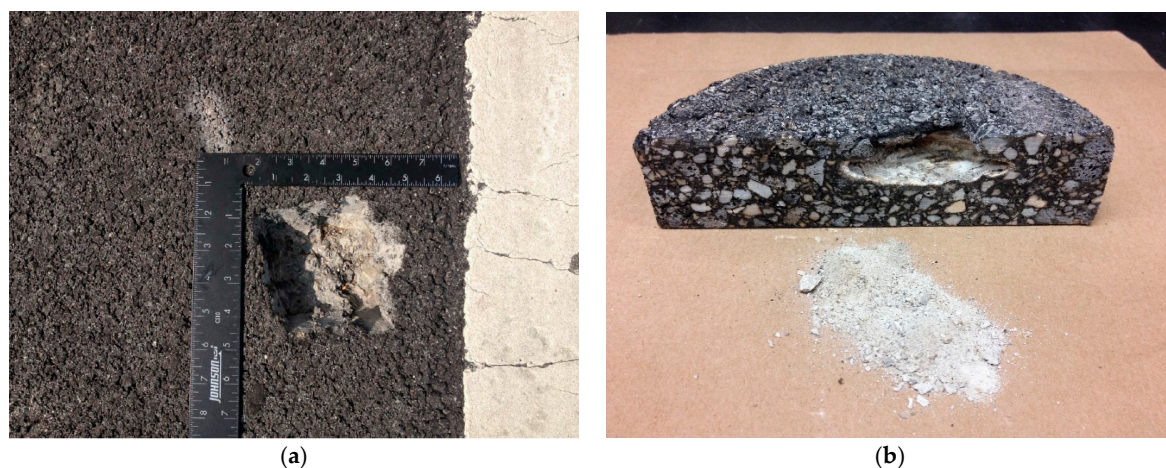
In spring 2013, the interchange pavement exhibited 633 popouts from the surface course in driving lanes, shoulder, and ramps. These popouts are small size holes with fine particles surrounding the holes. Referring to the repair method used in another project constructed in 2001, the clay balls in this project were repaired by cleaning and sealing with hot poured asphalt sealant individually. Figure 1a shows a clay ball after opened by a jack hammer and cleaned by a vacuum. Figure 1b is a field core from clay ball area after slicing in the middle of the hole. Over time, these clay balls which appeared to be agglomerations of fine material disintegrate from weather and leave a hole in the mix after being washed out.

Figure 1. Field observation of clay ball. (a) Opened and cleaned clay ball; (b) sliced core from clay ball area.

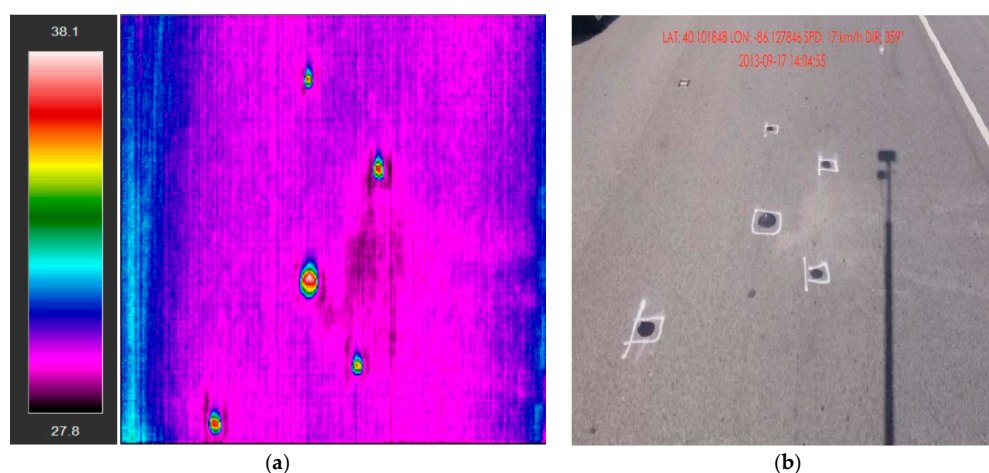
Figure 4a,b shows the images taken from the IR camera and the right of way camera, respectively. Note that the two cameras were taking photos simultaneously. As shown, all the five popout locations in Figure 4b were successfully captured by the IR camera in Figure 4a. The different colors in the IR image indicate temperature differentiation. The clay balls were identified in these areas with high temperature differentiate (i.e., higher temperature in the middle with lower temperature around). In general, a total of 633 holes (346 holes on the mainline and shoulders and 287 holes from ramps) were cleaned and filled with asphalt sealant, among which 564 cores were successfully captured by the IR camera. Among all the clay balls (69 in total) that were not successfully captured by the IR, the majority (50 in total) were missed due to the very small size of clay balls (i.e., with diameter less than 1 cm). It is noted that the angle of the two photos are not exactly the same: The IR camera took photos vertically perpendicular to pavement surface, whereas the right of way camera took photos with an angle to pavement surface.

Figure 4. Clay ball images from (a) IR camera and (b) right way of camera.

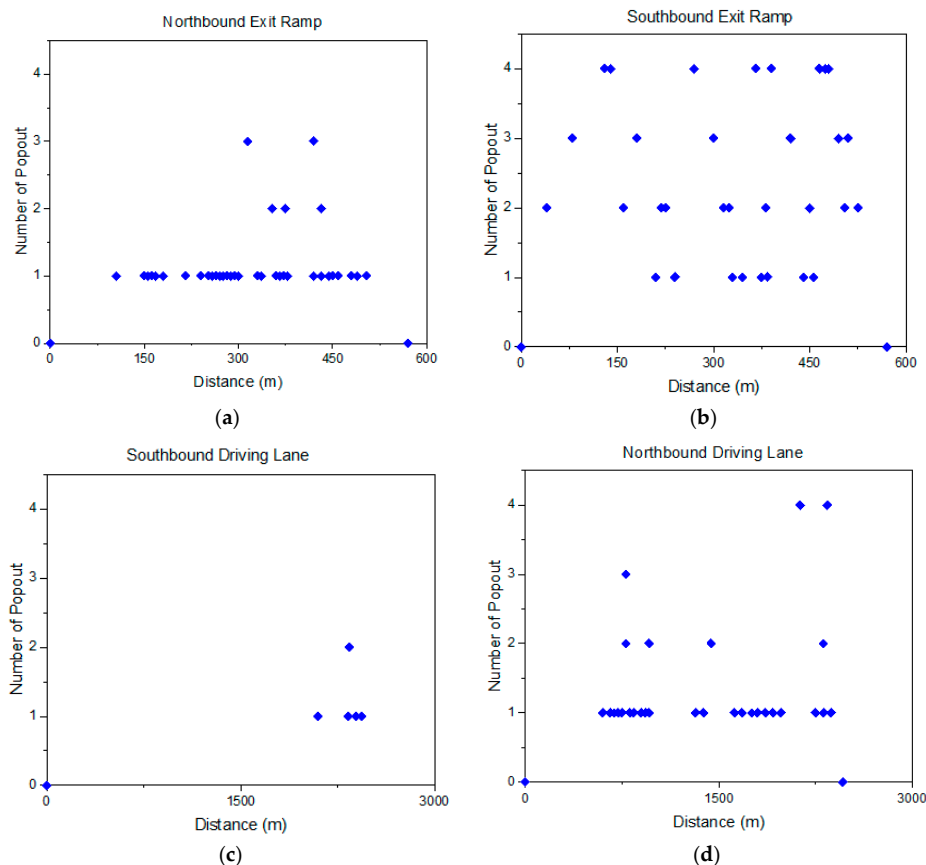
Figure 5 presents the clay ball distribution in the longitudinal direction (parallel to the direction of vehicle traffic) for both driving lane and ramp. The majority of the popouts were found in shoulder, ramp, and various locations in the driving lanes, shoulder, and ramp but few in the passing lanes. Additionally, most popouts were from the pavement location between wheel paths, whereas very few of these pop-out locations were witnessed within the wheel paths.

Figure 5. Clay ball distribution within (a) southbound exit ramp, (b) northbound exit ramp, (c) southbound driving lane, and (d) northbound driving lane.

As shown in Figure 5, the number of popout within southbound exit ramp is almost evenly distributed with around 61 m to 73 m as the gap distance. It should be noted that the typical laydown lengths of 20-ton surface mix in a truck with 165 lbs/yd² rate were 55 mt for main lane (3.7 m width)

and 66.4 m for shoulder (3 m width). Thus, it is possible that the non-uniform mix between two trucks could be a reason that caused clay ball in this area.

However, such trend was not observed in northbound exit ramp or driving lane. In those areas, the clay balls were distributed either as close as several meters and as far as one hundred meters. The fact that the “pop-out” locations do not seem to be consistent throughout the mix and the fact that these areas seem to be confined to what would amount to a typical truckload of material at a time based on length and concentration of the pop-outs and the randomness of these locations should rule out the possibility of the paving operation being an issue.

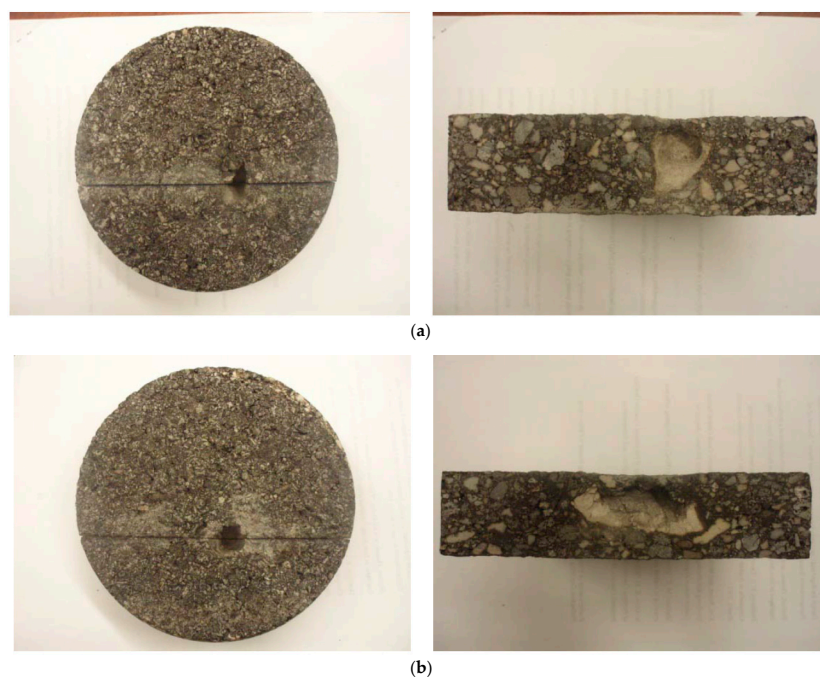
Figure 6 shows two clay ball examples that were squeezed, and their openings were collapsed. The left figure was pictured upside down, and the right figure shows sliced core in the middle of the hole. The diameter of each clay ball was measured and was ranged from 1 to 4 inches in diameter. Considering the ellipse sphere shape of the clay ball, several measurements were conducted and averaged. As seen, the hole on pavement surface is small in scale but the clay ball size is much bigger than the hole. The depth of the clay ball almost punctures the entire surface course thickness of 2 inches. It is also noted that good amounts of fines remained in the voids.

Figure 6. Clay balls with (a) one inch in diameter and (b) two inches in diameter.

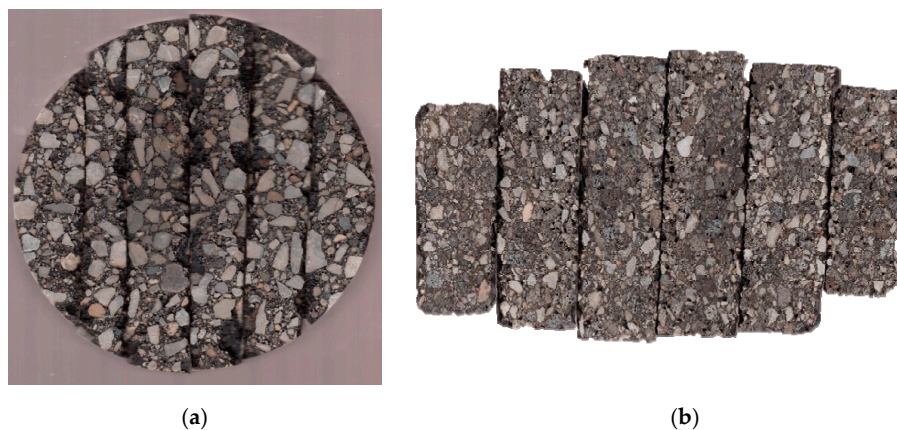
As aforementioned, a couple of cores were taken from pavement areas without clay balls to verify if there was any clay ball not exposed to the pavement surface. In the laboratory, each six-inch core was sliced into several pieces. Figure 7a,b shows an example of sliced core from top and side, respectively. As seen in Figure 7b, the samples are very clean and no clay ball was found. Additionally, there was no aggregate size larger than 1 inch in diameter, the critical size of clay ball for the popout. All the rest cores were sliced and no clay balls were observed as well, even for the cores taken from bad sections (with the large frequency of clay balls). This indicates that in the project evaluated all the clay balls were exposed to the pavement surface.

Figure 7. Cut surface of core sample; (a) top-down view and (b) inside of core.

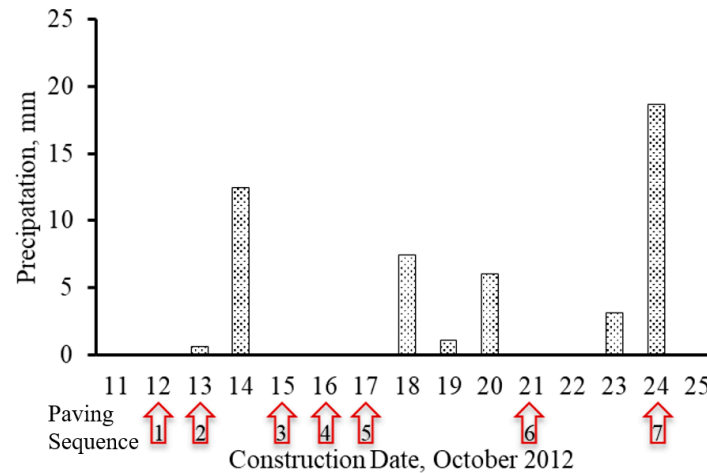
Figure 9 presents the precipitation during the days the road was paved with the paving sequences 1 to 7. As shown, the more precipitation could result in more moisture in aggregate stockpiles, and the wet aggregates may cause the material to become sticky and bind together, which increases the possibility of clay balls in a drum mixer. In general, paving in a day after the rain showed higher clay ball densities than others. For instance, paving sequences 3 and 7 were constructed one day after raining

Figure 9. Comparison of daily precipitations to paving dates.

and showed the highest clay ball density. It is noted that typically aggregate moisture was checked before construction, while raining during paving days could greatly increase aggregate moisture and increase the possibility of clay balls. Thus, check for aggregate moisture during construction, especially on or after raining could be necessary.
