Failed defibrillation with unexpected battery depletion by cable externalization of dual-coil defibrillator lead

Katsuhide Hayashi, MD, Thomas Callahan, MD, FHRS, Bruce L. Wilkoff, MD, FHRS

From the Cardiac Electrophysiology and Pacing Section, Department of Cardiovascular Medicine, Cleveland Clinic, Cleveland, Ohio.

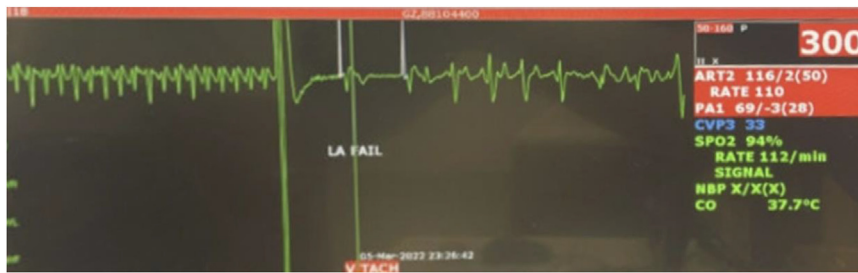
Figure 1 Electrocardiogram revealed that the patient was defibrillated with external cardioversion.

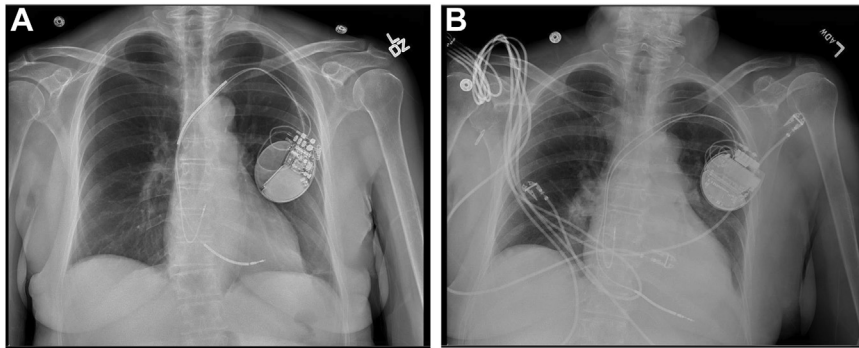
Figure 2 Image of chest radiograph. **A:** Before generator replacement. **B:** After generator replacement.

The ICD generator was removed, and the ICD lead was extracted using the laser sheath (16F; Spectranetics, Colorado Springs, CO) and Visisheath (Spectranetics) and a new generator (Galant™ DR CDDRA500Q; Abbott) and a new Optisure LDA210Q single-coil defibrillation lead (Abbott) were implanted. The lead was positioned in the pocket in a manner to minimize contact with the pulse generator (Figure 2B).

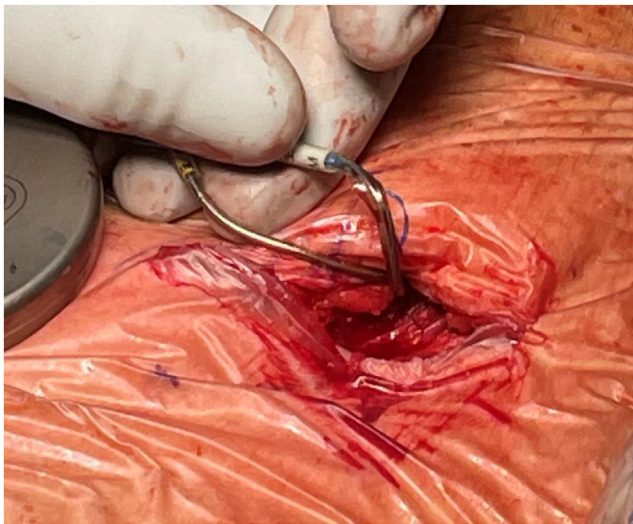
The left subpectoral pocket was opened and revealed externalization of the cables to the defibrillation coils over a 2- to 3-cm segment that had been resting under the ICD can and a clear breach in the Optim coating and silicone insulation (Figure 3). There were 2 small areas of possible

Figure 3 Intraoperative findings revealed externalization of the cables to the defibrillation coils over a 2- to 3-cm segment that had been resting under the implantable cardioverter-defibrillator can and a clear breach in the Optim coating and silicone insulation.

arcing on the can but no discoloration in the subpectoral pocket.

The failed ICD generator (Vigilant EL ICD DR) was returned to Boston Scientific to investigate the root cause of abrupt battery depletion. Detailed analysis revealed that the device battery voltage was not depleted. However, a radiograph of the device revealed that the internal high-voltage fuse was damaged. The damage to the fuse occurred during

delivery of the shock and then prevented any subsequent charging of the high-voltage capacitors and delivery of shock therapy. As a result, the subsequent attempted high-voltage charge resulted in the device's declaration of "complete battery depletion" because the capacitors could not successfully complete charging within 30 seconds. The defect in the Optim outer insulation and the pocket externalization, and the mild localized discoloration of the ICD can, together suggest the mechanism of shorted output when the device attempted to deliver a shock through the lead. This evidence indicates that distal coil conductor externalization shorted to the "hot" can electrode.
