# Repair of Block Masonry Panels with CFRP Sheets

**Abstract:** In the 1980s, block masonry started to be widely used for new constructions in Italy's earthquake prone areas. However, recent seismic events demonstrated that block masonry buildings may need to be repaired after earthquakes due to cracking. Construction defects are the main cause for cracking of block work masonry. Carbon fiber reinforced polymer (CFRP) sheets have been used as a local repair method for non-defective and defective wall panels. An experimental program was formulated to investigate the shear behavior of block masonry walls repaired with CFRP sheets. A total of six wall panels were constructed in the laboratory and tested in shear (in-plane lateral loading). It was found that, although the control (non-defective) wall panels had a high ultimate load capacity, the use of CFRPs reduces the effects of construction defects and restores the lateral load capacity in non-defective walls. Overall, this research suggests that the use of epoxy-bonded CFRP sheets could be used for local repair of cracked wall panels.

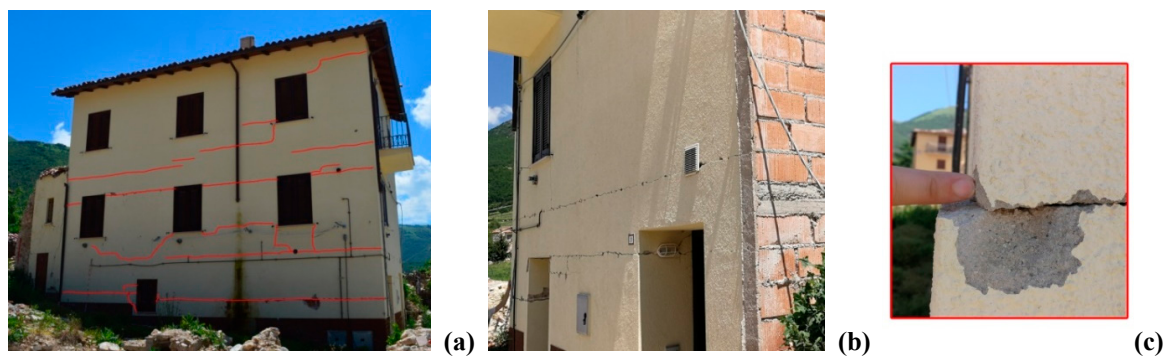
The earthquake in 2016 caused various damage to this building. Figure 5 shows the crack pattern where horizontal cracks opened along the mortar bed joints of the URM hollow load-bearing block masonry. These cracks were mainly concentrated near the joint block masonry—ring beam—floor. The main cause for this is likely to be the stress concentration, induced by the inertial seismic forces, transmitted by the horizontal diaphragms. These are typically very heavy (the dead load alone is about 9–11 kN/m<sup>2</sup>).

**Figure 5.** Crack pattern (red lines) of Building No. 1. (a) Horizontal cracks from the north; (b) horizontal cracks from the east, near the floor and (c) detail of the horizontal sliding.

Figure 5b shows detail of the horizontal sliding (20 mm) at the ground floor of the building. Relative displacements are smaller near the 1st and 2nd level joints. It is worth noting that this crack pattern has never been observed for this particular masonry type.

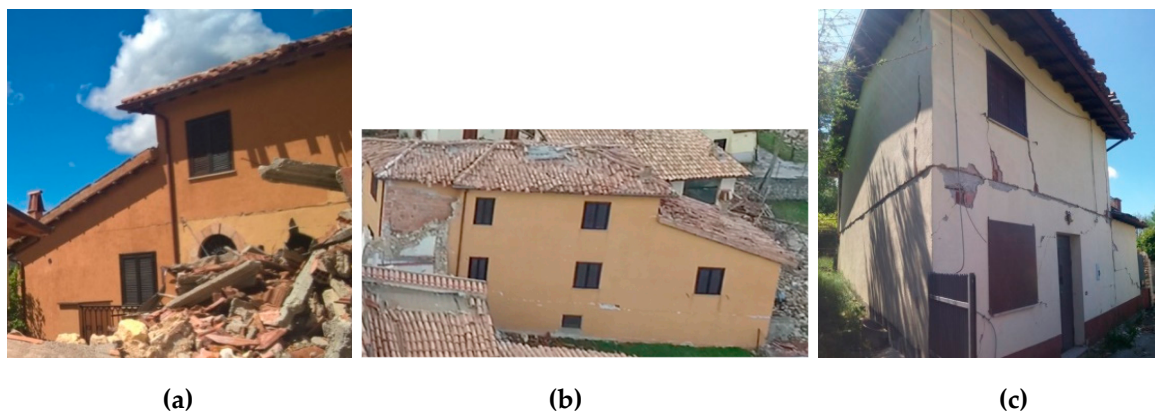
The second construction is a 3-story building. This building has external dimensions of 17.55 m × 4.8 m and it was reinforced in 1986 by demolishing several stonework walls. These were re-constructed with hollow blocks. The only un-demolished pre-existing stone wall was the one shared with the adjacent building (that was reinforced by grout injections and steel-mesh reinforced concrete coating). The thicknesses of the new URM block masonry are 45 and 30 cm, for the ground floor and the higher levels, respectively. The horizontal diaphragms (likely timber-beam floor) were also demolished in 1986 and replaced with 1-way steel-reinforced concrete joists, tile hollow blocks and a RC slab. An indicative configuration of the new floor is shown in Figure 4. During the earthquake in 2016, the building was seriously damaged. A long horizontal crack, passing through the wall thickness, opened near the first level floor (Figure 6a,b). Other horizontal cracks were noted near the floor at ground level. It is worth noting that the typical diagonal cracks, induced by in-plane lateral loading, or the also-common out-of-plane mechanisms, were not observed at all.

Figure 6. Crack pattern: (a,b) Building No. 2; (c) Building No. 3.

A 2-story building is the last case-study. This building, has a rectangular floor plan of 6.8 m × 9.7 m and was reconstructed in 1989 using new URM load-bearing block masonry. The horizontal diaphragms were made of traditional 1-way steel-reinforced concrete joists, tile hollow blocks and a RC slab. Ring RC beams were also used to connect the floor to the walls to prevent an out-of-plane collapse mechanism during an earthquake (as represented in Figure 4). The 2016 post-earthquake report of the state of the building (“Aedes” report [34]) highlights a medium level of damage. However, the building was evacuated and its use was not authorized. Figure 6c shows the damage: a horizontal crack opened in the external walls at the level of the first floor. This crack passed through the wall thickness. A horizontal sliding of 2 cm of the upper part of the building was measured by the technicians after the earthquake.

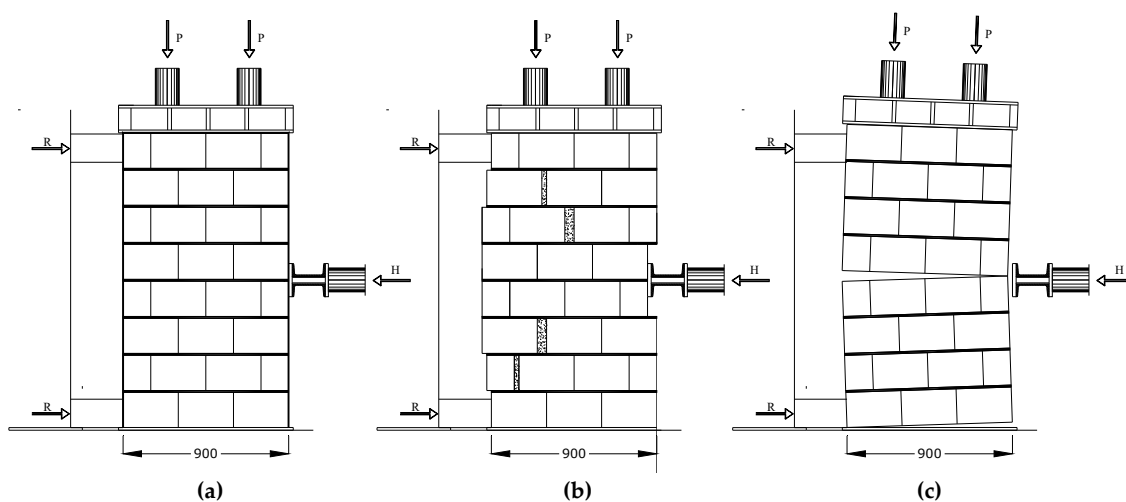
The test results seem to confirm the on-site post-earthquake survey of damaged buildings (Table 3). The non-defective panels exhibited a positive seismic response: horizontal failure loads were 158.68 and 150.55 kN, for a vertical stress of 0.2 and 0.3 MPa, respectively. The mean shear strength, calculated with Equation (1), was 0.156 MPa. Two different failure modes were recorded for non-defective panels: shear failure (diagonal cracking—Figure 16a,b) and local crushing in the area near the application of the horizontal lateral load. It should also be noted that test result for P1-ND-30 represents a lower bound value of the shear capacity: without the local crushing, the lateral capacity would be higher than 150.55 kN.

Figure 16. (a) Un-deformed wall panel, (b) shear failure (diagonal cracking), (c) bending failure (horizontal cracking) (units in mm).

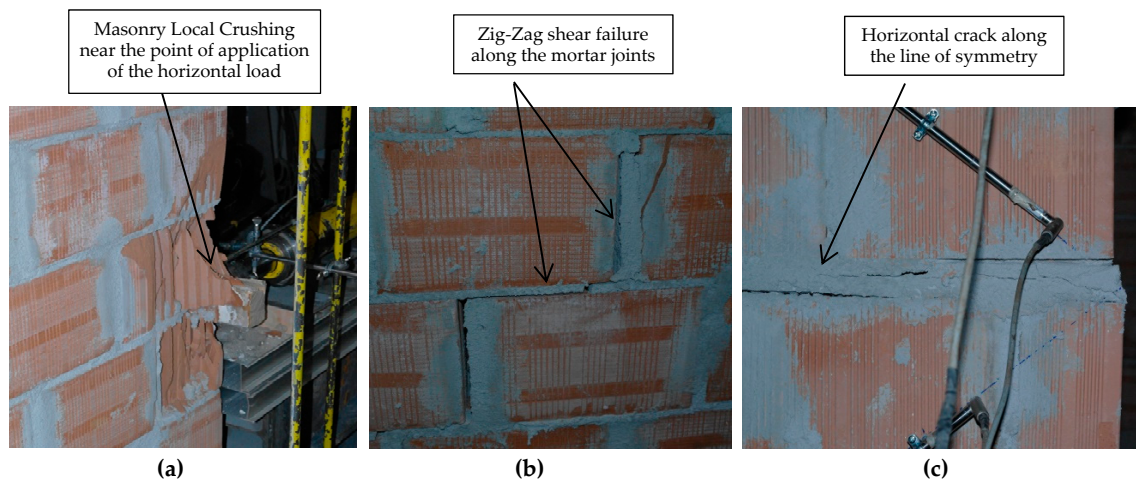
The results demonstrated that non-defective panels exhibited a very high shear strength: the average value was 0.156 MPa. This included the result of the P1-ND-30 sample, where local crushing was recorded (Figure 18a). If this result is excluded, the shear strength of non-defective panels was 0.175 MPa. The reader should be alerted about the limited number of available test results. Few standards provide information about mechanical properties of different masonry typologies to be used for design and calculations. The recent Italian Guidelines [42] provide such data. The guidelines suggests the range value of 0.08–0.17 MPa for hollow tile block masonry with cement mortar. It is interesting to note that our results demonstrate that the tested block masonry exhibited a much higher shear strength. Obviously, the Code provides characteristic values, including safety factors, but it could be suggested that the Code underestimates the mechanical properties of block masonry.

**Figure 18.** Failure modes: (a) un-defective control panel: local crushing; (b) un-defective control panel: diagonal cracking (zig-zag pattern), (c) defective control panel: horizontal crack along the panel's horizontal line of symmetry.

The failure mode of the defective panels entailed a different mechanism, compared to the non-defective ones (Figures 16c and 18c). Two limit states were noted for defective wall panels: a horizontal crack progressively opened between the two overhanging semi-panels (along the wall's horizontal line of symmetry). The mechanism consisted in a relative rotation around the point of application of the horizontal load of the two halves. This had a maximum thickness of 8–12 mm at the maximum horizontal load. The vertical confinement of the panel prevented further separation and rotation of the two halves. By comparing the maximum lateral load, it can be noted that the defective panels exhibited a reduced shear-load capacity: this was 40.8% smaller compared to non-defective panels. Following the formation of the horizontal crack, shear cracks also developed for a lateral load of 152.89 kN (P3-ND-20) and 182.98 kN (P4-DE-30) (second limit state), associated with a compressive stress of 0.2 and 0.3 MPa, respectively. These values are consistent with the failure loads recorded for non-defective wall panels (158.68 and >150.55 kN). The mean shear strength was 0.173 MPa.

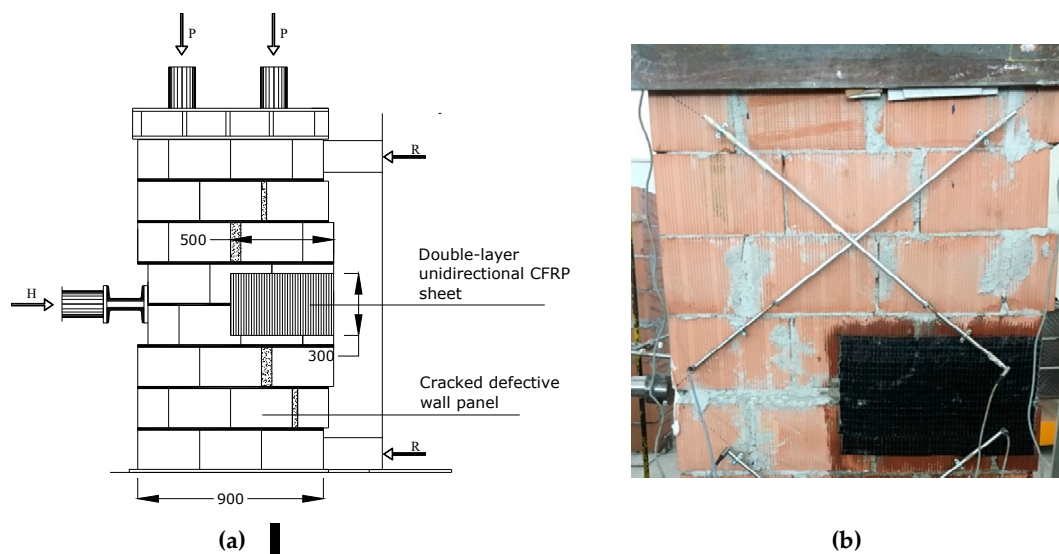
By increasing the in-plane lateral load (H), the wall panel started to exhibit increasing shear strains, reaching failure due to diagonal cracking (Figure 19), in one or both of the semi-panels. The failure mode was similar to that observed for non-defective control wall panels: cracks alternately opened in the vertical joints and in the horizontal mortar beds following a “zig-zag” pattern, leaving the tile blocks for the most part un-damaged. Apart from the initial bending deformation (due to the partial re-opening of the horizontal crack), the CFRP repair reversed the effect of the construction defect. Figure 20a shows the development of the angular strains of the two semi-panels during shear loading (Test No. P6-RE-30): the different values of the strains demonstrate that an equal distribution of the shear load between the two semi-panels is likely too simplistic.

**Figure 19.** (a) CFRP repair, (b) typical failure mode of repaired wall panels (detail of upper half panel) (units in mm).

All defective panels initially failed due to the formation of a horizontal crack in the bed joint between the two semi-panels. The defect was not critical, and it did not cause a high reduction of the lateral load capacity compared to the control panels: for some panels it was possible to continue to test up to the shear failure. In order to prevent the bending failure mode (horizontal cracking), a double layer of unidirectional CFRP sheets was applied on both sides of the panel. The CFRP repair was made using two 300 mm × 500 mm overlapping sheets, applied on both sides, with the fibers perpendicular to the horizontal crack. After the CFRP repair, defective panels were re-tested in shear, according to the same procedure used to test control panels.

The results of shear tests are summarized in Table 3. It can be noted that the repair was able to prevent the re-opening of the horizontal crack, and restore the original lateral load capacity of the control non-defective panels. The average shear strength  $\tau_0$  of repaired defective panels was 0.2005 MPa (Test No. P4-RE-30 and P6-RE-20). Similar to non-defective wall panels, a single limit state load was recorded for repaired panels. By comparing the first limit state load (Test No. P2-DE-20 and P5-DE-20, Horizontal Cracking Load = 70.08 kN,  $\sigma_0 = 0.2$  MPa) of the defective panels, with the limit state load of repaired wall panels (211.28 kN), we note a significant increment in lateral capacity.
