Case Report

Early Failure of a Novel Modular Dual Mobility Liner After Metal Release: Clinical Presentation and Detailed Retrieval Analysis

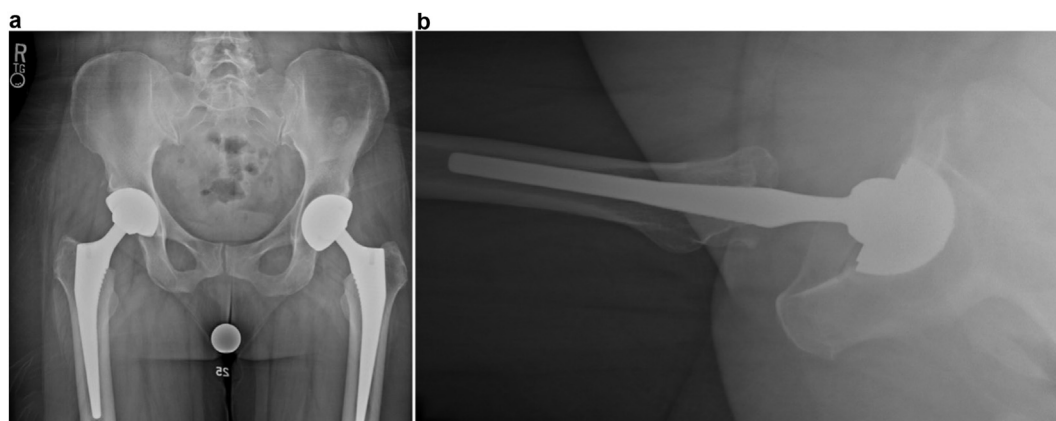
Figure 1. Prerevision surgery (a) anteroposterior and (b) lateral radiographs of the right hip without evidence of significant component compromise or loosening.

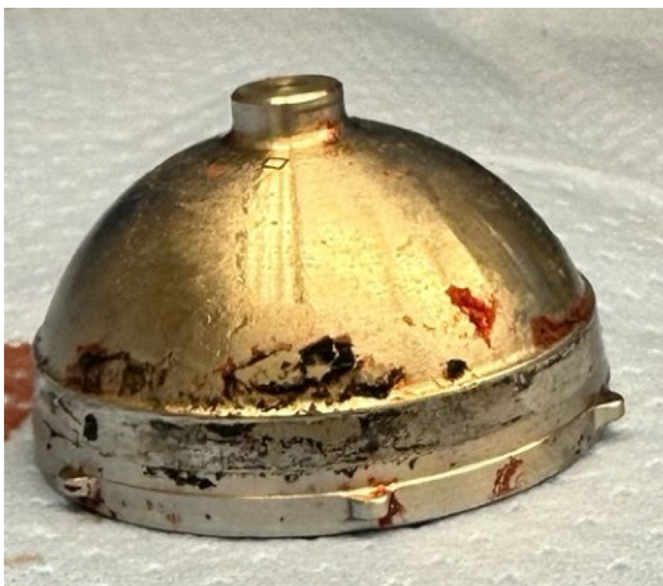
Our patient underwent revision surgery in September 2024. Her hip was accessed using a modified Heuter approach. During exposure of the components, it was noted that there was abundant soft tissue around the acetabulum, a capsule thickened to at least 3 times its typical thickness, and a thin soft tissue membrane inside the cup itself. The surrounding soft tissues did not demonstrate metallic or colored staining.

The CoCrMo liner appeared to be well seated. There were no acetabular screws present, so there was no sign of screw head or screw hole impingement. After removal of the liner with an impact tool on the rim of the shell, the liner was dissociated from the Ti cup. Gross visual inspection at the time of removal demonstrated signs that appeared consistent with corrosion (Fig. 2). The patient was exchanged to a new 36-mm ceramic head (Biolog Delta, CeramTec for Enovis, Wilmington, DE) and modular highly cross-linked polyethylene liner (Empowr 36E Liner, Enovis, Wilmington, DE), with retention of the femoral stem and acetabular cup. There were no intraoperative complications with postoperative radiographs demonstrating appropriate placement and alignment of components (Fig. 3). The patient was discharged home on postoperative day 1.

Figure 2. Explanted CoCrMo liner with a polar centralizing post and macroscopically visible dark corrosion products at and around the equatorial locking taper. CoCrMo, cobalt chrome alloy.

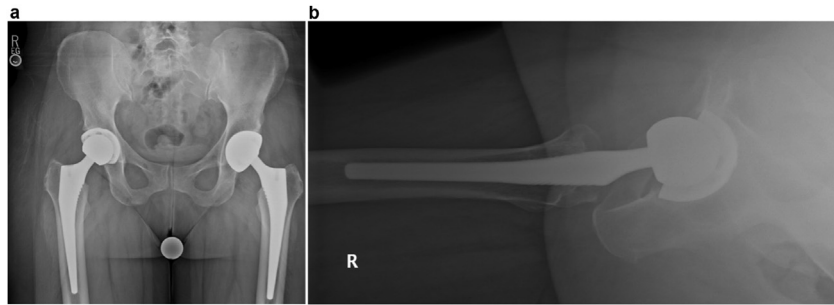
Figure 3. Postoperative (a) anteroposterior and (b) lateral radiographs of the right hip demonstrating appropriate placement of components without evidence of complication.

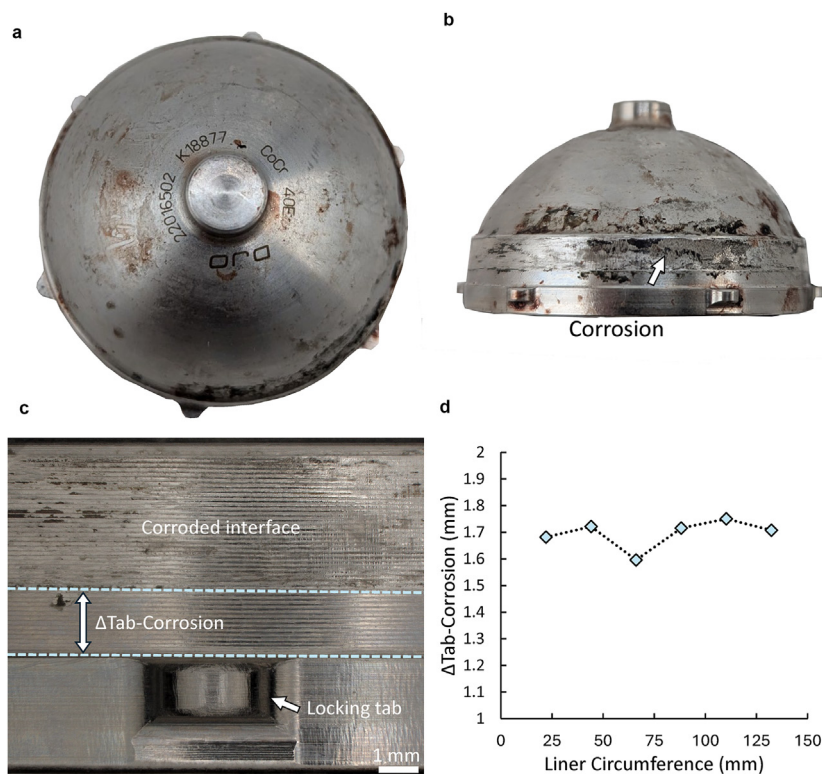
Digital images of the retrieved CoCrMo liner show top (Fig. 4a) and side (Fig. 4b) views before cleaning. Note the severe corrosion where the CoCrMo liner contacted the Ti-6Al-4V acetabular

component in vivo. At 30x magnification (Fig. 4c, after cleaning, Keyence VHX-7000, Keyence Corp., Itasca, Illinois), horizontal machined lines become visible. An undamaged area exists between the locking tab and the corroded interface. Measurements of the vertical distance between these 2 features ($\Delta\text{Tab-Corrosion}$) reveal a uniform undamaged region around the liner's circumference (Fig. 4d). We measured a minimum distance of 1.6 mm and a maximum distance of 1.75 mm. These data suggest a well-aligned liner with visually indistinguishable differences at each of the locking tabs. While the contact between modular components began at a homogenous height, 1.7 ± 0.05 mm from the locking tabs, within the regions themselves, contact is clearly nonuniform. Here, contact likely initiated at the local maxima on the manufactured surfaces and progressed heterogeneously during degradation processes, generating a surface where some areas appear corroded and others do not.

Figure 4. Digital images show a (a) top and (b) side view of a corroded CoCrMo liner. (c) Corrosion initiated at a fixed distance above the locking tab. (d) We measured a uniform distance across the circumference of the liner, indicating a well-aligned device in vivo. CoCrMo, cobalt chrome alloy.

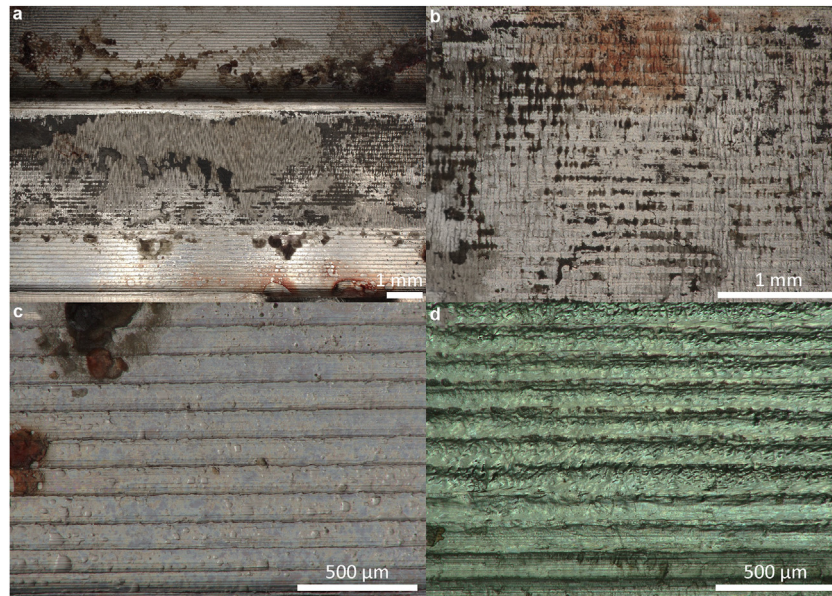
Degradation began and ended in clearly defined visual bands on the taper, likely governed by device geometry, but damage appears heterogenous inside those bands (Fig. 5A). Black oxide debris, column damage, and plastic deformation occur near one another. A digital image acquired at 100x magnification (Fig. 5b) identifies vertical trough-like features, which are characteristic of column damage. At the base of the tapered region, the CoCrMo alloy has an oil spill-like appearance (Fig. 5c), indicating structural changes to the passive oxide film. Within the corroded interface, in an area like Figure 4c, the CoCrMo alloy appears burnished with elongated ovals (Fig. 5d), consistent with mechanically assisted crevice corrosion (MACC).

Figure 5. (a) A digital image shows heterogenous damage modes within the contact region including (b) oxide debris, column damage, and (d) MACC. Outside of the contact region, (c) areas of the CoCrMo appear blue and brown, indicating structural changes to the passive oxide film. CoCrMo, cobalt chrome alloy.

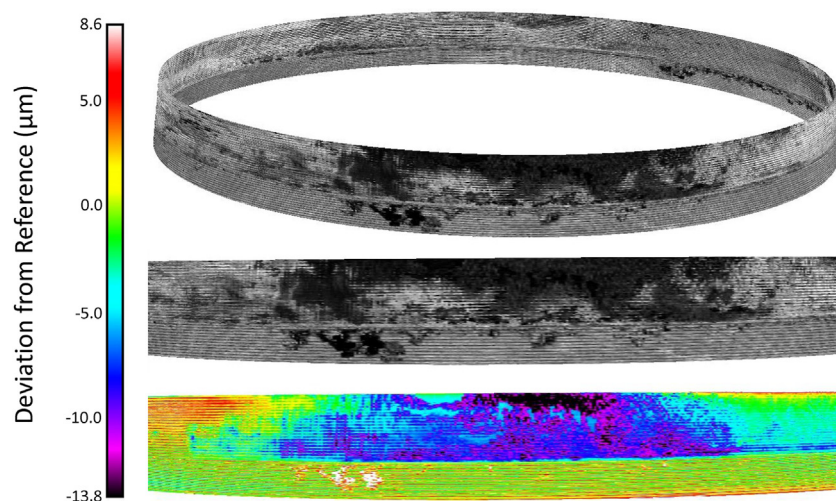
The tapered area of the liner's back side was scanned with an optical coordinate measuring machine (OrthoLux, RedLux, Romsey, United Kingdom). The resulting intensity map (Fig. 6, top) shows a 3-dimensional view of the corroded interface. The black and dark gray regions correspond with oxide debris and column damage regions, respectively. Features on the corroded region (Fig. 6, middle) mirror the digital images in Figures 4b and 5a. A heat map was generated after cone fitting of the undamaged areas showing intact machining lines (Fig. 6, bottom). It reveals that areas with column damage deviated the most from the reference, appearing black and purple. Across the corroded DM liner interface, we measured $0.76 \pm 0.03 \text{ mm}^3$ of material loss. This exceeds the maximum material loss values ($\leq 0.6 \text{ mm}^3$) previously published in the literature for malseated DM liners [4].

Figure 6. Using a coordinate measuring machine, we measured $0.76 \pm 0.03 \text{ mm}^3$ of material loss from the CoCrMo DM liner. Regions with macroscopic column damage deviated the most from the reference, appearing black and purple in the associated heat map. CoCrMo, cobalt chrome alloy; DM, dual mobility.

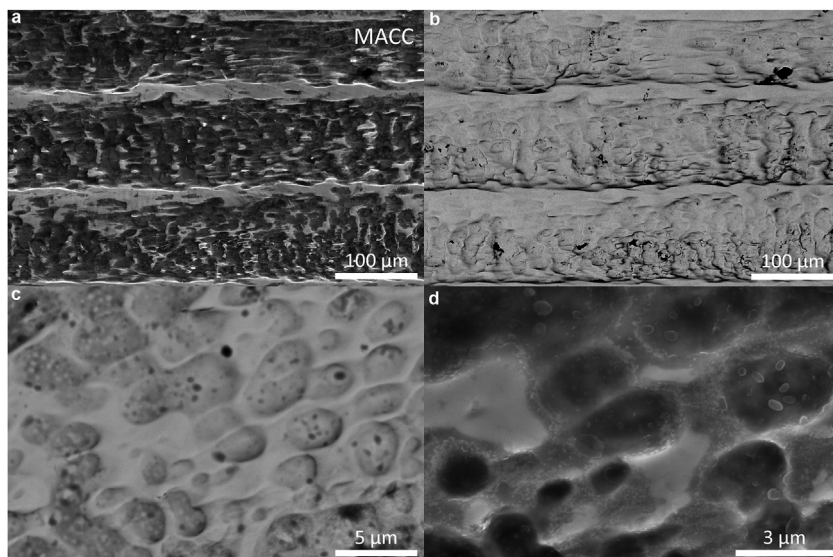
Scanning electron microscopy (Apreo 2S Lo Vac, Thermo Fisher Scientific, Waltham, Massachusetts) definitively demonstrates the damage modes identified using digital optical microscopy, including MACC (Fig. 7). Paired secondary (Fig. 7a) and back-scattered electron micrographs (Fig. 7b) show plastically deformed machine lines. In between, a chemically based corrosion attack dominates (ie, the crevice corrosion processes of the MACC mechanism). The diameters of the oval-like features vary, and in some cases, they interconnect (Fig. 7c). At 15,000x magnification (Fig. 7d), surface features and structural changes become visible. The bulk alloy contrasts with the edges of the ovals, which appear speckled. From secondary imaging alone, it is unclear if the contrast is due to organic or oxide debris. Additional debris collects at the bottom of each oval.

Figure 7. Scanning electron micrographs from the retrieved liner show MACC. (a) Machined lines plastically deformed. (b) In between the machine lines, chemically based corrosion processes generate oval-like features. (c) These appear elongated and interconnect. (d) Debris collected at the bottom of each oval.

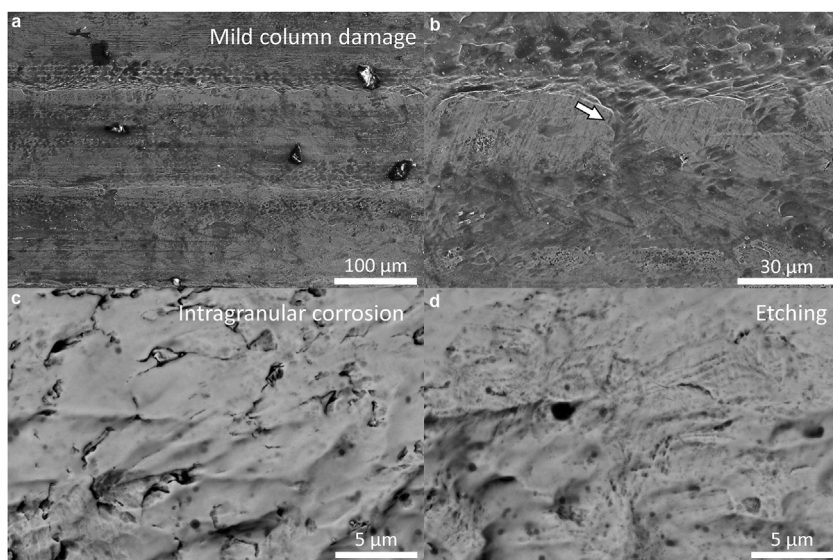
We documented column damage on the retrieved liner, ranging from mild (Fig. 8), to moderate (Fig. 9) to severe (Fig. 10). Faint vertical troughs initiate near MACC (Fig. 8a). This is most easily seen in a plastically deformed machine line, cleaved in 2 (Fig. 8b). Note the cluster of equiaxed pits in the bottom-middle of the micrograph, visually distinct from the burnished and elongated ovals (top of the micrograph). In the column features (Fig. 8c), intragranular corrosion initiates, degrading the grain boundaries. Within the troughs, individual grains appear etched (Fig. 8d). At 5000x

magnification, both surfaces (Fig. 8c and d) look burnished, suggesting mechanical interruption of the passive oxide film.

Figure 8. (a) Mild column damage can provide insights into how the chemically based corrosion damage mode initiates. (b) A column orthogonally intersects a plastically deformed machine line. Initial (c) column and (d) trough structures appear burnished. (c) While grain boundaries corrode within the columns, etching preferentially attacks the grains within the troughs.

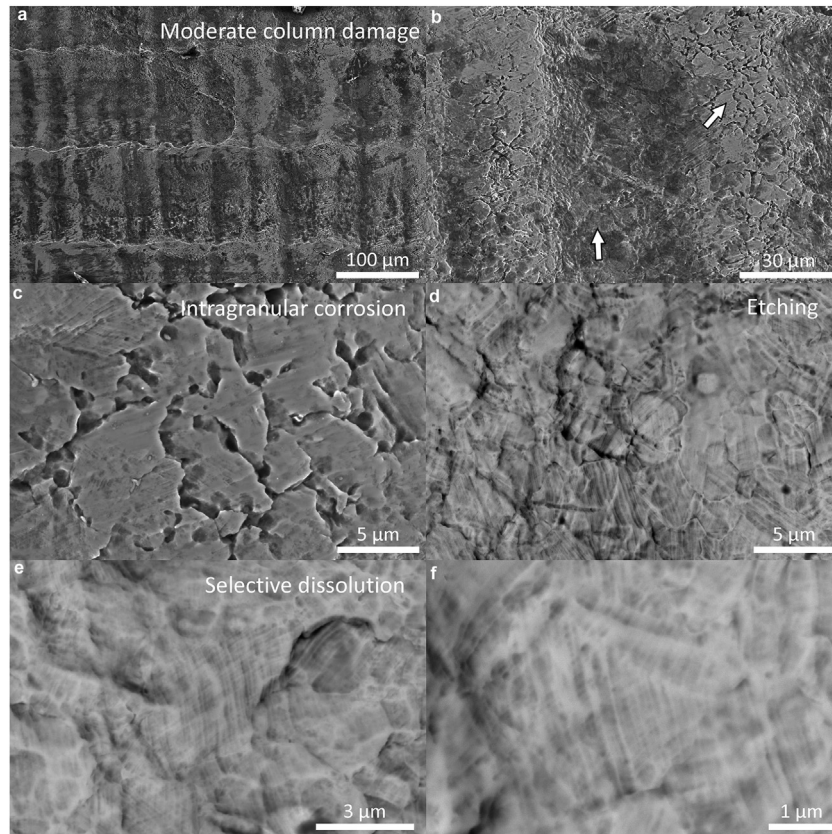
On areas of the liner with moderate column damage (Fig. 9a), the bimodal corrosion mechanism becomes clearer. The vertical troughs and columns visually contrast, and plastically deformed machine lines intersect horizontally. The CoCrMo grain boundaries dissolved from the surface of the columns (Fig. 9b). However, the wrought grains of the substrate alloy appear comparatively uncorroded. In contrast, within the troughs, degradation of the grains seems to be the leading edge of the corrosion attack, leading to comparatively more material loss. Thus, 2 selective dissolution processes simultaneously occur: (1) intragranular corrosion dominates on the columns (Fig. 9c) and (2) etching promotes degradation of the troughs (Fig. 9d). At 10,000x magnification, a backscattered electron (BSE) micrograph shows etching of individual wrought CoCrMo grains (Fig. 9e). A lattice structure is left behind, evidence of the selective dissolution (Fig. 9f).

Figure 9. (a) Material loss within the troughs characterized moderate column damage on the retrieved CoCrMo liner. Note the plastically deformed machine lines, decreasing in thickness compared to the mild column damage in Figure 7b. Here, corrosion is clearly bimodal. (c) Intragranular corrosion completely dissolved the grain boundaries from the column surface, while (d) etching promoted material loss in the trough. (e-f) At higher magnifications, lattice structures become visible in etched grains, evidence of a selective dissolution attack. CoCrMo, cobalt chrome alloy.

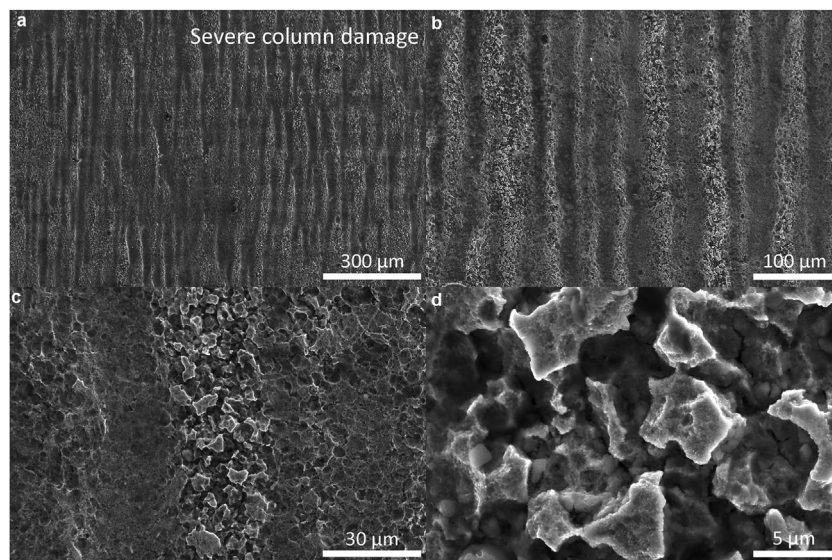
On regions exhibiting severe column damage, we observed a complete breakdown of the horizontal machine lines (Fig. 10a). Troughs and columns stretch continuously across the surface as contrasting vertical bands (Fig. 10b). Corrosion again appears bimodal. In the columns, the crevice corrosion attack degrades the remaining wrought grains (Fig. 10c). Although etch marks remain visible in the troughs, pitting now drives the chemically based corrosion attack. A secondary micrograph acquired at 5000x (Fig. 10d) reveals how intragranular corrosion on the troughs may progress to a more general corrosion attack. Large (>5 μm) voids intersperse between degraded wrought grains. Grains may have dissolved or fallen from the microstructure following severe intragranular corrosion.

Figure 10. On regions of the liner with severe column damage, we documented (a) complete degradation of the machine lines and (b) continuous columns and troughs. (c) Corrosion processes remained bimodal. In the troughs, pitting dominated. (d) A more general corrosion attack degraded the remaining wrought CoCrMo grains on the columns, with voids interspersed throughout. CoCrMo, cobalt chrome alloy.

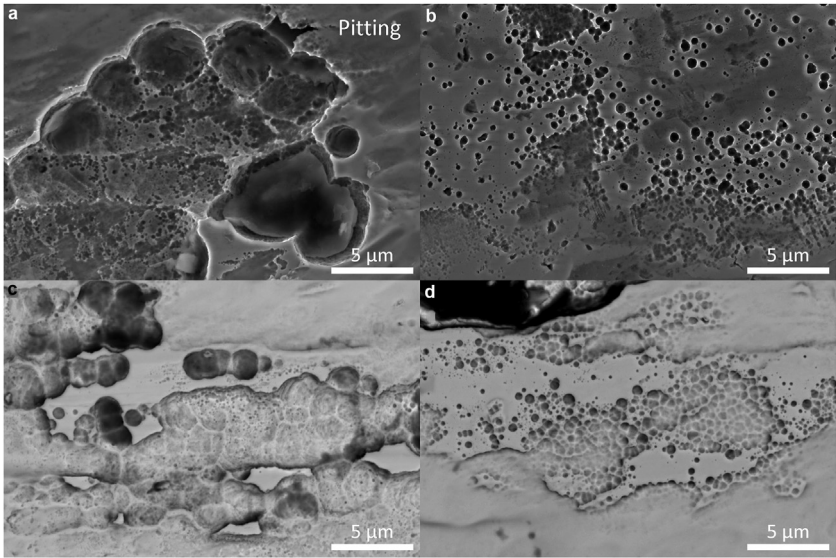
Micrographs reveal a pitting corrosion attack (Fig. 11). Pit diameters varied ranging from >5 μm (Fig. 11a) to submicron and smaller (Fig. 11b). Backscattered electron images show how pits may nucleate, grow, and interconnect (Fig. 11c-d). In all 4

micrographs, areas of the original machined surface remain, evidenced by uniform, continuous stretches of CoCrMo. At the base of the coalesced pits in Figure 11c, new pits nucleate.

Figure 11. Micrographs document pits on the retrieved liner. Note the contrasting diameters in (a) and (b). (c-d) Pits grew and coalesced, interconnecting.

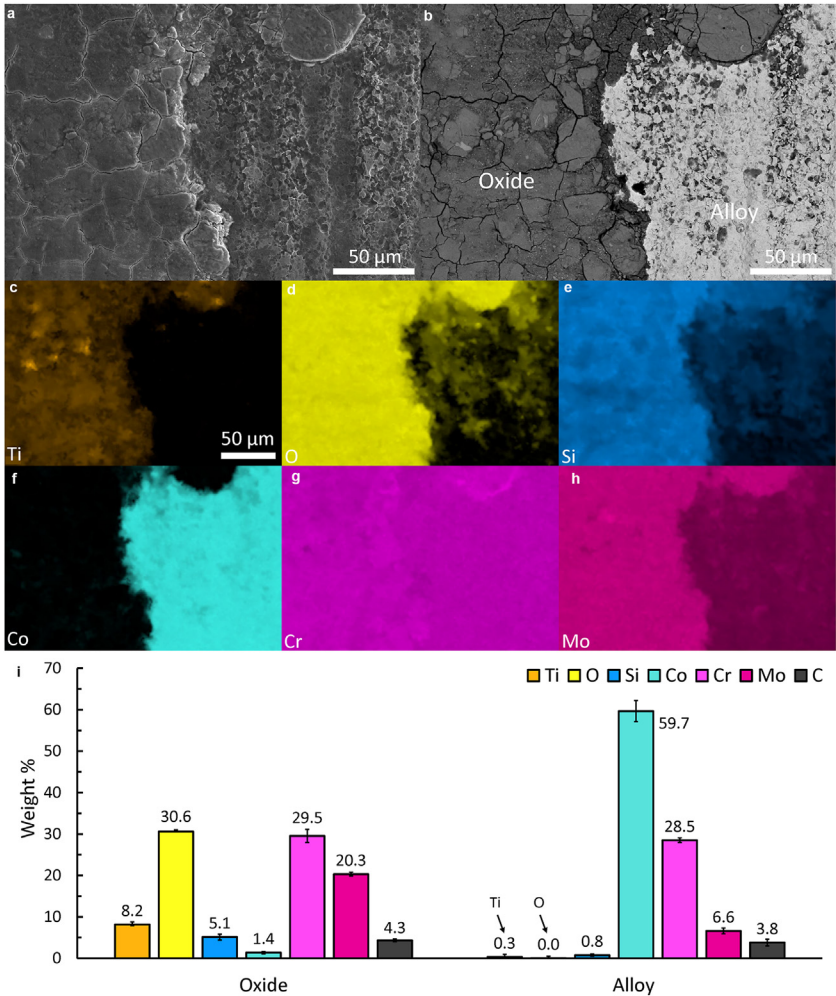
Black oxide debris (Fig. 12) remains one of the most easily recognizable forms of corrosion, visible during revision when surgeons separate modular metal components. Paired secondary (Fig. 11a) and BSE (Fig. 12b) images show a plate-like oxide film directly next to severe column damage. Energy dispersive x-ray spectrometry (EDS) maps qualitatively show titanium (Fig. 12c), oxygen (Fig. 12d), silicon (Fig. 12e), Cr (Fig. 12g), and molybdenum (Fig. 12h) in the corrosion debris. In the substrate alloy, maps identify mostly Co (Fig. 12f), Cr, and molybdenum. Region spectra ($n = 3$) acquired on both the oxide debris and the degraded CoCrMo quantify these findings (Fig. 12i). Note the increase in molybdenum in the corrosion debris (20.3%) compared to the substrate alloy (6.6%).

Figure 12. (a) Secondary and (b) BSE micrographs show oxide debris adjacent to severe column damage. Energy dispersive x-ray spectrometry (EDS) maps reveal (c) titanium, (d) oxygen, (e) silicon, (f) cobalt, (g) chromium, and (h) molybdenum. (i) Region spectra (n = 3) acquired on both the oxide debris and the substrate alloy quantifies the chemical differences. Note: To improve legibility, small boxes cover autogenerated text in the bottom left corner of each EDS map and should not be interpreted as the presence of an element.

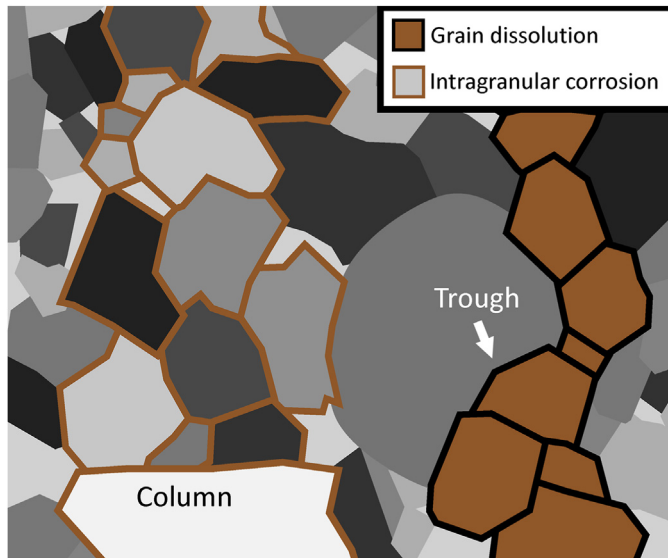
Figure 13. An illustration of the hypothesized bimodal corrosion mechanism shows intragranular corrosion processes preferentially corroding the columns. Within the troughs, etching dissolves the grains. Damage modes are overlaid on a wrought CoCrMo microstructure. This bimodal mechanism aligns well with existing hypotheses in the literature [32]. CoCrMo, cobalt chrome alloy.

On the columns, damage initiates as intergranular corrosion before transitioning to a more general corrosion attack. Within troughs, preferential dissolution of the grains rather than the grain boundaries appears to be the driving corrosion process. This too progresses, with micrographs revealing a pitting-like attack that is evidenced by voids in the severely corroded trough. Thus, our retrieval work provides unique insights into the column damage mechanism, suggesting bimodal, microstructurally driven processes. These findings align well with existing hypotheses, where a second corrosion mechanism is thought to occur beyond the molybdenum depleted regions [32]. However, the retrospective nature of retrieval analysis prevents us from determining whether the bimodal corrosion occurred concurrently, or if corrosion began preferentially.
