Case Report

A Case of a C-Stem Fracture at the Head-Neck Junction and a Review of the Literature

David Morley, Ian Starks, and Justin Lim

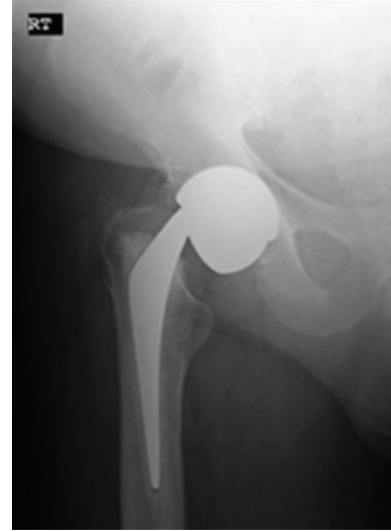
Plain radiographs showed a fracture of the C-stem at the head-neck junction (Figure 1). The inclination of the acetabular component measured 36 degrees.

FIGURE 1: Anteroposterior radiograph demonstrating the fracture of the C-stem at the head-neck junction.

The patient underwent a cement-in-cement revision of the right femoral component through a posterior approach; the rationale is to preserve bone stock in view of the patient’s young age. At the time of surgery, there was no evidence to suggest infection. The stem was confirmed to have fractured at the head-neck taper interface (Figure 2). The acetabular component was in excellent condition, with no evidence of scratches or loosening. The orientation was also felt to be satisfactory (inclination approximately 35 degrees, anteversion approximately 10 degrees), and so the cup was not revised. A high offset, size 5 C-stem AMT (DePuy, Warsaw, IN) and ASR XL 53 mm head (DePuy, Warsaw, IN) with a 12/14 taper adaptor was implanted. The 12/14 taper of the C-stem AMT was felt to be more biomechanically advantageous than the 9/10 taper of the C-stem.
