A Case of Riata® Dual Coil Defibrillator Lead Failure in a Patient with Ventricular Fibrillation

A 50-year-old man, who underwent a procedure for an implantable cardioverter defibrillator (ICD), visited the outpatient department of our clinic after suffering multiple ICD shocks. The ICD interrogation revealed recurrent shock due to a high frequency of noise that is sensed by the device as ventricular fibrillation. Chest radiography revealed a significant split in the insulation of the lead allowing the inner wire to protrude. We considered the removal of the failed lead, but the removal of ICD lead is potentially a high risk procedure, so we cut and capped a proximal part of the failed lead and inserted a new lead. This is the first report of a St. Jude Riata® dual coil defibrillator lead failure with clinical and radiologic evidence of a defect in lead insulation in Korea. (**Korean Circ J 2013;43:336-339**)

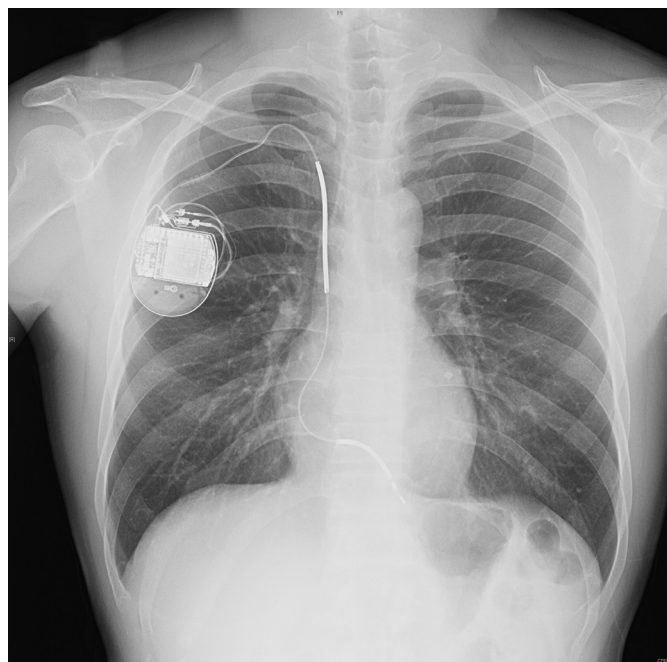
roduced via the right subclavian vein because the left subclavian vein was not visible, then advanced and placed in RV apex. Intraoperative lead parameters including sensing amplitude, threshold, and lead impedance were all within appropriate limits. The ICD lead was connected to the ICD device (Atlas™+VR®, St. Jude Medical, Inc., St. Paul, MN, USA). They were placed in the right infraclavicular subcutaneous site. He had chest radiography after ICD implantation (Fig. 1).

Fig. 1. Chest radiography two weeks later after implantable cardioverter defibrillator implantation.

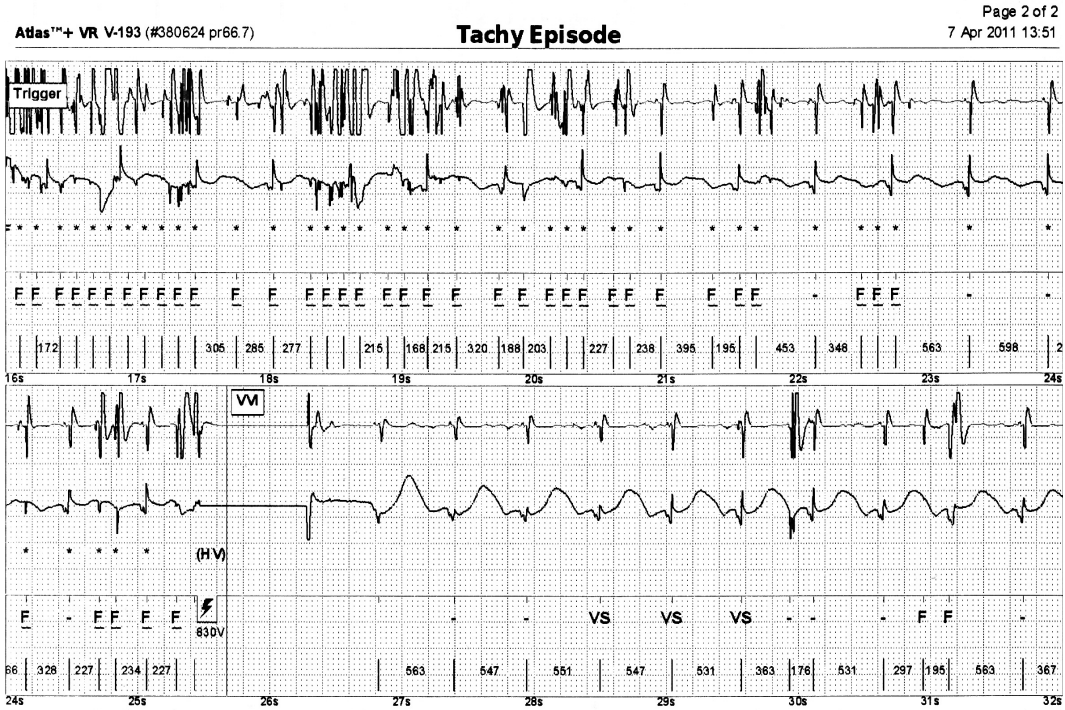
Approximately 3 years after the ICD implant, he received multiple shocks in the same day. He had never received a shock over 3 years of follow-up (Table 1). The ICD interrogation revealed recurrent shock due to a high frequency of noise that is sensed by the device as

ventricular fibrillation (Fig. 2). There was no evidence of other ICD malfunction, with a ventricular sensitivity of 0.3 mV as well as ventricular lead and shock impedances of 315 Ohms and 60 Ohms, respectively. After ICD interrogation, ventricular sensitivity was raised up to 0.6 mV. Chest radiography was not done at that time.

Fig. 2. Multiple noise sensing is marked as 'F's.

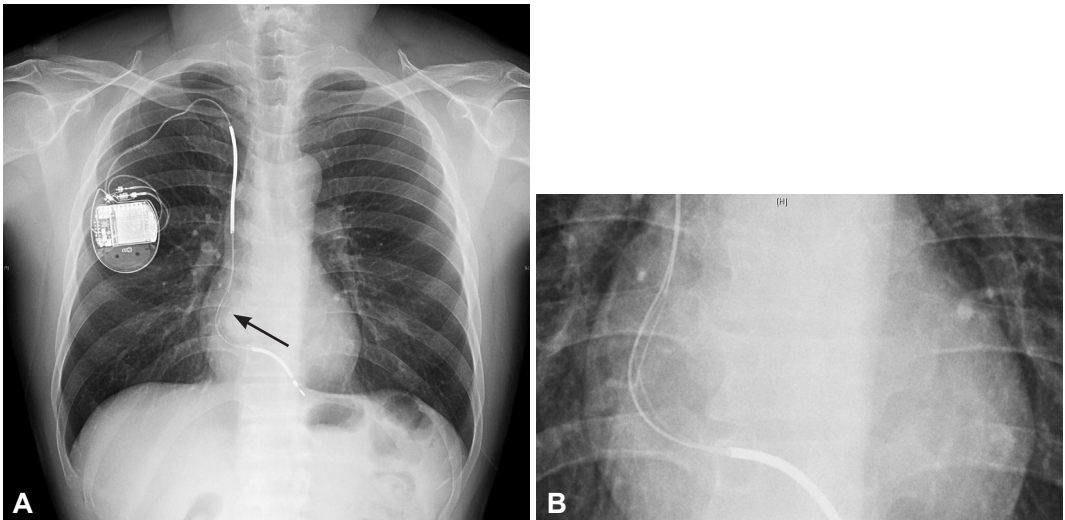
After 6 months of follow-up, routine chest radiography revealed a significant split in the insulation of the ICD lead allowing the inner wire to protrude (Fig. 3). He underwent a fluoroscopic evaluation for conductor external canalization. Before fluoroscopy, we considered removing the lead. But, we decided to leave a failed lead and insert a new ICD lead instead because of the high risk of complication during lead extraction. Under local anesthesia and fluoroscopic guidance, a previously inserted generator was removed and the proximal part of the old failed lead was cut and capped with encap®. A new single dual coil lead (DURATA® 7120Q/58, St. Jude Medical, Inc., St. Paul, MN, USA) with active fixation was inserted through the right subclavian vein and placed to the right ventricular mid-septum. After intraoperative measurements of pacing threshold, signal, and impedance, the lead was connected to a new single chamber generator (FORTIFY VR® CD1231-40Q, St. Jude Medical, Inc., St. Paul, MN, USA). The device and lead were placed appropriately in the pre-existed ICD pocket site, which were verified via postoperative chest radiography (Fig. 4). He has been followed up regularly with no further episode of inappropriate shock via the outpatient department for 6 months.

Fig. 3. A: chest radiography 3.5 years later after ICD implantation. An arrow indicates the defect of ICD lead. B: a significant outer insulation defect of ICD lead, allowing the inner wire to protrude, was noted. A magnified view of defected lead is shown. ICD: implantable cardioverter defibrillator.
