Intraoperative Magnetic Resonance Imaging (iMRI) mishaps - Troubleshooting an unsafe object attached to the scanner

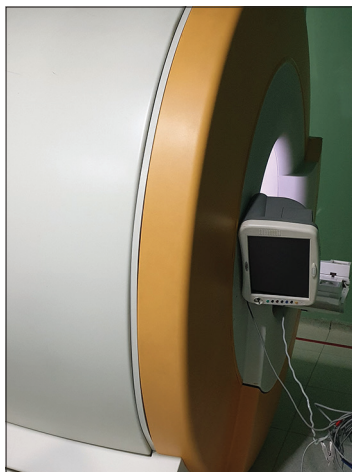
The unfortunate incident of 2001, where an oxygen cylinder accidentally brought into the vicinity of a magnetic resonance (MR) scanner resulted in a fatal injury to a 6-year-old boy, has impressed upon the world the grave consequences of projectile injuries.^[1] Despite strict regulations and multiple guidelines near-misses continue to be reported. Incorporation of magnetic resonance imaging (MRI) into the intraoperative environment has added to neurosurgical armamentarium but has also potentially increased the scope for errors. We report an unsafe event in the intraoperative MRI (iMRI) operation room (OR). Our OR support worker was replacing fresh linen in the iMRI OR while preparing it for the second case. Due to the force of habit as in other ORs, on that fateful day, he entered the OR in a hurry with a monitor still in his hand. It led to the pulling of the transport monitor to the magnetic console [Figure 1]. This is how, despite many safety precautions and protocols in place, an MR unsafe transport monitor found its way into BrainSuite© iMRI. (Brainlab AG, Germany). BrainSuite iMRI holds both scanner and MR compatible table in the same room. Surgery is conducted outside the 5G line and the table is rotated 180 degrees to access gantry for a scan. Presence of theatre support workers doing duty in both iMRI as well as a normal OR resulted in an error of judgment.

Figure 1: MR unsafe monitor attached to the bore of MRI scanner

Fortunately, there were no physical injuries but the consequences of the event were, nevertheless, severe.

Strict enforcement of checklists and protocols is the key to avoid mishaps.^[4,5] A dedicated person with the sole responsibility to oversee screening and restrict entry, mandatory tutorials at regular intervals (to refresh knowledge and reiterate safe practices) and pocketless scrubs for personnel entering MR suite are some of the suggestions that could be implemented in the Indian scenario.^[6]
