Case report

Fracture of an S-ROM stem at the sleeve-stem junction

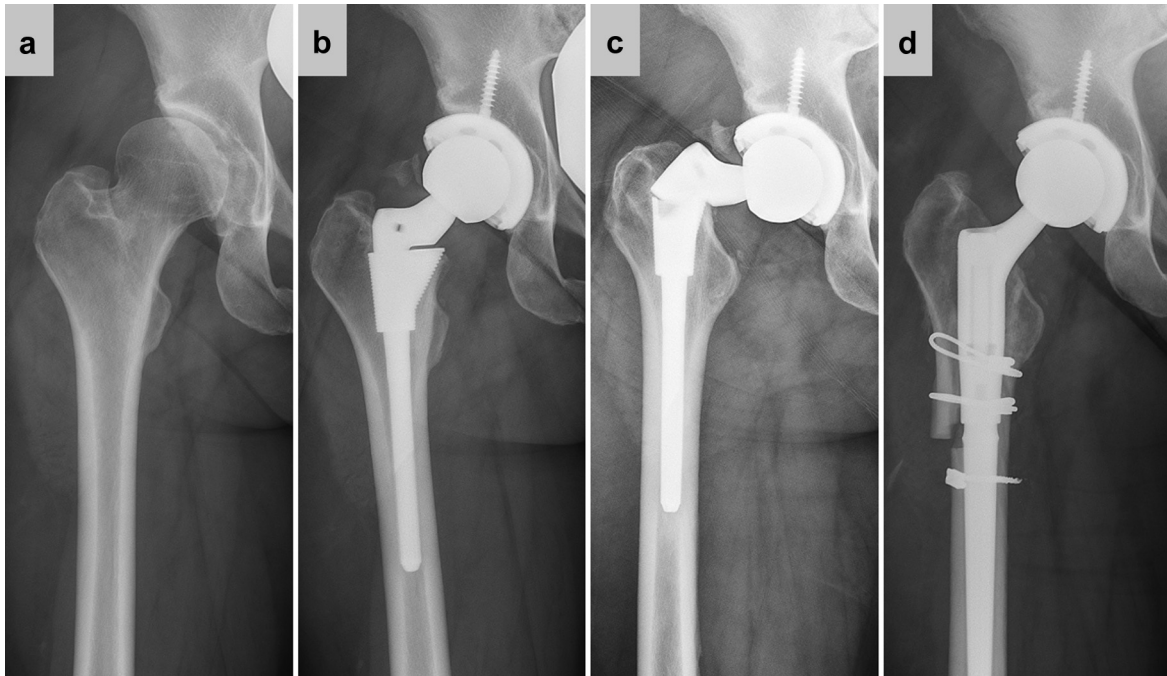
Figure 1. Chronologic radiographs (a) October 2, 2013 preoperative anteroposterior radiograph of the right hip showing secondary osteoarthritis due to hip dysplasia (b) December 18, 2014 postoperative radiograph of the right hip after total hip arthroplasty with a S-ROM prosthesis and a Pinnacle cup (c) July 5, 2017 follow-up radiograph of the right hip showing a fracture of the femoral component at the level of the sleeve-stem junction with a valgus malalignment (d) August 14, 2017 postoperative radiograph of the right hip after revision performing and ETO, implanting of a Restoration Modular Hip System and reposition of the greater trochanter with Dall-Miles cables. The original cup could be preserved.

and thrusting her right foot against a raised grate. Initial radiographs showed no evidence of fracture or loosening, and the clinical examination showed no limitation in range of motion. The patient developed worsening pain over the next few days and went to the emergency department owing to inability to bear weight on her right leg. Radiographs showed a fracture at the sleeve-stem junction of the right femoral component. There was no evidence of loosening or periprosthetic fracture (Fig. 1). Revision surgery was therefore indicated and performed in July 2017.

The reconstruction was performed using a 15 × 155 mm tapered modular revision stem with a 19 + 20 mm proximal body and a 36 + 7.5 mm head (Restoration Modular Revision Hip System, Stryker, Kalamazoo, MI). The trochanteric osteotomy segment was fixed with 2 Dall-Miles cables.

Postoperative imaging demonstrated adequate reduction of the trochanteric segment and a well-sized and positioned implant. The patient was mobilized toe-touch weight bearing (Fig. 1).

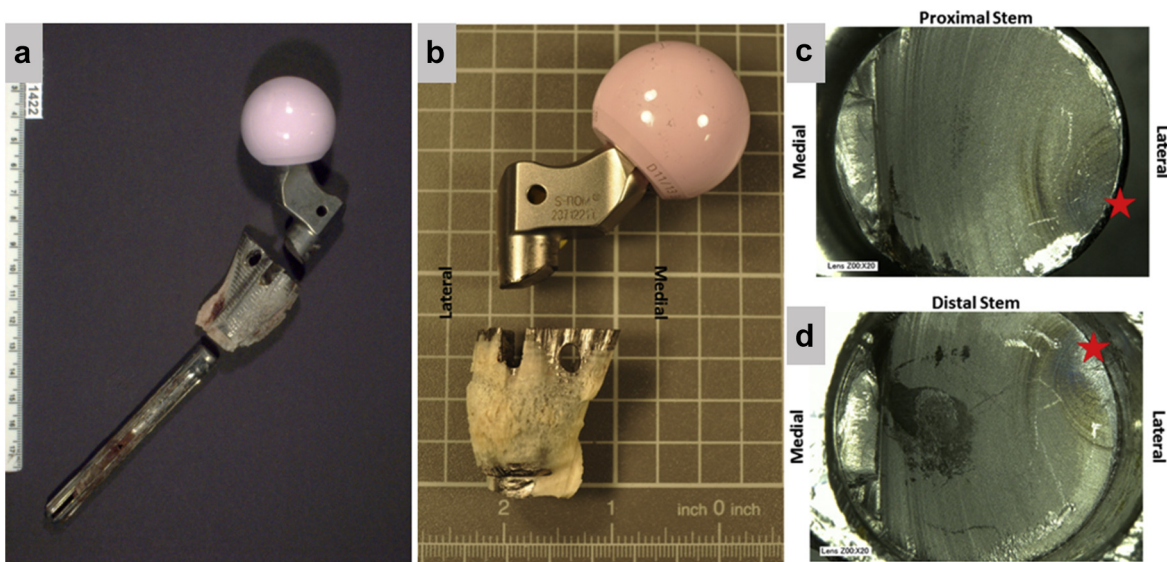
Figure 2. Macroscopic image and surface analysis of the revised S-ROM Modular Hip System. (a) The sleeve and the polished stem show substantial bony ingrown; (b) retrieved fractured component oriented to show where the fracture occurred at the stem within the femoral sleeve. Magnified images of the proximal (c) and distal (d) stems are shown highlighting the fracture origin at the red star. Beach marks propagate medially across both surfaces to the final fracture point, at medial edge.

The S-ROM femoral stem fractured within the connection to the modular sleeve; the stem diameter was 14 mm at the point of fracture. The damage patterns on the fracture surfaces of both the proximal and distal portions of the fractured stem were consistent

with fatigue fracture due to cyclic loading (Fig. 2). The clamshell, or beach marks, spans most of the fracture surface of the implant, indicating a low-load, high-cycle fatigue failure. Macroscopic imaging revealed the origin of the fracture at the anterolateral edge of the stem. No material defects or other stress concentrations were noted at the origin of the fracture. The clamshell marks show propagation of the fracture medially through the cross section of the stem until the final fracture near the medial edge. The implant stem and sleeve were assessed visually at the modular junction for any evidence of corrosion and fretting. Both the stem and the sleeve had moderate corrosion and fretting on the lateral side adjacent to the origin of the fracture (Fig. 3) [12]. The femoral sleeve had substantial bone ongrowth and no visible signs of damage on the outside surface.

Surgery was performed through a posterior approach. The broken proximal segment of the femoral stem was removed from the surgical site (Fig. 2). The sleeve was ingrown into the metaphysis. Using a combination of pencil tip burrs and thin osteotomes, the bone-implant interface was disrupted. To improve the extraction force for the sleeve, a carbide burr was used to drill a hole in the lateral aspect of the visible sleeve to accommodate the hook (from the Stryker Restoration modular proximal body extraction tool) of the S-ROM Extraction instrument (DePuy Synthes, Warsaw, IN). The sleeve appeared to be cold welded to the stem, and direct removal was not possible. Therefore, the decision was made to proceed with an extended trochanteric osteotomy (ETO). A prophylactic distal Dall-Miles cable was placed. Based on templating, the ETO was measuring 130 mm from the tip of the greater trochanter. After ETO, the distal splines of the stem were well fixed and bone ongrowth had occurred into the splines. Flexible osteotomes and 2.0 mm K-wires were used to disrupt the interface, but the stem was still well fixed, and it was difficult to gain access to the diaphysis circumferentially due to the proximally metaphyseal sleeve. We then used the carbide tip burr to burr through the proximal stem distal to metaphyseal sleeve allowed for better visualization. The sleeve was then removed. A size 11 trephine was passed over the stem up to the distal tip. At this point, the stem loosened and could be removed.

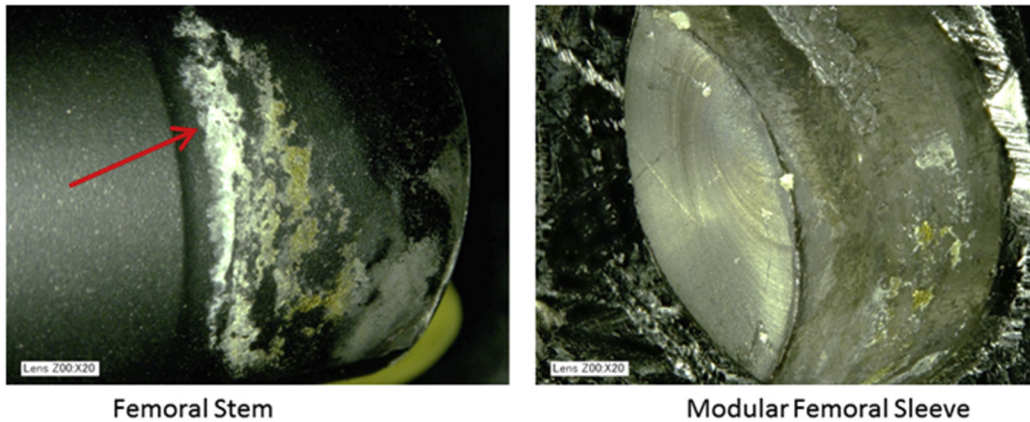
Figure 3. Corrosion and debris observed on the femoral stem and the modular femoral sleeve. Small remnants of bone ongrowth seen proximally on femoral stem (indicated by an arrow).

report of a fractured S-ROM stem in 2014. In our case, biomechanical surface analysis showed damage patterns consistent with fatigue fracture due to cyclic loading rather than significant corrosion and fretting.

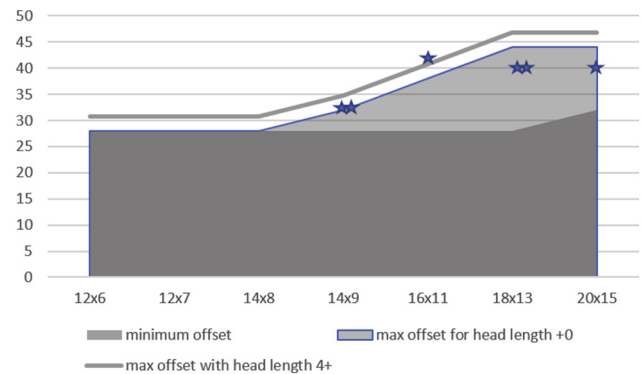
Figure 4. Maximum offset in mm (y axis) available for each stem size (x axis). Stars mark offset-stem-size combination of fractured implants. The affected combinations rather had a high offset.

diameter mainly influences the fracture resistance of the implant. Figure 4 displays the relations between stem size and offset for the reported fractured implants. The maximum offset available for the S-ROM system increases with increasing stem diameter. Most fractured implants had a high offset in relation to the available offset range for each stem size.
