Case report

Tibial tray fracture in a modern prosthesis with retrieval analysis

John J. Callaghan, MD ^{a,*}, David E. DeMik, MD, PharmD ^a, Nicholas A. Bedard, MD ^a,
Andrew N. Odland, MD ^b, William M. Kane, PhD ^c, Steven M. Kurtz, PhD ^{c,d}

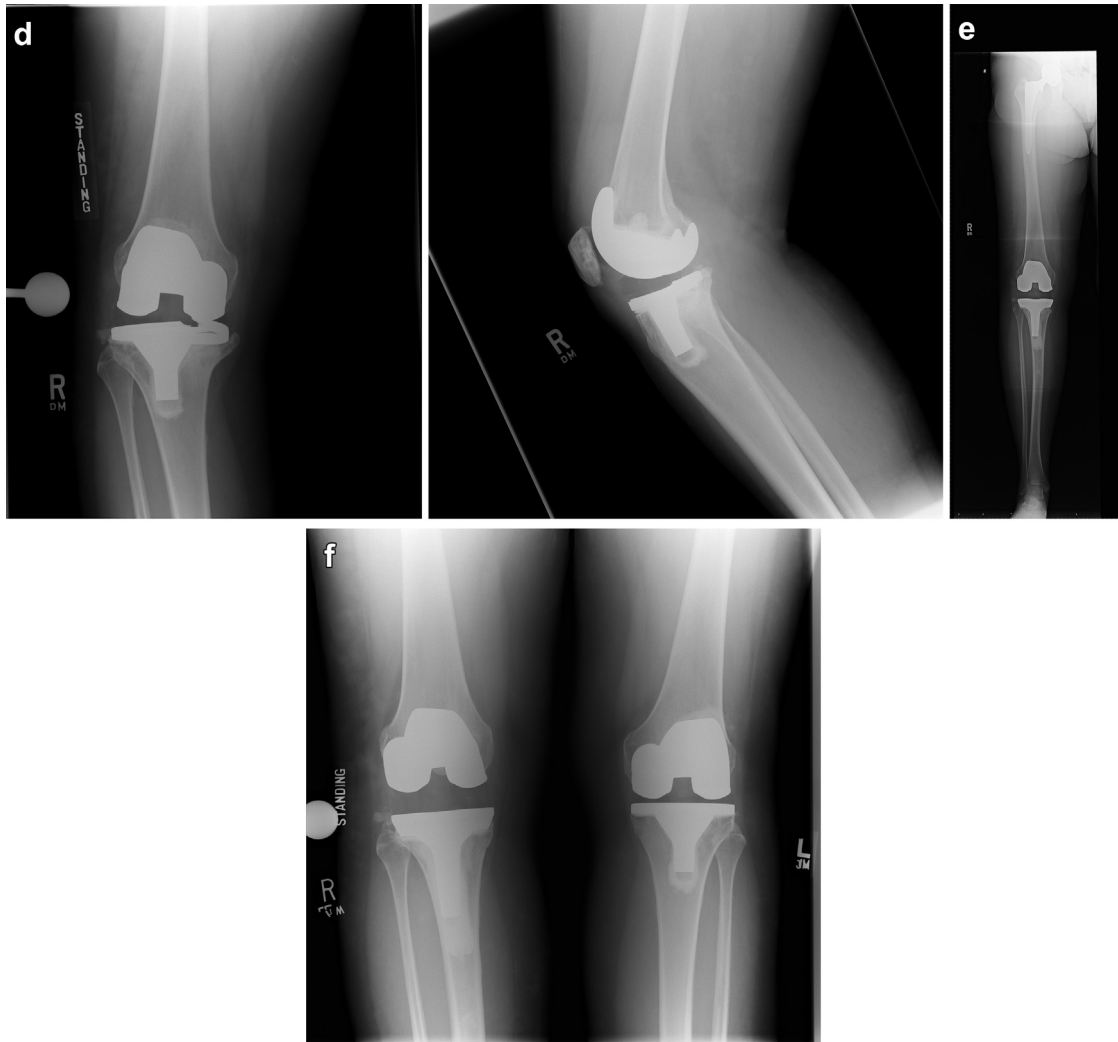
Examination of her knee revealed a fixed valgus deformity of approximately 15°–20° and a range of motion of 0°–110°. Radiographs demonstrated right knee osteoarthritis with valgus deformity (Fig. 1a). The patient failed conservative measures for her symptoms and elected to undergo right TKA in February 2009, utilizing a PFC Sigma design (DePuy, Warsaw, IN) with a polished, chrome cobalt tibial tray. The prosthesis was fixed with cement, and a 12.5-mm polyethylene insert was used. The procedure was uneventful. Postoperatively, the knee was in 5° valgus alignment and knee radiographs demonstrated a stable implant (Fig. 1b). The patient did well after surgery and obtained complete pain relief.

At 1-year follow-up, she complained of recent onset medial knee pain in the area of the pes anserine bursa. Radiographs were unremarkable (Fig. 1c). She was diagnosed with pes anserine

Figure 1. (a) Anteroposterior (AP) long leg preoperative radiographs from February 2009 (b) AP right knee at 6 weeks postoperative (c) AP bilateral knees at 1 year postoperative (d) AP and lateral radiographs first demonstrating tibial tray fracture in July 2010 (e) AP long leg radiographs 1 month after revision procedure (f) AP bilateral knees at 5 years after revision procedure.

bursitis and received a short course of oral corticosteroids. She returned 3 months later without improvement in her symptoms and she underwent a corticosteroid injection into the pes anserine bursa. The injection provided partial relief, but she returned 1 month later with progressive symptoms. At this time, the right knee was found to be in 15° varus. Radiographs were obtained and demonstrated a fracture of the tibial tray (Fig. 1d).

The patient underwent revision of the tibial component in July 2010. At the time of surgery, there was necrotic bone within the posteromedial aspect of the tibial plateau. High-speed burrs were used to debride the necrotic bone to healthy bleeding bone. A DePuy PFC Sigma revision tibial component was inserted and fixed with cement. No augments were needed, and the alignment of the knee was corrected. The patient tolerated the procedure well without complications (Fig. 1e). Intraoperative cultures and cell counts did not provide evidence of any underlying infection. She returned to full activity postoperatively and was asymptomatic at her most recent follow-up, 5 years later (Fig. 1f).

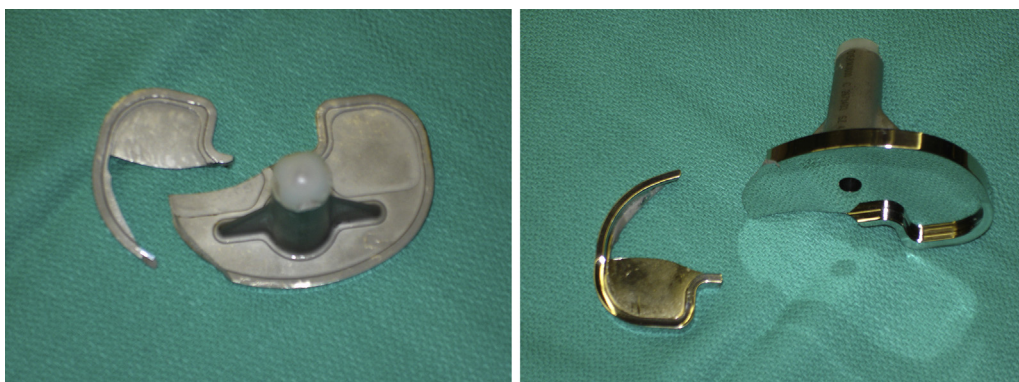
The fractured tibial tray was first examined visually (Fig. 2). The fracture extended through the width of the tray in 2 primary directions (Fig. 3). The first extended from the corner of the posterior notch in the medial direction toward the outer rim. The second segment began at the anterior surface and travelled medially, initially with a similar contour to the outer rim. The segments met in the medial tray and separated the fractured component from the rest of the prosthesis. No indications of material defects, such as porosity, were observed nor were any witness marks from impact or tool damage.

Figure 2. Fractured tibial tray.

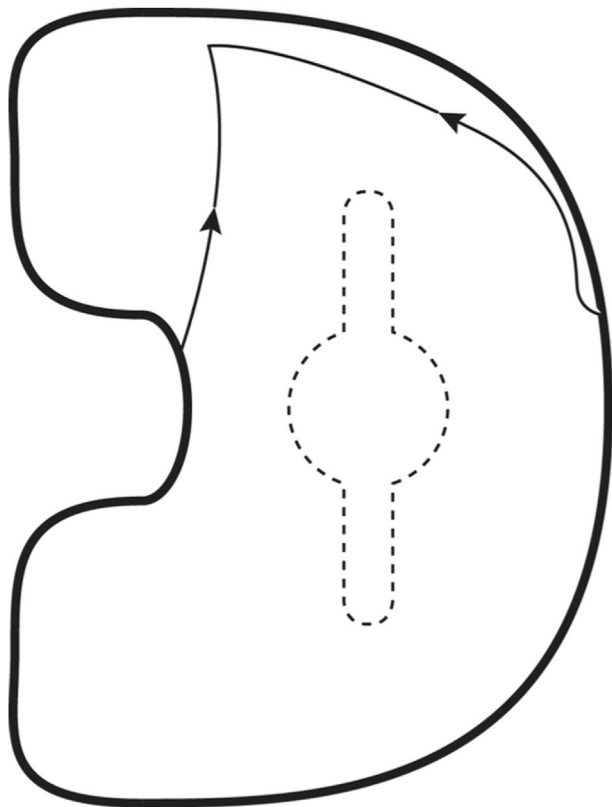
Because the crack grew by fatigue over most of its length, only small loads were likely present, allowing the 2 halves of the tray to remain attached by even a small ligament of cross-section until final failure occurred. Had the cyclic loads been larger, it would be expected that the remaining ligament of the cross-section holding the 2 halves of the tray together would eventually give way, creating a large area of the fracture surface indicative of ductile overload. Given the significant difference in direction of the 2 fracture segments, it is likely that each grew as separate cracks emanating from anterior and posterior points on the tray, eventually intersecting further out in the medial direction (Fig. 3).

Figure 3. Schematic of tibial tray. The 2 fracture segments likely emanated from the anterior and posterior edges of the tray and grew in the directions indicated by the arrows. The approximate position of the post and flange support beneath the tray is indicated (not to scale).

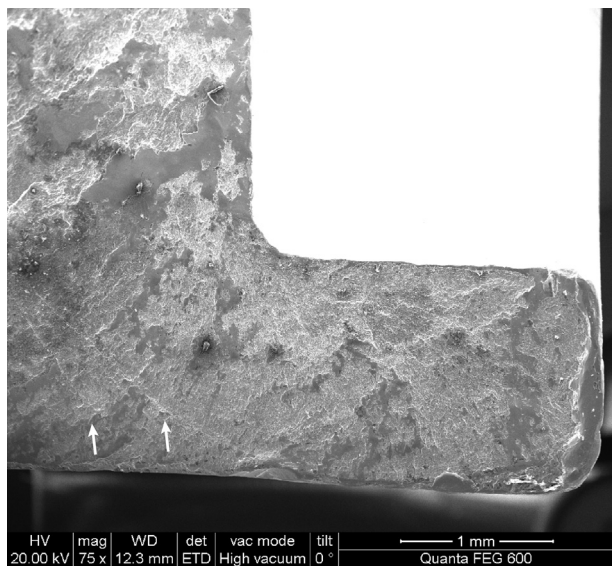
The fractured tibial tray was then sent for analysis by scanning electron microscopy. Study of the component revealed both beach marks and striations. Beach marks are macroscopic indications on the fracture surface that resemble parallel lines, such as those created as water flows over sand on a beach, and indicate the position of the crack front at different times as it grows progressively across the component (Fig. 4). When variations in loading occur, the roughness of the fracture surface changes, creating these lines that can often be seen with the naked eye. Fatigue striations are similar parallel lines on the fracture surface that are observed on the microscopic scale (Fig. 5). As the crack grows under cyclic loading,

In some small regions where the fracture surface was damaged by rubbing, the morphology of the fracture could not be determined. Such rubbing itself is often consistent with a fatigue mechanism, where partially fractured components are held in close proximity to each other while the crack continues to extend through the component. The opposing faces of the fracture surface tend to rub against each other as they deform under cyclic loading. Therefore, fatigue fracture was determined to be the most likely mechanism of failure.

Figure 4. SEM micrograph of the tray fracture surface. Beach marks are indicated by the white arrows. Some areas of rubbing are also noted where the surface looks smooth. SEM, scanning electron microscopy.

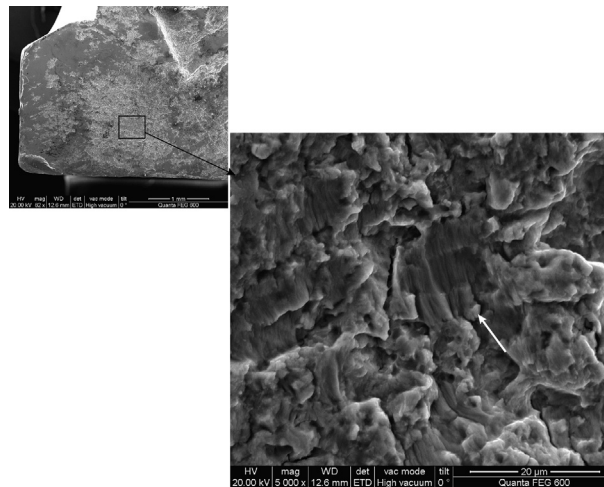
the crack front progressively advances by a short distance with each or every few cycles. Each striation is an indication of the crack position after each individual or every few cycles. Fatigue striations were observed over the majority of the fracture surface, indicating the component was cracking for a considerable period of time under a relatively low loading scenario.

Figure 5. SEM micrograph of another region of the fracture surface. Inset shows fatigue striations (white arrow) at high magnification. SEM, scanning electron microscopy.
