Case Report

Fracture of the Femoral Component Caused by Insufficient Crimping after Modern Unicompartmental Knee Arthroplasty

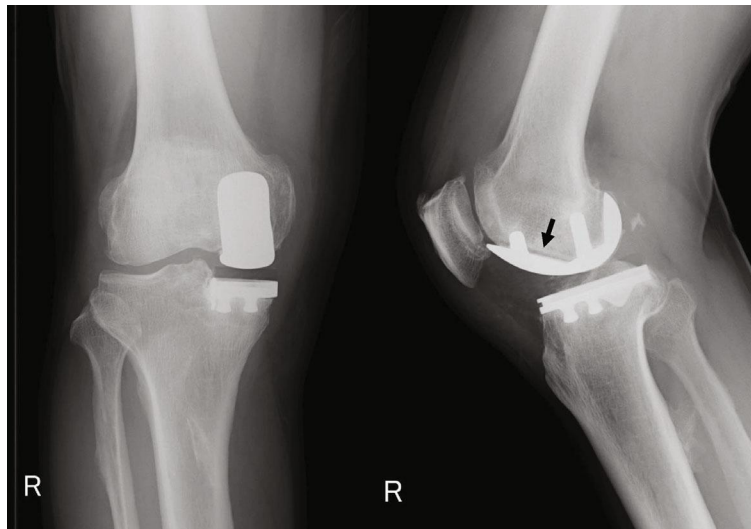
FIGURE 2: Plain radiography demonstrating a radiolucent line around the femoral component at the 1-year follow-up.

At the 1-year postoperative follow-up, the patient reported occasional right knee pain. Radiography revealed a radiolucent line around the femoral component (Figure 2). However, he was followed up by observation alone because he only had occasional mild right knee pain that was relieved by medication.

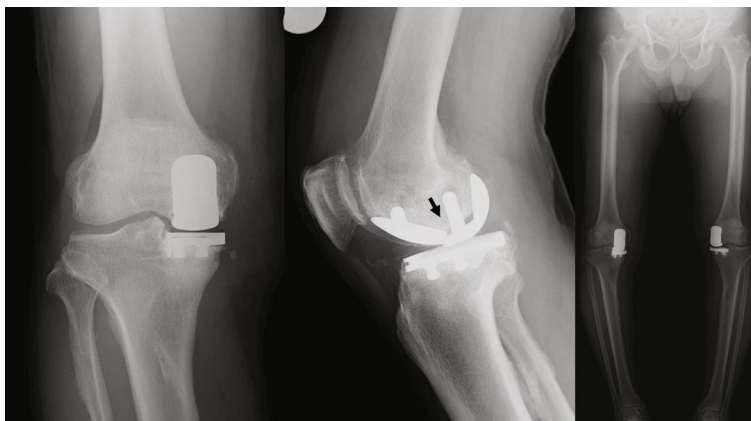
At the 8-year postoperative follow-up, he complained of increasing right knee pain, and radiography revealed fracture of a metallic femoral component, loosening of the femoral component, and marked narrowing of the medial joint space (Figure 3). There were no trauma events postoperatively. On careful analysis of past radiographs, a small crack sign was found in the femoral component, which had been missed at

FIGURE 3: Radiography demonstrating fracture and loosening of the femoral component at the 8-year follow-up. Marked narrowing of the medial joint space is also seen.

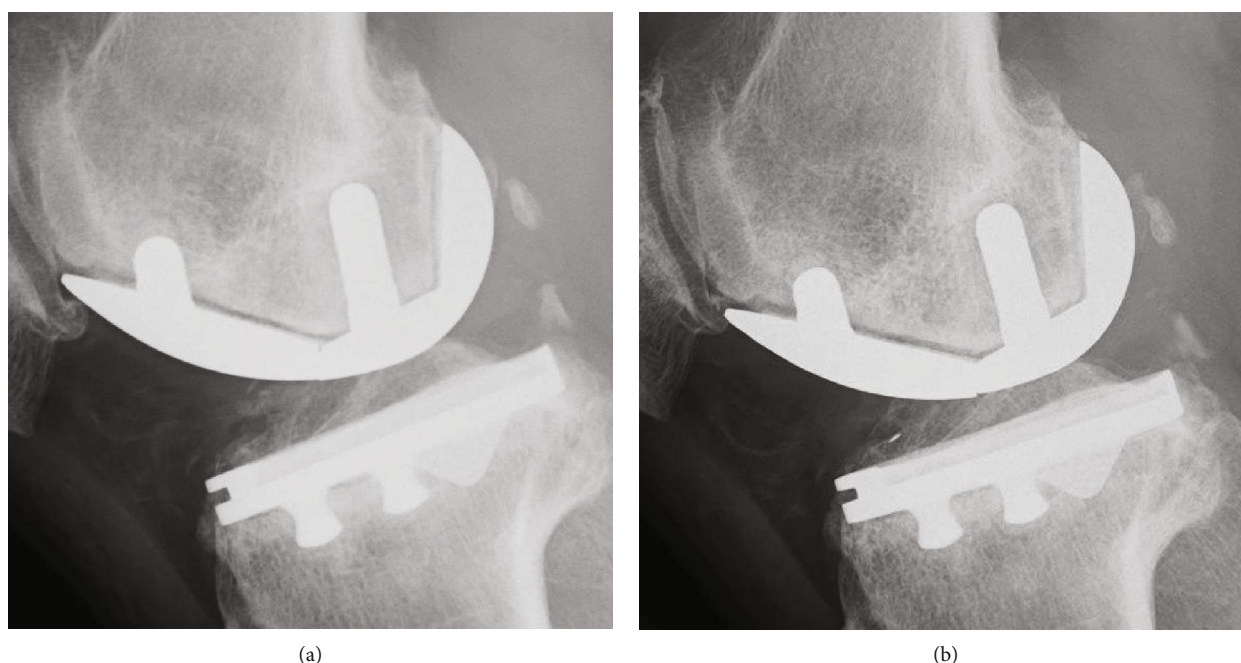
FIGURE 4: A small crack sign is found in the femoral component, which had been missed at the (a) 6- and (b) 7-year postoperative follow-up.

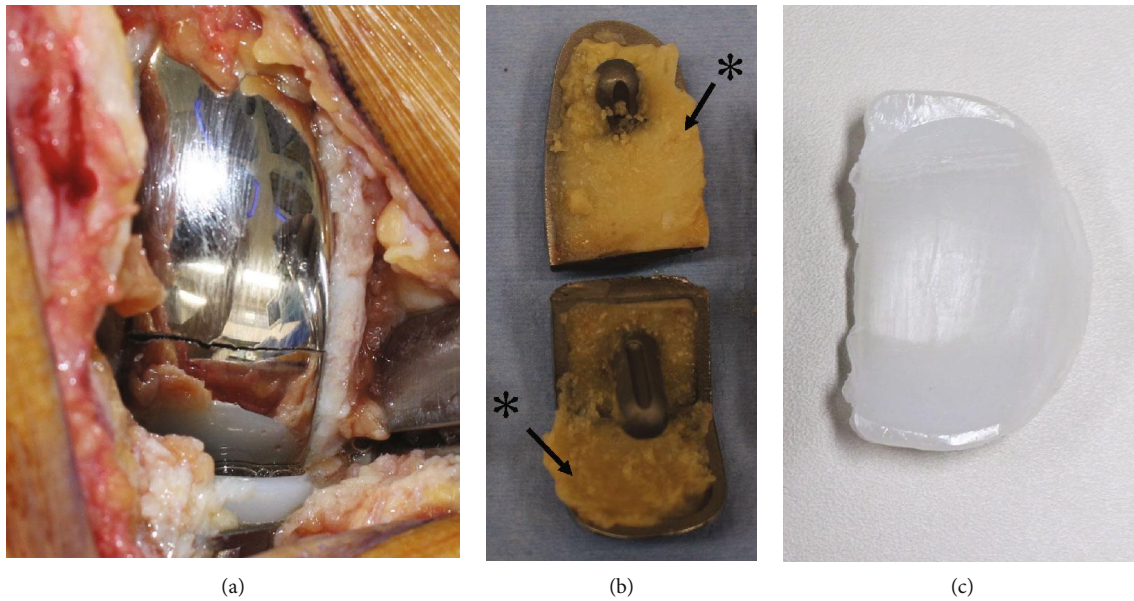
Intraoperatively, a fracture and loosening of the femoral component were observed (Figures 5(a) and 5(b)). There was marked wear of the middle part of the polyethylene insert (Figure 5(c)). However, the tibial component was well-fixed. Clear joint fluid and mild synovitis were detected. There was no sign indicating infection during the surgery, and all culture examinations were negative. The posterior and anterior cruciate ligaments were stable, and there was sufficient bone stock after the removal of the UKA implants.

FIGURE 5: (a) Fracture of the femoral component is noted intraoperatively. (b) Thick cement mantle observed at both lateral sides of the distal surface and at the medial side of the posterior surface (*). (c) Marked wear of the middle part of the polyethylene insert.

In the present case, the fracture site was the boundary between the distal and oblique posterior surfaces of the femoral component, which is the thinnest part of the femoral component. In addition, the metallic fracture site was, to some extent, distant from a peg. This is in contrast to a finding by Manzotti et al. [9] in which fracture of the femoral component occurred adjacent to the peg in old generation UKA implants, such as UC-plus, St George Sled, or Allegretto prosthesis. These authors, along with some other researchers [10, 14], have suggested that older UKA femoral implant designs have a higher risk of breakage and that this risk has reduced with newer UKA designs that incorporate a thicker
