# Conductor cable externalization in an atrial hemodynamic sensor lead in a patient presenting with inappropriate shocks

Sing-Chien Yap, MD, PhD,\* Mark G. Hoogendijk, MD, PhD,\* Suzanne D.A. Valk, MD,† Sweder W. Van de Poll, MD, PhD,† Peter van der Kemp,† Tamas Szili-Torok, MD, PhD\*

From the \*Department of Cardiology, Erasmus MC, University Medical Center Rotterdam, Rotterdam, The Netherlands, and †Department of Cardiology, Franciscus Gasthuis and Vlietland, Rotterdam, The Netherlands.

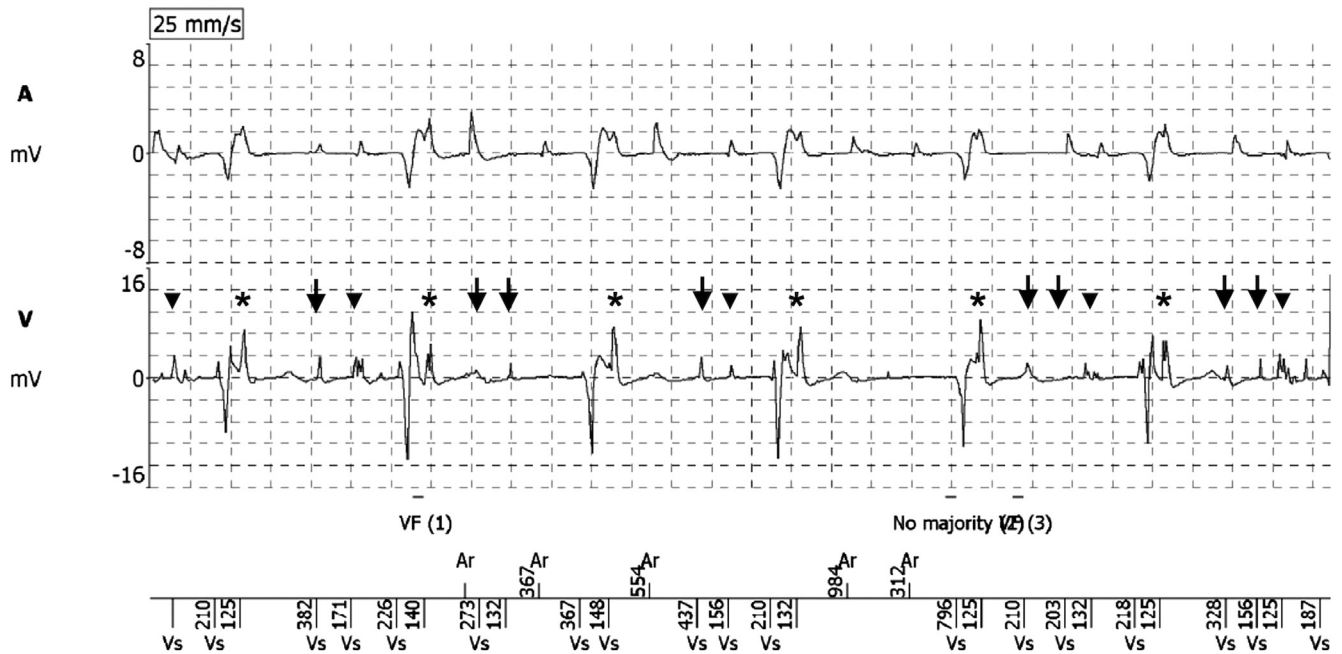
All her electrical parameters were in the normal range until she presented with an ICD storm in May 2019. She experienced 5 inappropriate ICD shocks before arrival at the emergency room. Upon arrival at the emergency room she lost consciousness after an inappropriate ICD shock initiated ventricular fibrillation (VF) and additional ICD shocks failed to terminate VF. Finally, external defibrillation terminated VF. The patient experienced 19 ICD shocks in total. Her post-shock electrocardiogram demonstrated RV pacing only, hence loss of biventricular pacing. When the device was interrogated, both the atrial and ventricular channel showed discrete nonphysiologic noise (Figure 1). Discrete noise on the atrial channel was usually blanked out and not detected. Discrete noise on the ventricular channel was either perisystolic (just after ventricular electric activation or just before atrial electric activation) or at random. After the ICD storm, the measured impedances of the atrial lead, RV pacing lead, left ventricle (LV) pacing lead, and RV coil were 240  $\Omega$ , 2913  $\Omega$ , >3000  $\Omega$ , and >3000  $\Omega$ , respectively. The LV pacing configuration was LV tip to RV coil. The lead trends demonstrated a progressive decrease in RV sensing amplitude and a sudden increase in both the LV lead impedance and high voltage impedance in the period preceding the ICD storm

**Figure 1** Electrogram just before the first inappropriate implantable cardioverter-defibrillator shock. Both the atrial (A) and right ventricular (V) channel showed discrete nonphysiologic noise. Discrete noise on the atrial channel was usually blanked out. Discrete noise on the ventricular channel was either perisystolic (just after ventricular electric activation [asterisks]) or just before atrial electric activation [arrowheads] or at random (arrows). Note that the noise is low in amplitude.

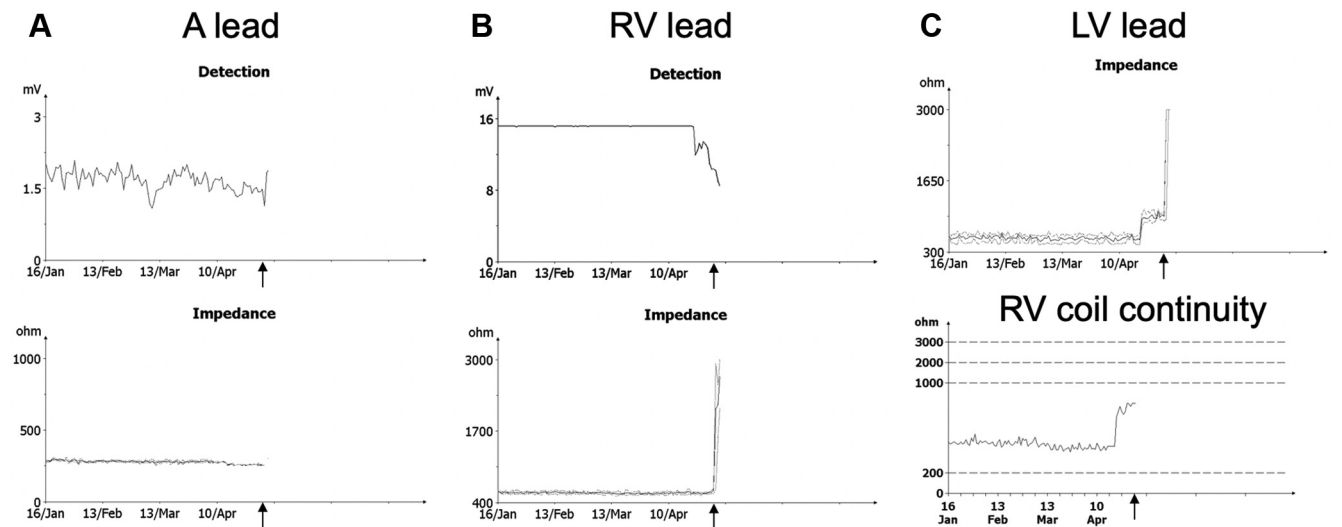
(Figure 2). Furthermore, there was a slight decrease in the atrial lead impedance preceding the abovementioned changes. On fluoroscopy, a fracture and protruding coil conductor cable was seen just proximal to the RV coil. Furthermore, externalization of conductors of the atrial lead was noted (Figure 3A). All leads demonstrated excessive slack.

**Figure 2** Lead trends. **A:** Upper panel: atrial lead sensing amplitude; lower panel: atrial lead impedance trend. **B:** Upper panel: right ventricle (RV) lead sensing amplitude; lower panel: RV lead impedance trend. **C:** Upper panel: left ventricle (LV) lead impedance; lower panel: RV coil continuity. The period preceding the implantable cardioverter-defibrillator storm (arrow) was characterized by a progressive decrease in RV sense amplitude (suggesting insulation failure), a sudden increase in LV lead impedance (configured as LV tip to RV coil), and high voltage impedance. Note that the impedance of the atrial lead showed a slight decrease since mid-April.

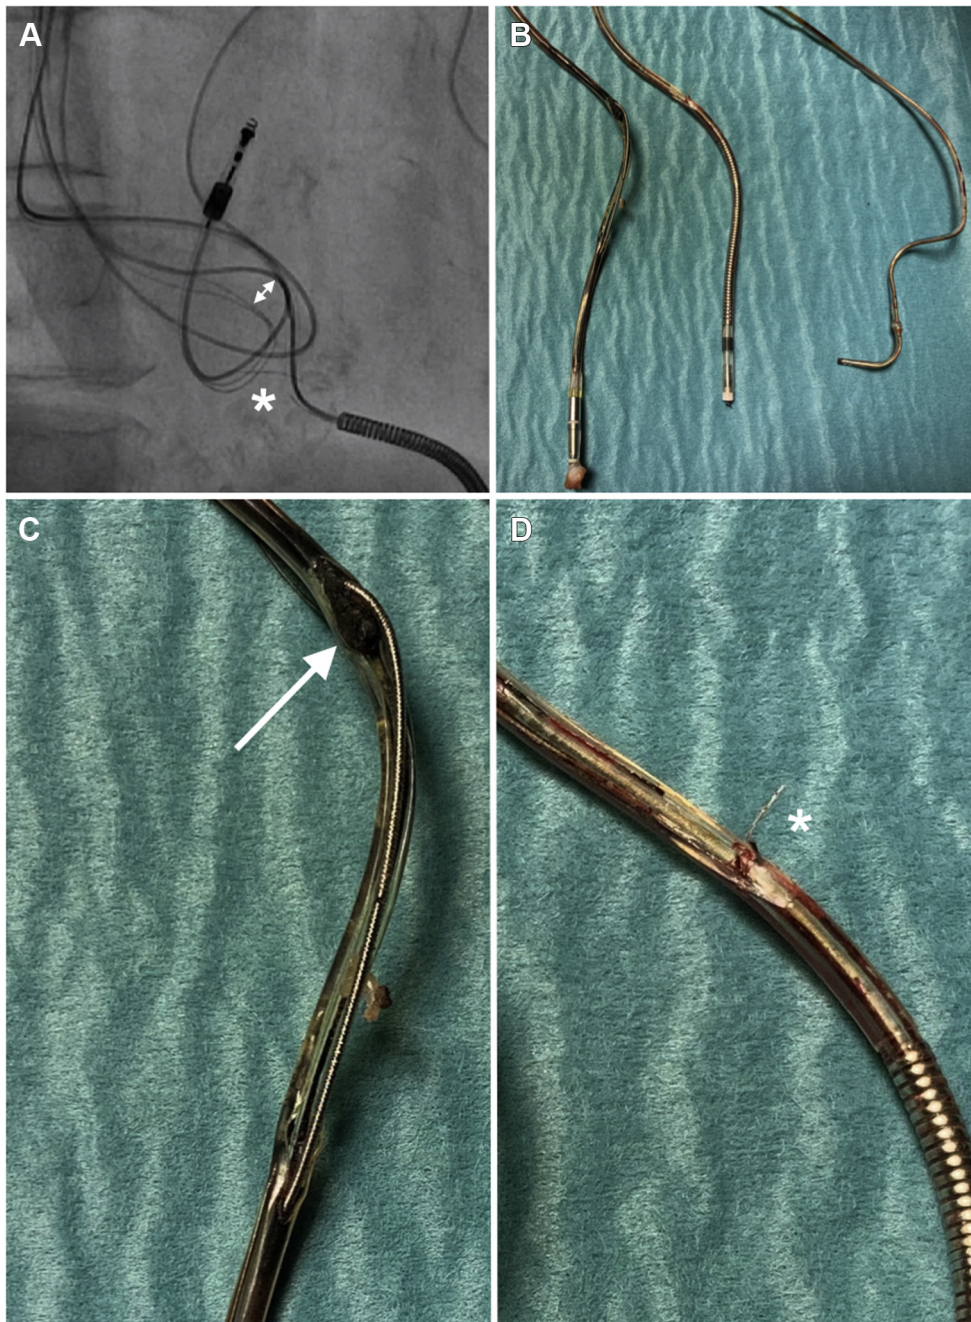
extraction tools (Figure 3B). Inspection of the extracted SonRtip atrial lead showed externalization of the pace coil over a distance of approximately 4.5 cm (Figure 3C). There was accumulation of biologic debris at the proximal site of the insulation breach. Inspection of the extracted Protego S lead demonstrated a conductor cable protruding through a breach in the silicone jacket insulation 1.5 cm proximal to the shock coil (Figure 3D). The insulation breach of the Protego S lead had smooth edges. As the patient had developed

**Figure 3** Failed SonRtip (MicroPort, Shanghai, China) atrial lead and Protego (Biotronik, Berlin, Germany) defibrillator lead before and after extraction. **A:** Pre-extraction fluoroscopy demonstrating conductor cable externalization of the SonRtip lead (*double arrowheads*) and fracture and protrusion of the shock coil conductor (*asterisk*). **B:** Overview of the 3 extracted leads with, from left to right, SonRtip lead, Protego S lead, and QuickFlex (St. Jude Medical, St. Paul, MN) 1258T left ventricular lead. **C:** Detailed view of the SonRtip lead. Old, dark blood was seen in the lead body distant from the insulation breach. Note that the tip conductor coil is protruding out of the silicone body with accumulation of biologic debris and altered blood underneath the coil (*arrow*). There is a large insulation breach over a distance of approximately 4.5 cm. Additional cables remain within their lumens. **D:** Detailed view of the Protego S lead. Discrete breach in the silicone insulation proximal to the shock coil with protrusion of part of the shock coil conductor cable (*asterisk*).

to LV tip to RV coil). Interestingly, the insulation defect of the SonRtip lead was not associated with a significant change in electrical parameters before the ICD storm. During routine follow-up there was only mild attenuation of the atrial signal and mild augmentation of the ventricular far-field signal causing inappropriate mode switch episodes. The breach in the insulation jacket of the SonRtip atrial lead was large, with ragged edges. The build-up of biological debris underneath the pace coil (arrow, [Figure 3C](#)) clearly suggests a pre-existing insulation breach that was not caused by the extraction procedure. The mechanism of CCE is most likely IOA.

suspected to be IOA. Excessive slack of the atrial lead may have contributed to this phenomenon, but the multilumen design may also contribute to IOA. Data regarding the long-term longevity of these multilumen atrial leads are limited, because these leads have been in use for <9 years. According to the May 2018 product performance report of MicroPort there were only 5 cases (0.07%) of insulation breach (location not specified) in 6968 worldwide implants.<sup>10</sup> CCE was not reported in the product performance report; however, underreporting of CCE is possible, as this defect is not always accompanied by electrical abnormalities and is only detected with fluoroscopic imaging.

The patient was transferred for a full system extraction, which was performed 12 days after her ICD storm. All leads were extracted with simple manual traction without specific
