Case Report

Fatigue Failure of Semiconstrained Total Knee Replacement: Magnetic Resonance Imaging Diagnosis With Tips and Tricks for Extraction and Reconstruction

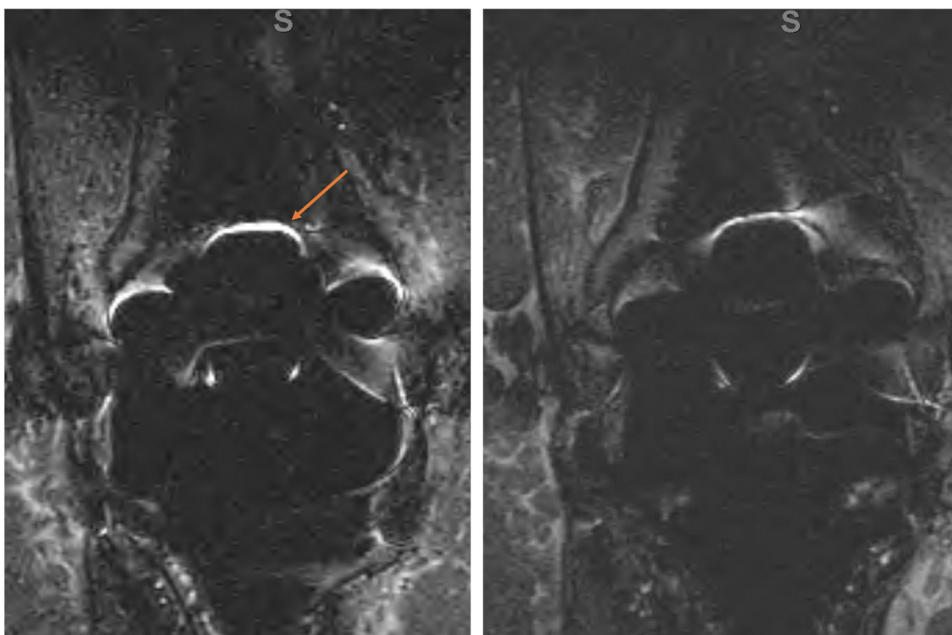
2015, including arthroscopic debridement of the meniscus, TKA, and multiple revision arthroplasties due to prosthetic joint infection with *Staphylococcus aureus* and *Streptococcus agalactiae*. Prior to this clinic visit, X-rays and MRI were performed at an outside hospital. The radiographs (image unavailable) were negative for any signs of TKA failure; however, the MRI scan displayed a fracture at the stem-taper junction (Fig. 1).

Figure 1. MRI Showing Fractured Morse taper.

Of note, we reiterate the importance of diagnostic imaging in evaluating a patient with a complex surgical history. The initial radiographs did not reveal a fracture of the morse taper nor the loose bushing; however, the MRI revealed the loose bushing and fluid within the component space, which aided in our diagnosis of catastrophic TKA failure. One recent study assessing the diagnostic performance of MRI for component loosening in patients with TKA concluded that an MRI examination should be considered for all problematic TKAs and, in some instances, may outperform standard X-ray imaging due to its superior performance in depicting soft-tissue synovial abnormalities and in evaluating the implant-bone interface [15]. To the best of our knowledge, MRI has not been previously used to diagnose implant fractures.

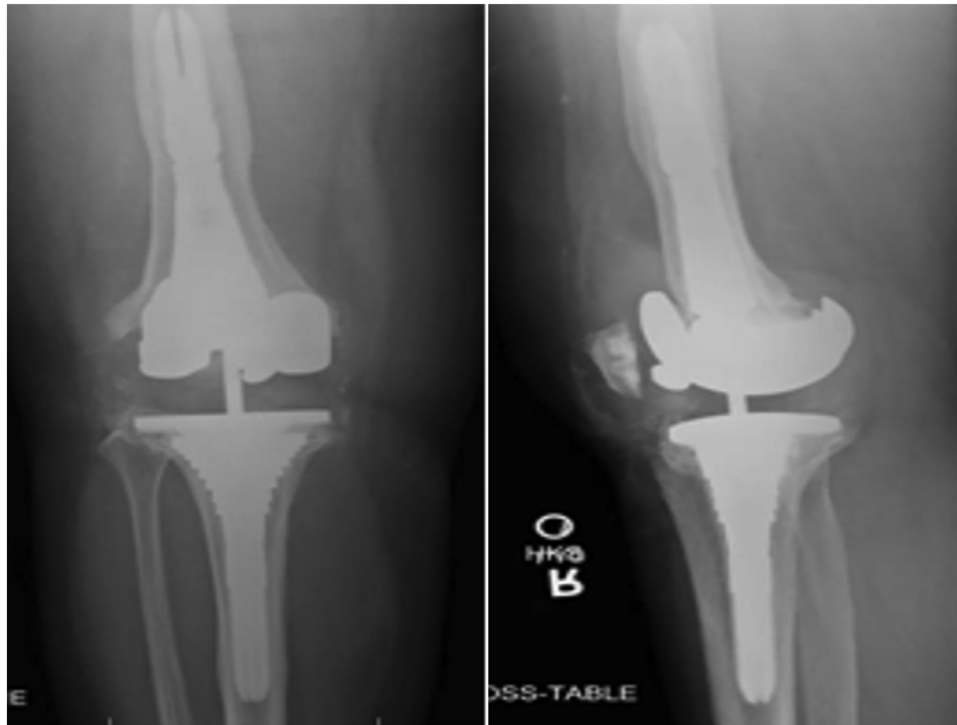
Upon presentation to our clinic, the patient demonstrated significant ligamentous laxity, especially at the medial aspect of the knee, with a range of motion from 0° to 90°. Interestingly, while radiographs (Fig. 2) obtained at our institution showed a loose adaptor bolt in the knee joint, they did not demonstrate any clear evidence of a stem fracture. The overall component alignment appeared acceptable.

Figure 2. Pre operative x ray showing loose bolt.

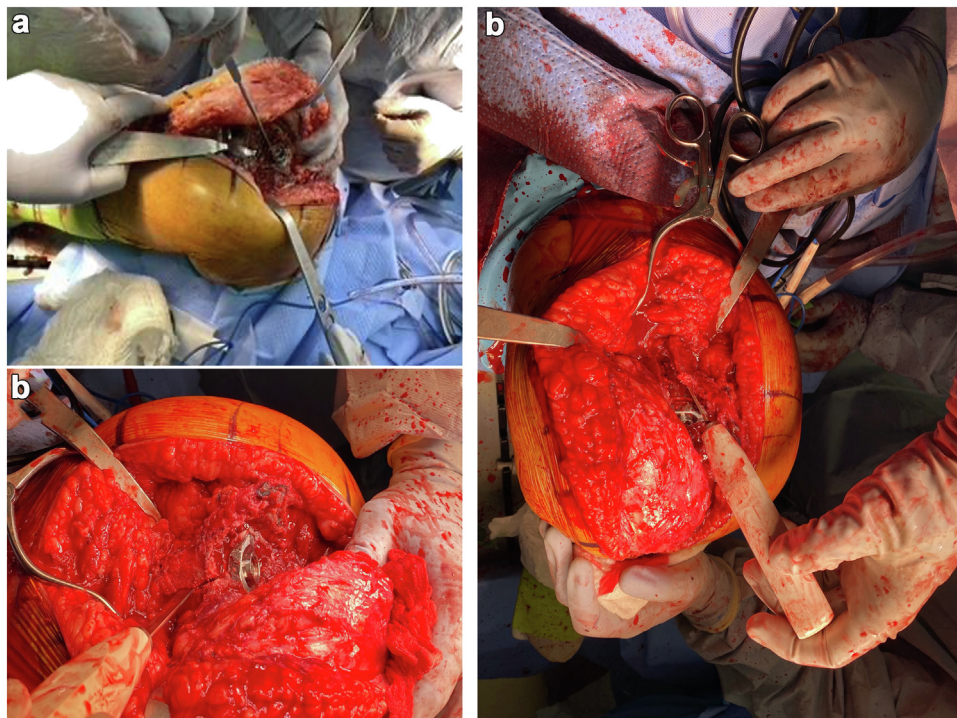
Intraoperatively, the femoral component was found to be grossly unstable. We identified the loose adaptor bolt, and the femoral component was removed without difficulty. However, part of the adaptor bolt remained within the broken morse taper (Fig. 3a and b). We could not remove the broken part of the adaptor bolt and attempted a standard technique to remove the very well-fixed metaphyseal sleeve without success. Consequently, an anterior quadrangular femoral osteotomy was performed to remove the entire femoral stem, which contained the loose threads in the socket. A prophylactic cerclage wire was first placed proximal to the osteotomy line to prevent further propagation of the osteotomy. An oscillating saw was used to perform the vertical limb of the osteotomy, which was on the medial side, and a pencil-tip burr was then used to carve the proximal end as well as perforate the lateral side to complete the osteotomy. The osteotomy fragment was progressively freed up from the sleeve and elevated off the anterior

Figure 3. Intra operative x ray showing anterior quadrangular osteotomy.

Intraoperatively, we were presented with the great challenge of removing the fractured adapter bolt connecting the femoral stem to the condylar component. None of our surgical instruments were capable of grabbing and removing the loose bushing threads sitting in the socket. Therefore, we had to perform an anterior quadrangular femoral osteotomy to remove the entire femoral stem with the sleeve containing the loose threads. As the osteotomy increased the risk of a condylar fracture, we used 2 cortical screws and 2 prophylactic cerclage wires to reinforce the distal femur while repairing the osteotomy site. This surgical technique allowed us to successfully disengage the morse taper and remove the femoral implant. As the implant stem bypassed the taper area significantly higher up and because the screws were inserted in the cancellous bone, we believe that the stress from these screws should be distributed and will likely not predispose to later fracture. In our patient, the tibial component was retained as it was well-fixed and appropriately aligned, while the femoral component was replaced with a rotating hinged implant. Primary indications for using a hinged arthroplasty are severe distal femoral bone loss, severe flexion gap instability which cannot be matched by the extension gap, and the presence of a totally disrupted medial collateral ligament, as in our patient [12]. Although hinged knee implants have been associated with excessive strain at the fixation interface, the rotating bearing design in the implant we used can act to diminish the stress. Issack et al. previously reported 2 cases of fracture at the taper lock at the femoral stem-condylar junction in cemented revision arthroplasties [13]. One of these patients had a well-fixed tibia component and only had the femoral component revised, similar to our patient. However, the fractures described were found in Optetrak constrained condylar knee arthroplasty implants (Exactech, Gainesville, FL) [13]. Given the significant differences in biomechanical load distribution in a constrained condylar knee implant vs a rotating platform implant, we felt the particular fracture found in our patient was worth reporting [14].

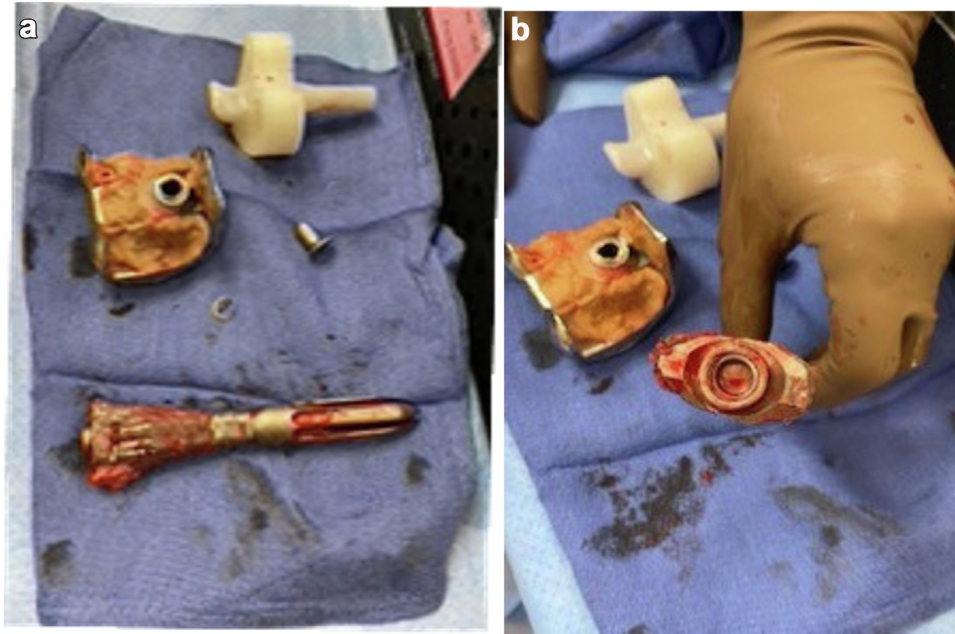
surface of the sleeve which allowed access to the well-fixed sleeve. The attachment of suprapatellar tissue on the lateral side of the osteotomized anterior surface was preserved to keep vascularity, which is different from the technique described by Merz and Farid [6]. Once it was free, a trough was made in the sleeve using a metal cutting burr. This gave us a tether point to use a bone tamp, and we were able to mallet the femoral component out without difficulty (Fig. 4a and b).

Figure 4. Extracted implant showing fractured morse.

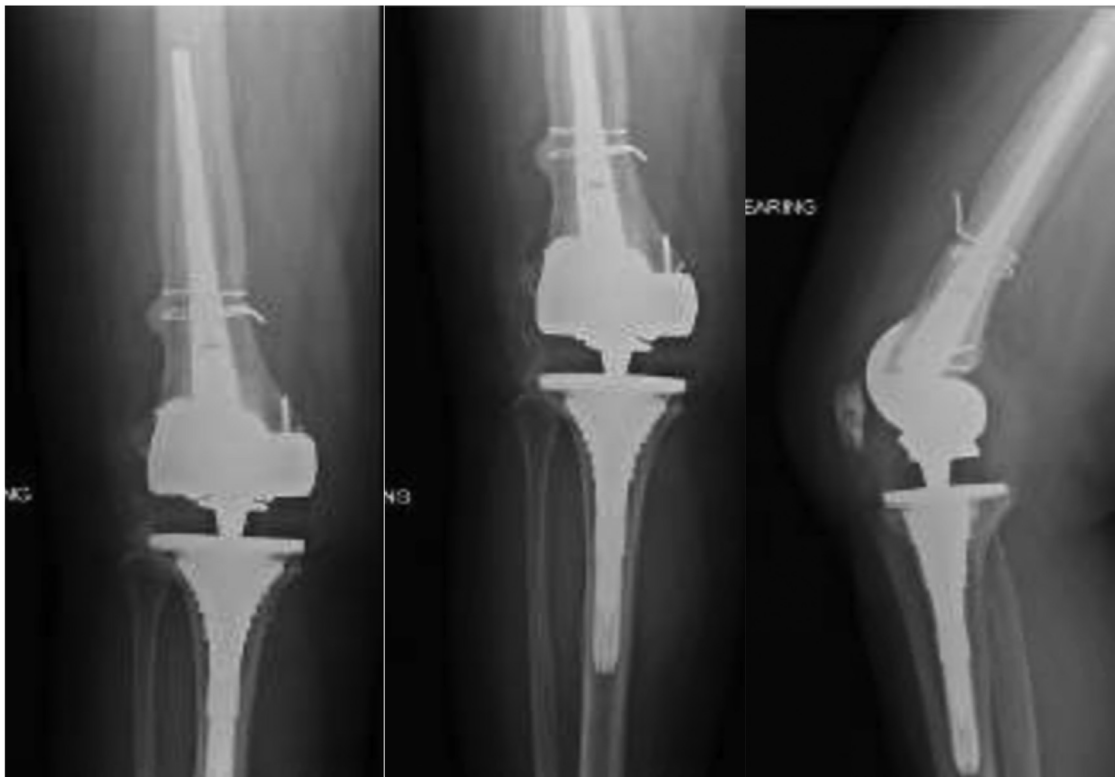
Figure 5. 3 months post operative x ray.

The osteotomy was repaired using a cerclage wire. We found that when the cerclage wire was placed distally, it tended to slip proximally due to the conical nature of the distal femur. We developed a technique to hold the wire, similar to that illustrated by Appleton et al. [7]. We placed cortical screws on either side of the femoral shaft anteriorly which prevented the wire from migrating proximally to the screw. Once the cerclage wire was tightened and able to stay in place, we removed the screw. We also placed a figure-of-8 wire to hold the condyles for any inadvertent split that might have occurred during osteotomy. This was done by inserting 2 cortical screws in the condyles anteriorly and placing a doubled 18-gauge wire in a figure-of-8 pattern with the screws as anchor points. This was progressively tightened until there was no slack. We have previously found success with this technique both for prophylaxis as well as for fixing condyle fractures. Since the femoral stem bypasses the screws, the screws do not produce a stress-riser effect. The femur was then prepared to accept a DePuy Synthes S-ROM rotating hinged knee (S-ROM; DePuy Synthes, Warsaw, IN), including a femoral stem connected to the condylar component via a morse taper junction. A hinged knee component was selected due to the absence of a medial collateral ligament. The polyethylene component was exchanged as well. The knee was able to achieve full extension and 110° of flexion. Final radiographs revealed a well-placed revision TKA (Fig. 5).
