Bore Disruption: An Unusual Mechanical Failure of Two Hip Hemiarthroplasties

Federico Dettoni¹ Umberto Cottino¹ Silvia Spriano² Davide Edoardo Bonasia¹ Roberto Rossi^{1,3}

Joints 2017;5:51–56.

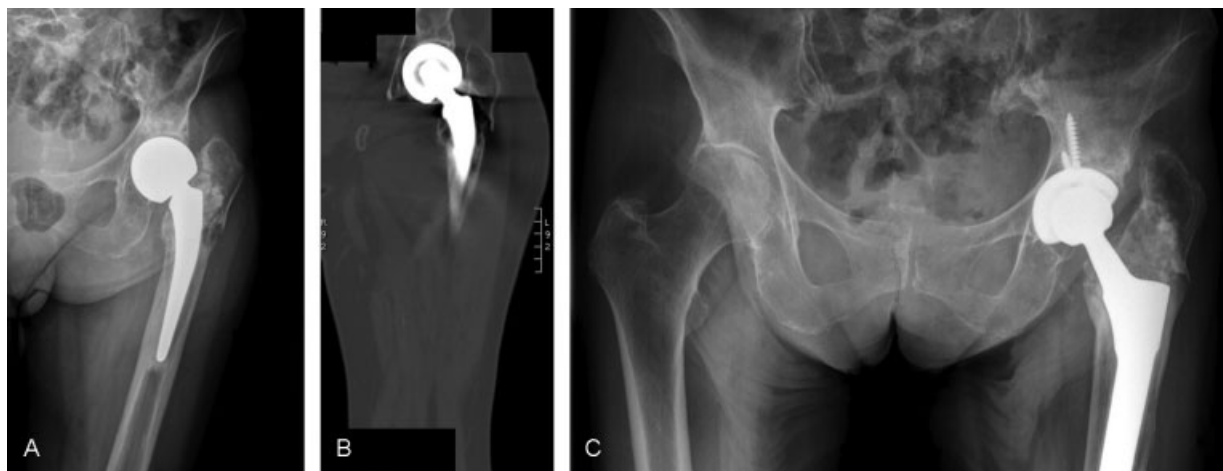
First case was of a 67-year-old woman affected by hypertension and a non-Hodgkin lymphoma, who was referred to our observation in 2008. She was plainly active at the time of trauma. The patient was affected by a femoral neck fracture, secondary to a lymphoma localization. An Ellittica (Samo, Bologna, Italy) cemented HA was implanted (47-mm head, M stem). After surgery, the patient returned to her normal life. She came back to our observation 5 years later, in 2013, for an atraumatic hip pain at the same hip. She was first evaluated in the emergency department, where a plain radiograph was performed. At a first sight, the diagnosis was not clear, and a computed tomography (CT) scan was requested. Observing the CT images, a dislocation inside the head of the neck and Morse taper of the stem was detected, and a prosthesis failure was diagnosed.

Fig. 1 Case 1. (A) Preoperative X-ray and (B) computed tomography scan of broken hemiarthroplasty. (C) Postoperative X-ray of conversion to total hip arthroplasty.

The HA was revised to a total hip arthroplasty (Wagner SL Stem with Trilogy cup, Zimmer Inc., Warsaw, Indiana, United States) (▶ Fig. 1). After surgery, the patient returned

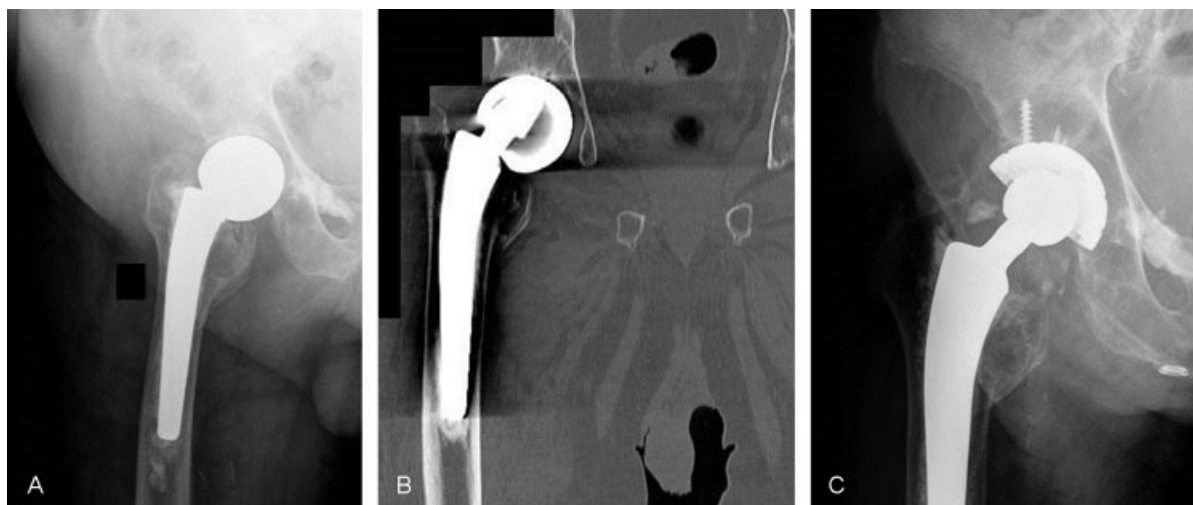
The second case was of an 80-year-old man affected by atrial fibrillation, non-Hodgkin lymphoma, and chronic renal insufficiency. He referred to our emergency department for a femoral neck fracture in 2003. Prior to the fracture, the patient was active, with complete deambulatory autonomy, and reported jogging twice a week. An Ellittica-cemented HA (Samo, Bologna, Italy) was implanted (51-mm head, XL stem). After surgery, the patient returned to his normal life, including sports. In 2010, he felt a sudden pain in the hip while walking and then referred to our emergency department. A plain radiograph was performed. A shortening of the stem neck was clearly detected; therefore, a CT scan was requested. The migration of the neck of the HA inside the head was clearly visible, and a breakage of the head cone was diagnosed.

Fig. 2 Case 2. (A) Preoperative X-ray and (B) computed tomography scan of broken hemiarthroplasty. (C) Postoperative X-ray of conversion to total hip arthroplasty.

The HA was converted to a total hip arthroplasty (THA), implanting an ABG cup (Stryker, Kalamazoo, Michigan, United States) (56 mm) with a polyethylene inlay, leaving the implanted stem and replacing the broken head with a ceramic head (Samo, Bologna, Italy) (► **Fig. 2**).

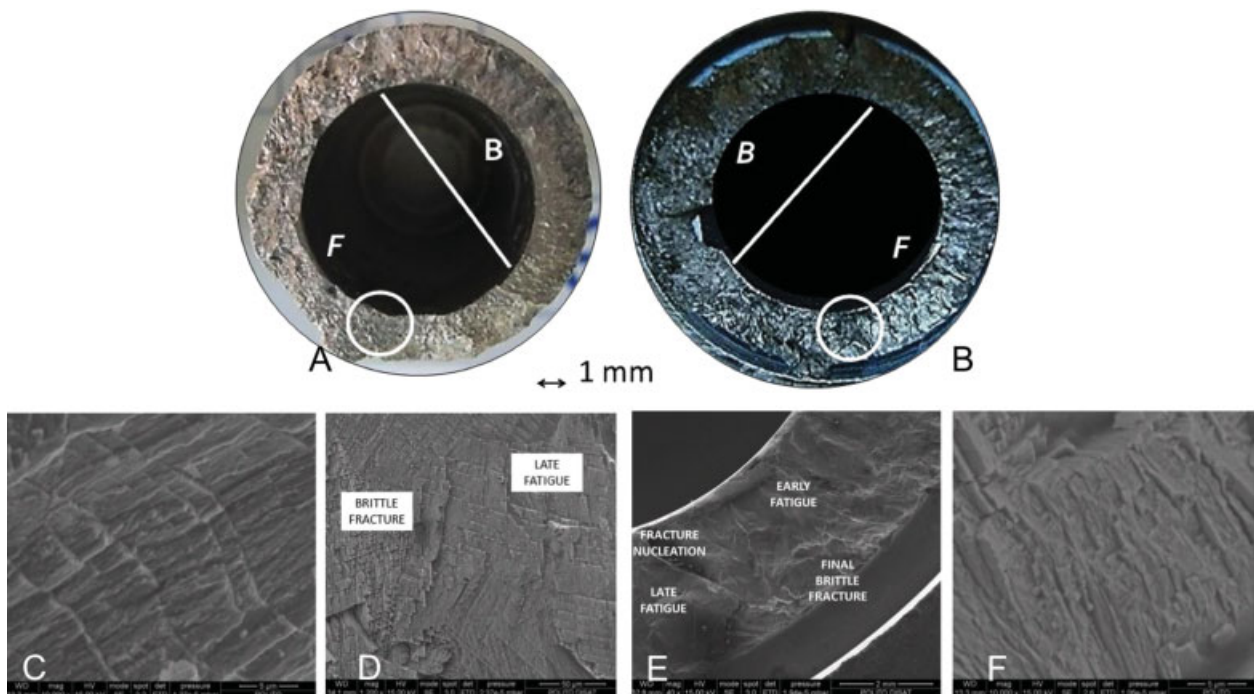
The fracture surfaces of case 1 were two annuli, with an inner diameter of 8 mm and an external diameter of 12 mm.

It was possible to observe only a single site of initiation of the fatigue fracture, with no morphological or microstructural defect near the initiation site. More than half of the fracture surface was due to a mechanism of fatigue, whereas the other half corresponded to final fracture. The mechanism of fracture observed was the so-called transgranular and not intergranular pattern. Striations appeared as relatively evenly spaced parallel lines; this pattern of fracture is often present on fatigue fracture surfaces of cobalt alloys. Each striation actually represents a shallow crack resulting from a single stress cycle of approximately 5 microns. Some zones with evidences of final fracture were observed only near the outer edge of the fracture surfaces with the presence of a lot of cleavage planes, in different directions on the different crystals, suggesting that final fracture occurs with a brittle mechanism. To check the chemical composition of the metal alloy of the prosthesis, an energy dispersive spectroscopy (EDS) analysis was performed: cobalt, chromium, and molybdenum have been identified in the ratios required for the cobalt-alloy 66Co-28Cr-6Mo (ASTM F 1537), declared by the manufacturer, without any trace of contamination (►Fig. 3).

Fig. 3 Scanning electron microscopy analysis of case 1. (A) Bore section. (B) Head side. “F” stands for “fatigue fracture” and “B” stands for “brittle fracture.” The circles correspond to the nucleation site of the fracture. (C) A magnification of the late fatigue zone on the bore. (D) A magnification of the transition area between the late fatigue and final brittle zone on the bore. (E) An overview of the nucleation site of the fracture on the head. (F) A magnification of the early fatigue zone on the head.

It can be stated that the failure of the prosthesis in case 1 has occurred for a high number of fatigue cycles. The appearance of the fracture surface of case 2 is consistent with the presence of a torsional stress and two initiation points. The second initiation point showed a macroscopic lateral groove that originated from mechanical processing by a tool. The defect, resulting from machining, was a stress concentration factor, critical for the initiation and propagation of the fracture. A responsibility of the machining

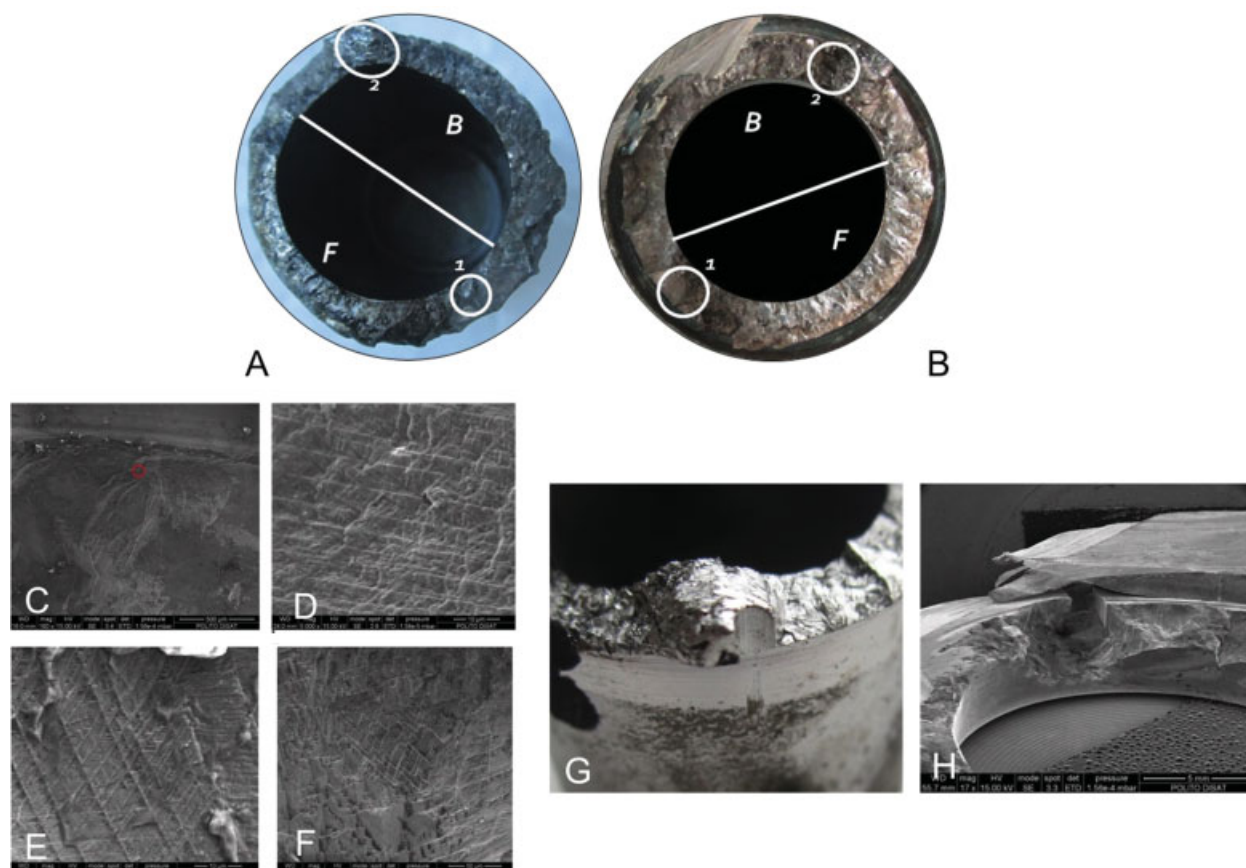
In case 2, the mechanism of fracture was transgranular, similarly to that noticed in case 1. Unlikely case 1, two initiation points of the fracture were identified, located on the outer edge of the samples, at approximately 180 degrees one from the other. The second initiation point (the most interesting) was identified in correspondence of an evident cavity in the fracture surface of the femoral head and in a protuberance of the fracture surface of the head cone. Moving radially from the outer edge (first initiation point) toward the center of the prosthesis, the propagation appeared

initially slow and then increasingly faster until the inner edge, where the final part of the fracture occurred, with wrinkled and uneven structure (brittle fracture). The difference observed between the two cases was a widespread presence of fatigue striations in multiple directions in case 2, according to the presence of two crack initiation points. Observing the second initiation point at a low magnification, a macroscopic lateral groove was noted. This groove came from mechanical processing by a tool, as shown by the regular streaks on its inner surface. Around this initiation, the fatigue fracture propagation was quite limited and evolved rapidly into final fracture. It can be concluded that the defect, resulting from machining, was a stress concentration factor, critical for the initiation and propagation of the fracture. Even in this case, the EDS chemical analysis did not record either contamination or relief or significant chemical differences in respect to the declared chemical composition (►Fig. 4).

Fig. 4 Scanning electron microscopy analysis of case 2. (A) Bore section. (B) Head side. “F” stands for “fatigue fracture” and “B” stands for “brittle fracture.” The circles correspond to the nucleation site of the fracture. (C) An overview of the nucleation site of the fracture on the head. (D) A magnification of early fatigue zone on the head on the head. (E) A magnification of the late fatigue zone with striations in multiple directions. (F) A magnification of the final brittle fracture on the head. (G,H) macroscopic images of the fracture surfaces of the prosthesis, near point 2 of initiation of the fracture: a later groove can be seen on both the stem seat and the femoral head.
