Case report

Fracture of the neck of an uncemented femoral component unrelated to trunnion corrosion

Jonathan R. Peterson, MD ^{a,*}, Timothy M. Wright, PhD ^b, Samuel S. Wellman, MD ^a, Paul F. Lachiewicz, MD ^a^a Department of Orthopaedic Surgery, Duke University, Durham, NC, USA^b Hospital for Special Surgery, New York, NY, USA

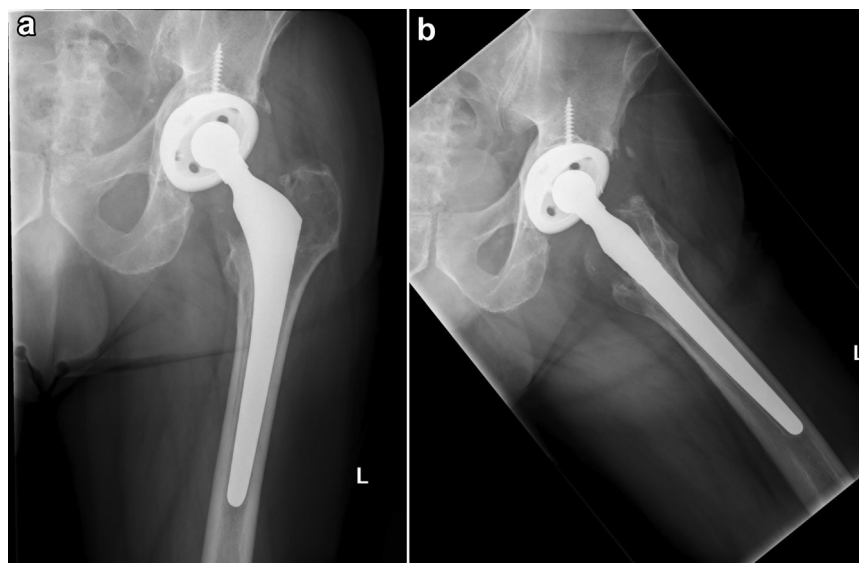
Figure 1. Anteroposterior (a) and lateral (b) radiographs of the left hip before head and liner exchange. Radiographs demonstrate polyethylene wear and osteolysis in the greater trochanter.

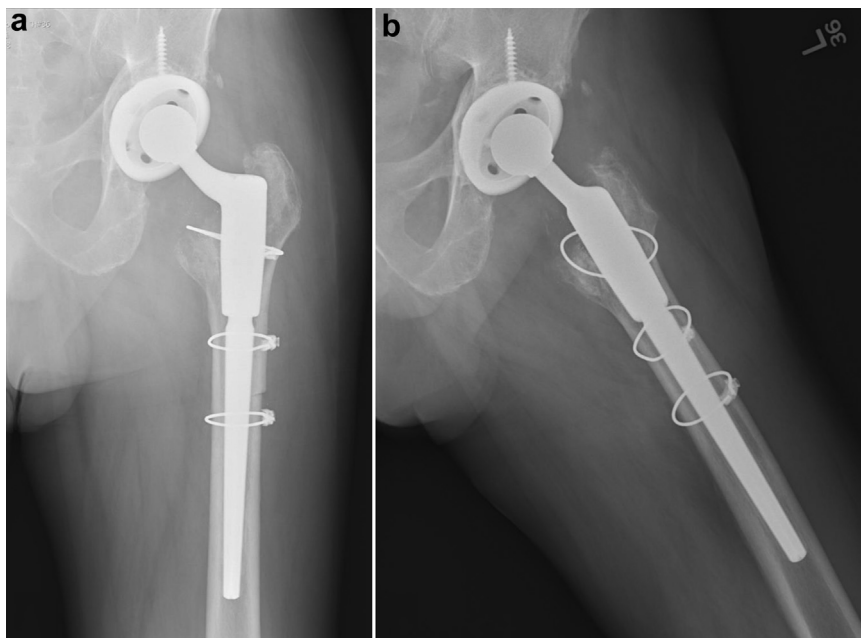
Figure 3. Anteroposterior (a) and lateral (b) radiographs of the left hip at 3 months postoperatively. Radiographs demonstrate healing of the osteotomy site and stable positioning of the components.

At revision, no corrosion at the trunnion was observed, and no pseudotumor or abductor muscle necrosis was found. The acetabular component was well fixed and was retained. The femoral component removal required a 10-cm extended trochanteric osteotomy, and a modular tapered fluted stem (Restoration; Stryker) was implanted, with a 32 + 8-mm cobalt-chromium alloy head; the osteotomy was repaired with cables. No postoperative complications occurred. At 3 months postoperatively, the patient had mild thigh pain and was able to ambulate long distances with one crutch. Radiographs showed good fixation and a healed osteotomy (Fig. 3a and b).

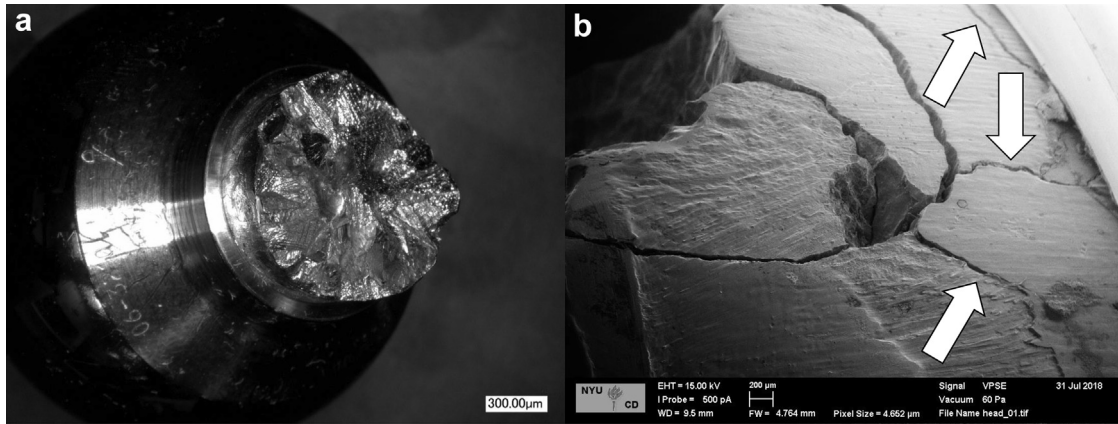
corrosion of the trunnion was found, consistent with the intraoperative findings. The surfaces of the fracture of the neck are consistent with fatigue fractures in cobalt-chromium alloy with an intergranular appearance (Fig. 4a). In addition to the crack that formed the main fracture (Fig. 4b), electron microscopy showed a considerable number of intergranular cracks, consistent with intergranular corrosion, as the probable cause for the failure. No accompanying material defects, such as porosity, were noted on the fracture surface.

Figure 4. Macroscopic photograph (a) of the fractured implant demonstrating typical fracture between the grains of the Co-Cr casting that resembles a series of up and down pyramids. Electron microscopy image (b) demonstrating additional intergranular cracks besides the one that formed the main fracture (arrow heads). Co-Cr, cobalt-chromium.
