Erosion and Corrosion Resistance Performance of Laser Metal Deposited High-Entropy Alloy Coatings at Hellisheidi Geothermal Site

Andri Isak Thorhallsson ^{1,*}, Francesco Fanicchia ², Emily Davison ², Shiladitya Paul ²

Abstract: Geothermal process equipment and accessories are usually manufactured from low-alloy steels which offer affordability but increase the susceptibility of the materials to corrosion. Applying erosion-corrosion-resistant coatings to these components could represent an economical solution to the problem. In this work, testing of two newly developed laser metal deposited high-entropy alloy (LMD-HEA) coatings—CoCrFeNiMo_{0.85} and Al_{0.5}CoCrFeNi, applied to carbon and stainless steels—was carried out at the Hellisheidi geothermal power plant. Tests in three different geothermal environments were performed at the Hellisheidi site: wellhead test at 194 °C and 14 bar, erosion test at 198 °C and 15 bar, and aerated test at 90 °C and 1 bar. Post-test microstructural characterization was performed via Scanning Electron Microscope (SEM), Back-Scattered Electrons analysis (BSE), Energy Dispersive X-ray Spectroscopy (EDS), optical microscopy, and optical profilometry

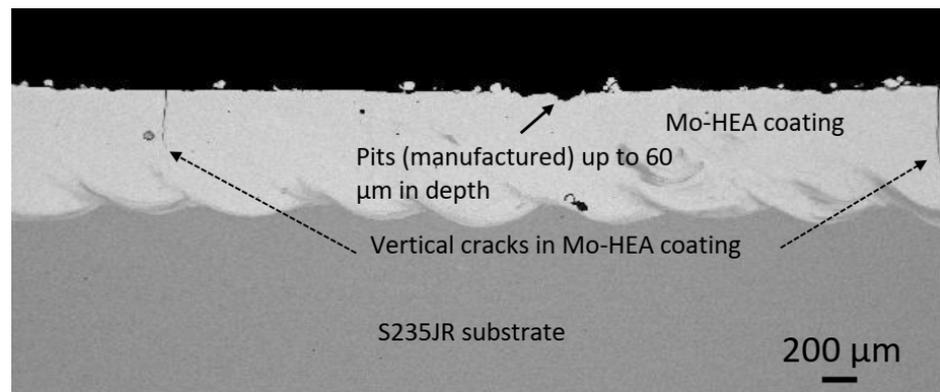
The analysis of the unexposed samples revealed that significant variance was observed in the HEA coating thicknesses, between samples, and within each sample. This variance was mainly due to the coating-substrate profile variance. Manufacturing pits up to 50–60 μm in depth were also observed in the Mo-HEA coatings. The surface profile analysis showed that manufacturing pits were observed on all the unexposed samples, and manufacturing cracks were also observed in the coating of the Mo-MO-HEA-S235JR sample, as can be seen in Figure 2, but no cracks were though observed in the coating in sample Mo-HEA-316L.

Figure 2. Unexposed sample Mo-HEA-S235JR. Vertical cracks were observed in the Mo-HEA coating on substrate S235JR, and variance on the coating surface, in the form of pits, was also observed.

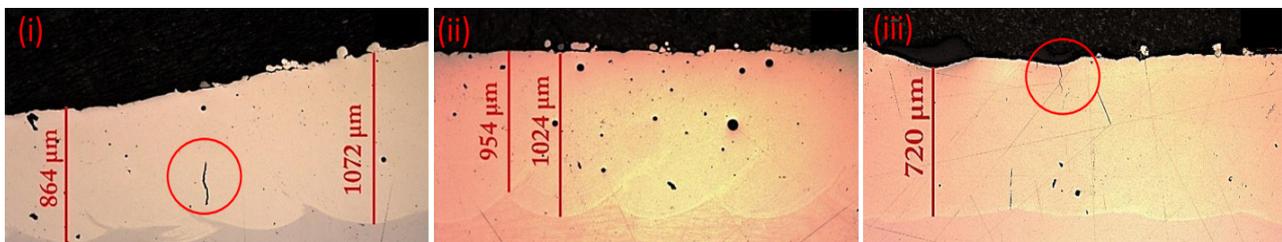
Figure 3. (i) Mo-HEA-S235JR with manufacturing crack in the coating, (ii) Mo-HEA-316L with no crack in the coating, and (iii) Al-HEA-304L samples with crack after the exposure.

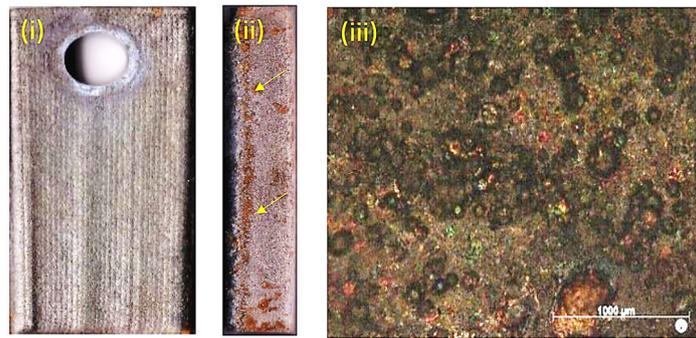
In the testing at the wellhead of HE-23, the Mo-HEA coatings on the carbon steel and stainless steel substrates were not prone to corrosion damage apart from the manufacturing crack damage that was observed on the unexposed samples. A negligible corrosion effect was observed in the Mo-HEA coated samples in the surface analysis, but some curvature was observed in the Mo-HEA-S235JR sample. The curved shape of the sample could be due to the creeping of the sample that resulted from thermal stresses arising from the heating and cooling of the Mo-HEA-S235JR sample during the laser metal deposition of the Mo-HEA powder on the substrate. After the wellhead test, more brownish and reddish iron corrosion products were observed at the interface of the Mo-HEA coating and the carbon steel S235JR substrate in comparison with other locations on the substrate. The iron-based corrosion products formation could have formed during the test but may have also have formed after the test when wet samples were removed from the test chamber and exposed to the ambient atmosphere for a short period before drying and storage of the sample. The increased iron-based corrosion product formation on the Mo-HEA coating and the carbon steel, S235JR, substrate may also have been induced by the galvanic effect, i.e., the increased oxidizing effect of the noble Mo-HEA coating on the carbon steel substrate when the sample was wet, removed from the test chamber, and exposed to the ambient atmosphere. The iron-based corrosion products formed at the Mo-HEA coating and S235JR substrate in the curved sample can be viewed in Figure 4.

Figure 4. Mo-HEA-S235JR sample after the exposure in the wellhead test: (i) front face with negligible erosion damage observed, (ii) cross-section of the sample showing curvature and iron-based corrosion products in the coating-substrate interface, and (iii) magnified surface of the front face showing sphere-like unfused Mo-HEA powder on the surface.

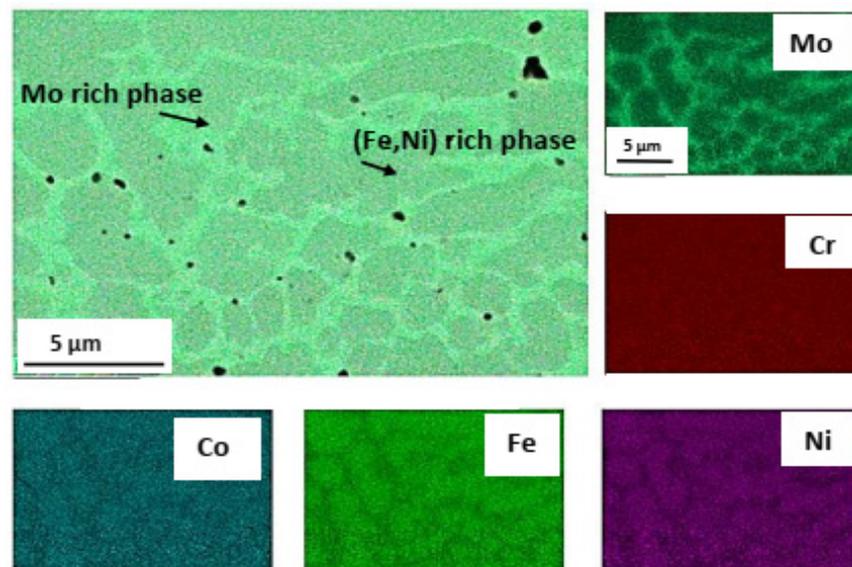
Figure 5. Pores (entrapped gas bubbles) were preferably observed in the Mo-rich phase in the Mo-HEA coating.

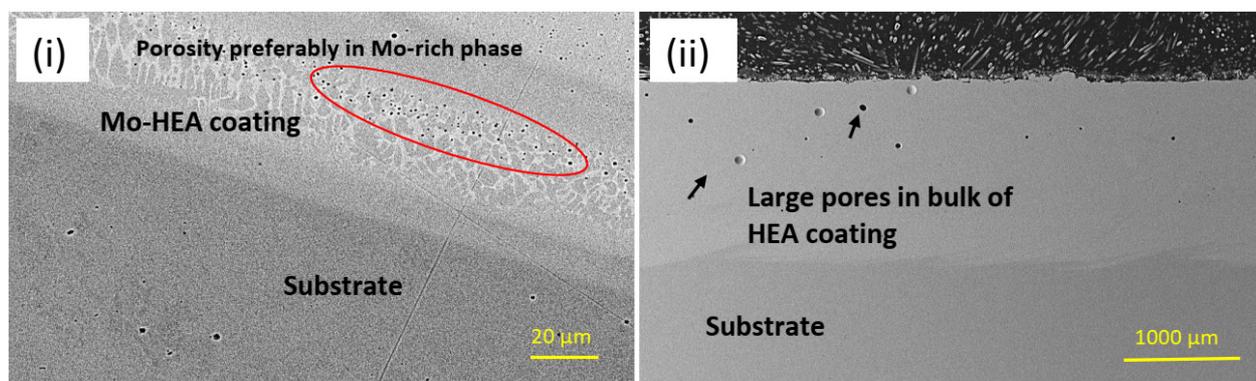
Porosity appears to be localized in the bulk of the coating, but smaller pores were observed in the area closer to the substrate, as seen in Figure 6.

Figure 6. (i) A high number of pores was observed in the Mo-HEA coating at the substrate but (ii) at a lower frequency and larger volumes in the bulk coating and closer to the surface.

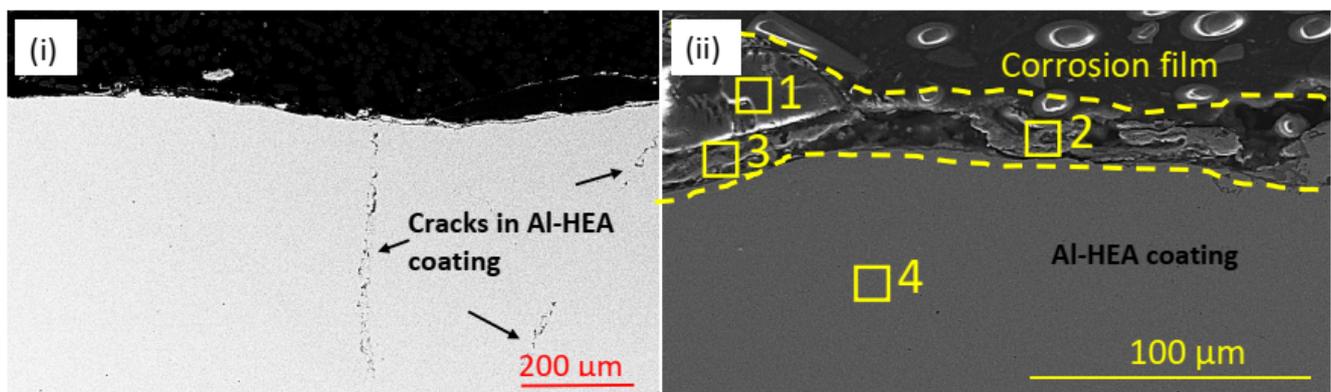
The Al-HEA coating was prone to corrosion damage in the wellhead test in addition to the manufacturing cracks in the coating. Oxide-rich corrosion film in the thickness range 20–40 µm was observed on the surface as seen in Figure 8 and Table 4, indicating that the oxidation could be due to a reaction with oxygen-containing molecules in the geothermal fluid. Some sulfide-based corrosion products were also detected in the corrosion film.

Figure 8. (i) Manufacturing cracks and (ii) oxide-rich corrosion products (and some sulfides) on the surface on the exposed in the Al-HEA coating in sample Al-HEA-304L in the wellhead test.

Location	Element (wt.%)										
	O	Na	Al	Si	S	Cr	Ca	Cr	Fe	Co	Ni
1	46.0	-	52.7	-	-	-	0.2	1.1	-	-	-
2	2.6	-	4.3	-	2.1	-	-	12.5	33.3	18.6	26.7
3	9.8	1.3	4.6	0.3	5.7	-	-	14.7	26.8	16.2	20.7
4	-	-	3.1	-	-	-	-	15.2	37.6	19.1	24.9

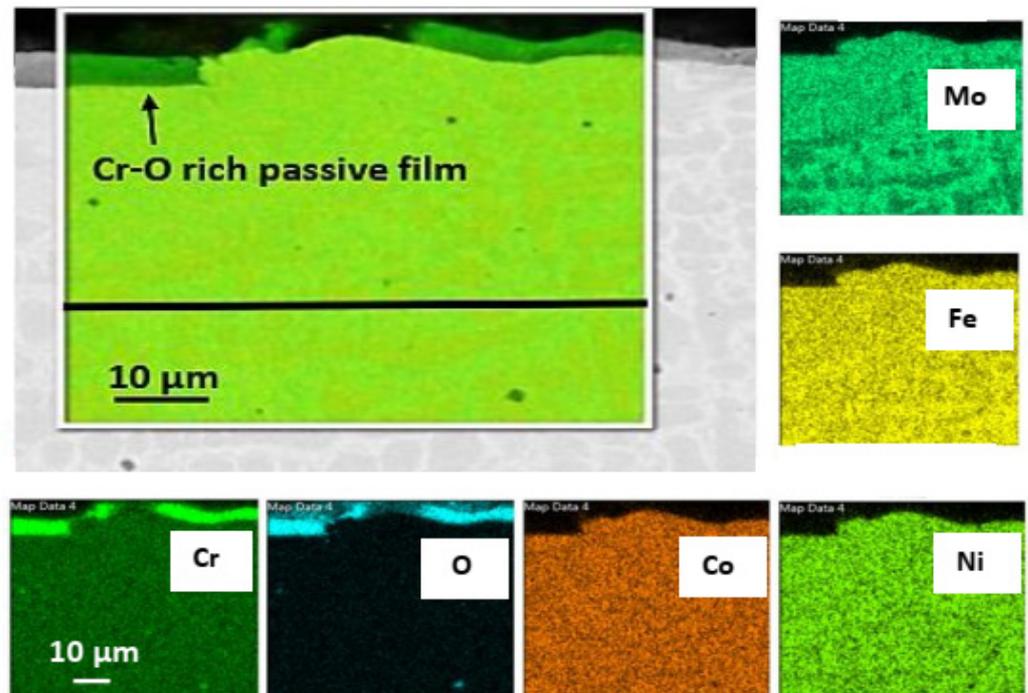
For the Mo-HEA coating on the 235JR and 316L substrates, no corrosion damage was observed after the exposure in the aerated testing. It was, however, observed that the Mo-HEA coating had formed a partial, Cr-O rich, passive layer on the surface as seen in Figure 9.

Figure 9. Elemental mapping of the Mo-HEA coating showing the extent of the discontinuous passive film formed on the coating.

The oxide passive film resulted from the exposure to the oxygen in the aerated fluid, but to some surprise, the Cr-O film was always discontinuous on the surface and did not cover the whole surface of the Mo-HEA coating. The reason for the discontinuous oxide layer on the surface is not fully understood, but one explanation is that Cr concentration gradients that are present in the bulk coating near the surface and sluggish diffusion rate of Cr from the high entropy material to the surface could result in slow oxide layer formation in some locations. Hence, a propagating growth of the oxide film to become more continuous on the surface could be attained by longer exposure periods in the aerated fluid, but this should be verified with longer exposure periods. Another explanation could be that the oxide film was at some point continuous, but the oxide film is brittle, and some parts of it flaked off and were removed by the fluid during the exposure.

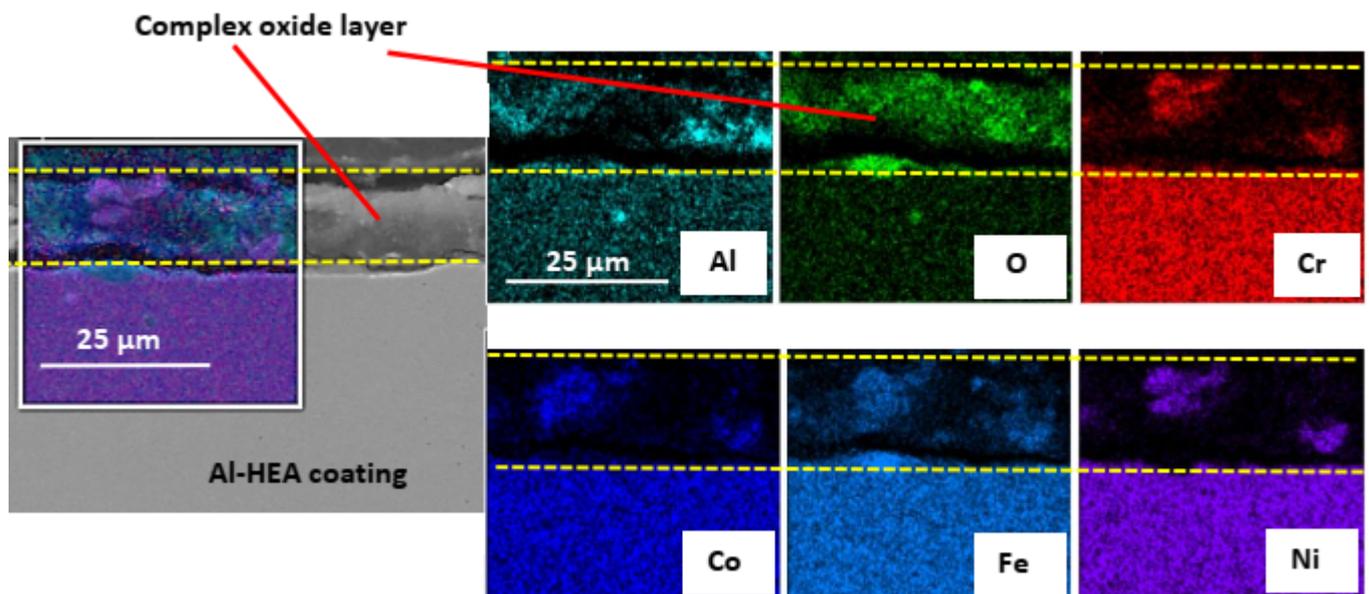
The oxide layer formed on the Al-HEA coating had different composition and structure in comparison with the Mo-HEA oxide layer after the aerated test. The oxide layer on Al-HEA coating was found to have more corrosion damage characteristics rather than passive layer behavior, i.e., not with compact structure. The Al-HEA oxide layer was in some cases detached from the bulk material, and the layer was composed of oxides from all the elements in the HEA as seen in Figure 10.

Figure 10. In some cases, the complex oxide coatings formed on the Al-HEA coating surface was continuous after the exposure to the aerated fluid.

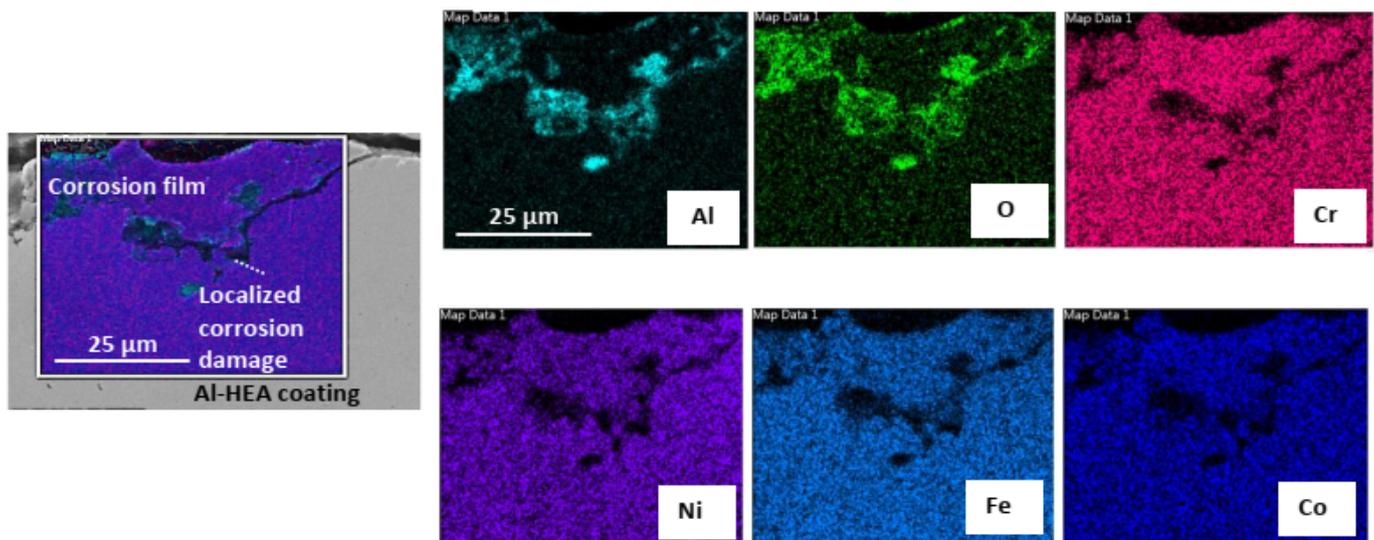
In addition, localized corrosion damage enriched in Al-O was also observed on the surface of the Al-HEA coating in locations where the complex oxide film had not formed to a significant extent as seen in Figure 11. Localized oxide corrosion forms were observed in the aerated test but not in the wellhead test.

Figure 11. Elemental mapping of localized corrosion damage observed on the surface of exposed AL-HEA coating in the aerated test.

The Al-O-rich localized damage might suggest that the oxidation of Al has faster kinetics than the oxidation of the other elements. This localized corrosion behavior also strengthens the assumption that the complex oxide film is not passive. Cracks were also observed in the Al-HEA coating in the sample Al-HEA-304L after the exposure in the aerated environment as seen in Figure 12.

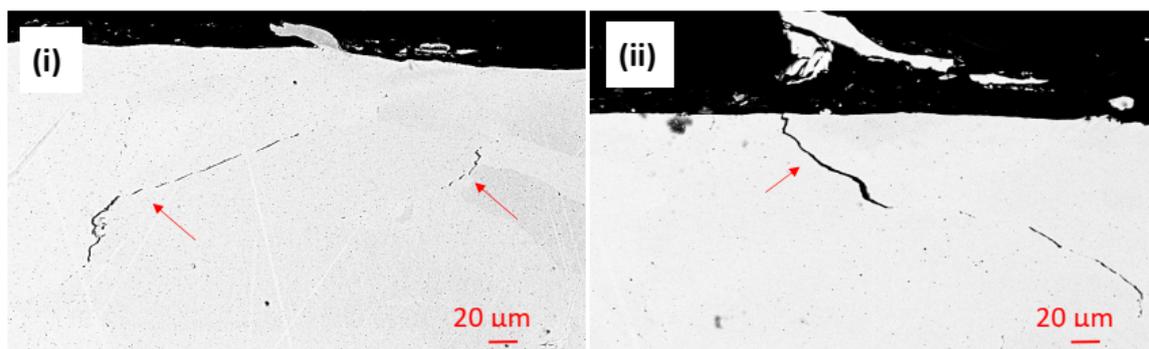
It was noted that the shape and appearance of the cracks in the aerated testing were more curved and thinner in comparison with the cracks observed in the Al-HEA coating after the exposure in the wellhead test. The effect of a difference in temperature in the aerated and the wellhead, and hence the extent of thermal stresses, could explain to some extent this variance in cracking behavior. However, no corrosion products were observed in the cracks in the Al-HEA coating, and hence the cracking was concluded to have formed due to internal stresses in the coating.

Figure 12. Cracks were observed in (i) the bulk and (ii) at the surface of the Al-HEA coating in the aerated testing.

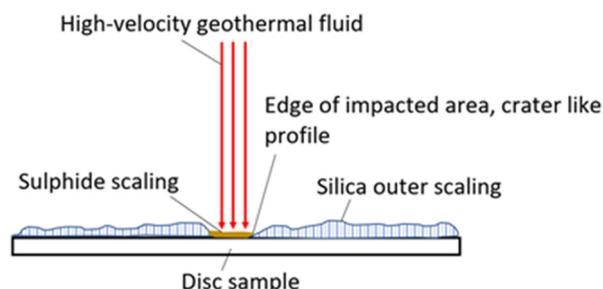
Due to the large extent of scaling and material deposition on the samples after the exposure, the surface roughness measurements were only an indicator of the scaling/precipitation landscape rather than on the extent of erosion of the HEA coatings. As a result, the surface roughness measurements were inconclusive in our analysis. In the erosion test, the high-velocity fluid hit the HEA coatings deposited on a substrate test plate. Generally, the impacted area (where high-velocity fluid hit the surface) was covered with sulfide scaling, but outside of the impacted area, silica scaling was more profound, as exhibited in Figure 13.

Figure 13. The most common scaling (inner sulfide and outer silica scaling) profile on samples after exposure in erosion testing.

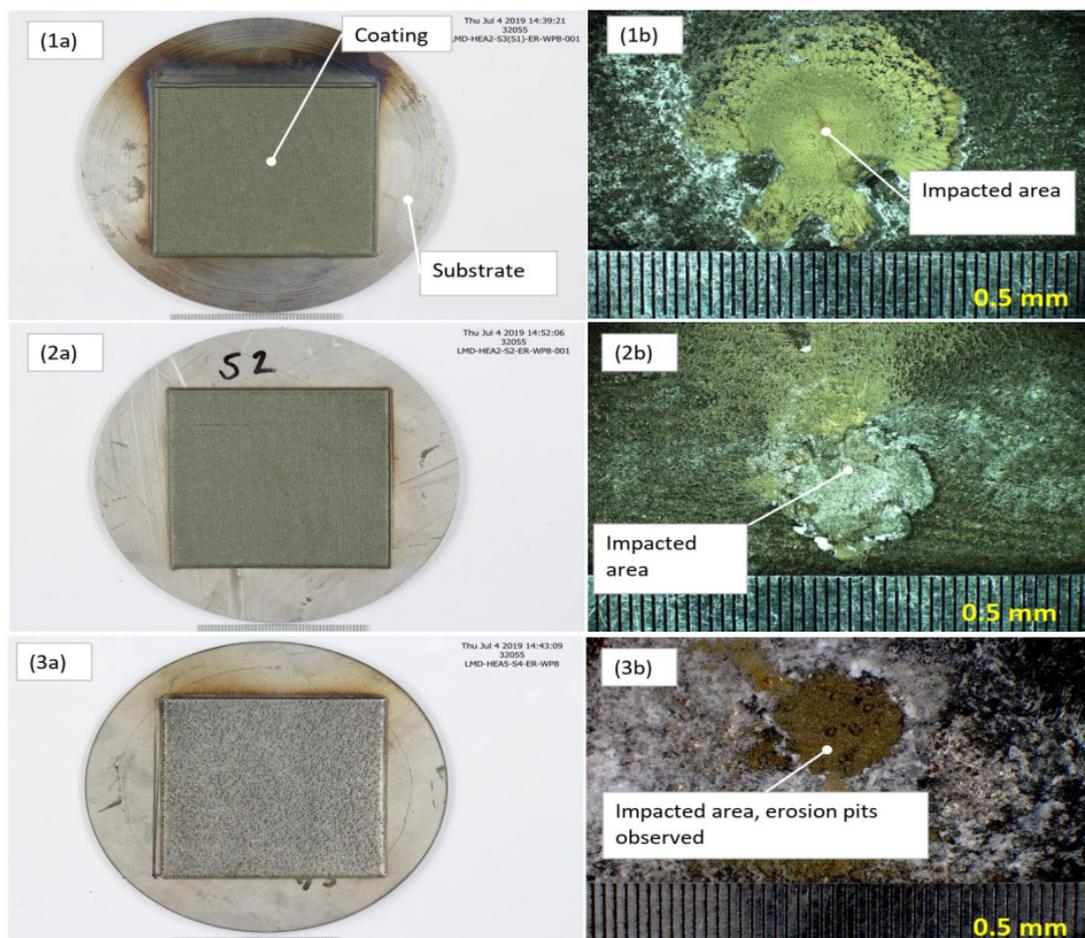
After the erosion test exposure, the samples were covered with sulfide and silica scaling. No evident erosion effect was observed on the samples at low magnification in the stereoscope/microscope, but erosion pits could though be observed in the Al-HEA coating, as seen in Figure 14.

Figure 14. Erosion disc test samples. (1a) Mo-HEA-S235JR test plate before exposure and (1b) the impacted area after exposure. (2a) Mo-HEA-316L test plate before exposure and (2b) the impacted area after exposure. (3a) Al-HEA-304L test plate before exposure and (3b) the impacted area after exposure.

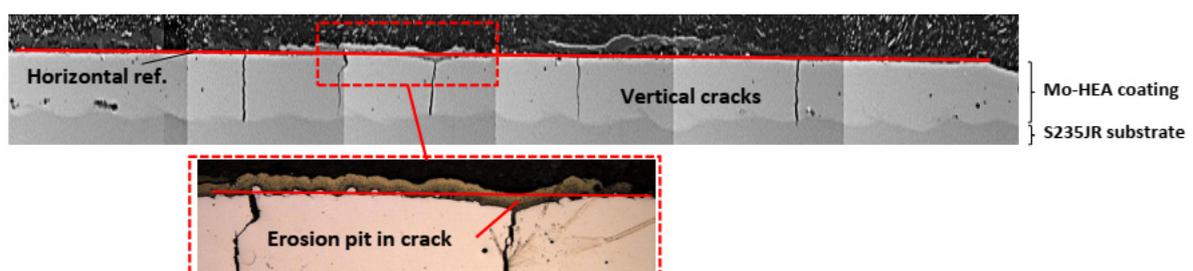
The results of the corrosion performance of the Mo-HEA coatings in the erosion testing were in good agreement with the results from the wellhead and aerated testing; i.e., the Mo-HEA coating was not prone to electrochemical corrosion. In the erosion test, however, the Mo-HEA coating was prone to erosion damage in one vertical crack at the surface, as can be seen in Figure 15.

Figure 15. The surface profile of Mo-HEA coating in the Mo-HEA-S235JR sample after the exposure in the erosion testing. The erosion pit was concluded to have formed in one of the vertical cracks in the Mo-HEA coating.

Because the erosion pit (no pit observed in the unexposed sample) was observed in the center of a vertical crack in the Mo-HEA coating, it was concluded that the crack had induced some turbulence flow of the fluid when it hit the surface of the crack and hence increased the erosion effect of the fluid, resulting in the formation of a significant erosion pit in the crack. Detailed analysis of the erosion pit in the crack showed that sulfide and silica scaling, but no corrosion products, were in the crack. The sulfide content in our analysis was associated with high Fe and Cu content in the scaling. The smooth surface on erosion pits also implies that erosion occurred on the surface on the vertical crack as seen in Figure 16i and Table 5.

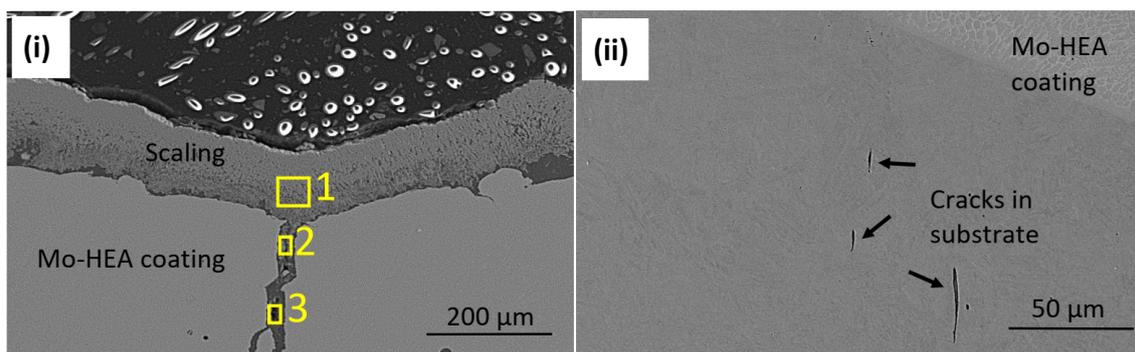
Figure 16. (i) Analysis of scaling/deposits in the eroded crater area and (ii) vertical microcracks were observed in the carbon steel substrate, at the coating interface, in the MO-HEA-S235JR sample.

Location	Element (wt%)										
	O	Na	Al	Si	S	K	Ca	Cr	Fe	Cu	Ag
1	19.3	0.9	2.3	10.6	22.2	0.8	0.5		21.3	21.2	1.1
2	11.5	-	1.3	5.8	27.7	0.5	0.3	0.3	28.3	22.4	2.1
3	51.3	2.6	7.6	33.5	-	2.9	1.7	0.2	0.3	-	-

In the Mo-HEA-S235JR sample, some vertical microcracks (Figure 16ii) were observed in the S235JR substrate at the Mo-HEA coating and S235JR interface that likely formed during the LMD process i.e., manufacturing. The difference in thermal expansion properties and hence thermal stresses arising in the cooling after the LMD process could explain the vertical microcracks in the S235JR substrate to some extent.

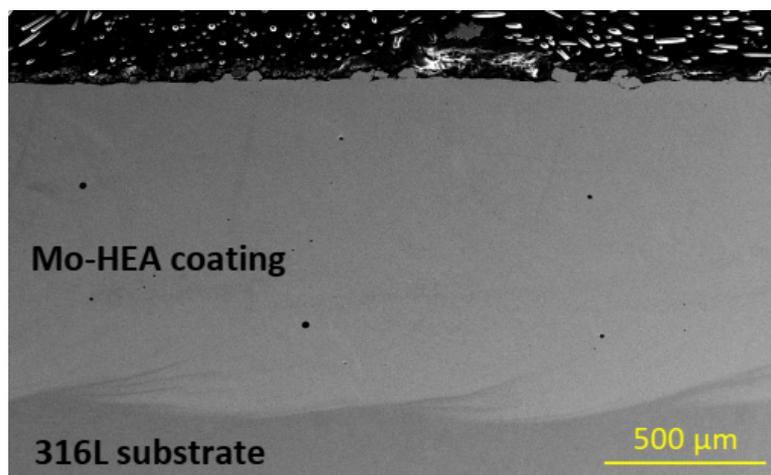
The Mo-HEA coating in the Mo-HEA-316L sample was not prone to any cracking in the erosion testing, as can be seen in Figure 17. This result implies that the stainless steel substrate is more compatible with the Mo-HEA coating in regard to the laser metal deposition method. The Mo-HEA coating was not susceptible to any corrosion damage in the test, which shows that the Mo-HEA coating has good erosion resistance when no cracking is inducing the erosion effect on the surface as concluded from the erosion observed in Mo-HEA coating on a carbon steel substrate.

Figure 17. No cracking or erosion damage was observed in the Mo-HEA-316L sample in the erosion testing.

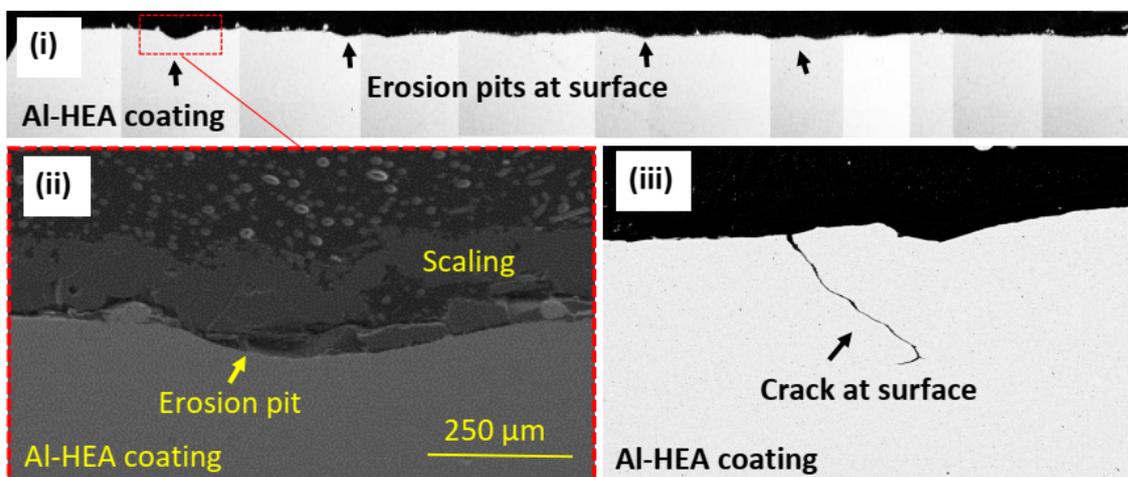
Cracking of the Al-HEA coating was, however, observed in the Al-HEA-304L sample in the erosion testing. The erosion-corrosion effect was evident in the impacted area, and

the extent of erosion on the Al-HEA-304L sample could be observed on a large area in the surface profile, a couple of erosion pits with significant depth and smooth erosive shape were observed on the Al-HEA coating, as seen in Figure 18.

Figure 18. (i) Surface profile (BSE image) of exposed Al-HEA-304L sample with erosion pits at the surface, (ii) one erosion pit at high magnification (SEM image), and (iii) crack observed eroded in Al-HEA coating (BSE image) at the surface.

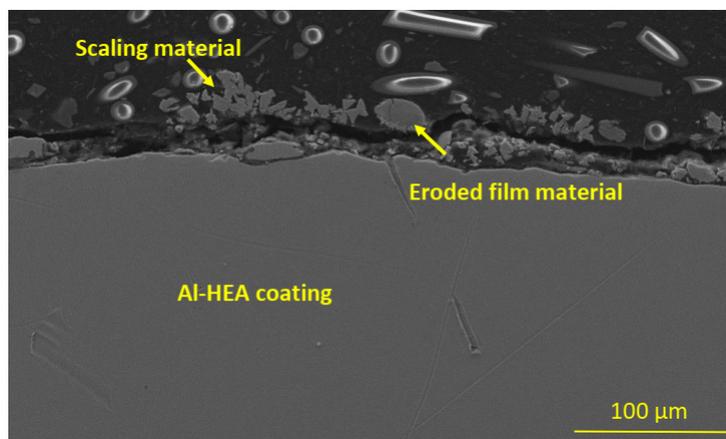
The erosion-corrosion damage in the Al-HEA coating was also observed by the detached, eroded material residuals on the surface, among the scaling and deposited material from the geothermal fluid, as can be seen in Figure 19. This observation further strengthens the conclusion that Al-HEA is prone to erosion in the testing environment.

Figure 19. Eroded, detached Al-HEA material was observed at the surface in the sample AL-HEA-SS in the erosion test.
