Influence of the Thermal Cutting Process on Cracking of Pearlitic Steels

Abstract: The paper presents research results of the influence of heat input into high carbon rail steel during cutting processes on microstructure transformation and cracking. The massive block of steel prepared for rail rolling processes was cut and examined by nondestructive magnetic testing and destructive testing by microscopic examination and hardness measurements. The results show unfavorable microstructure changes where pearlite and transformed ledeburite were obtained. The effects of the presence of such microstructures are high hardness near to cutting surfaces (above 800 HV) and microcracks which grow into low hardness block cores during rolling and rail shaping.

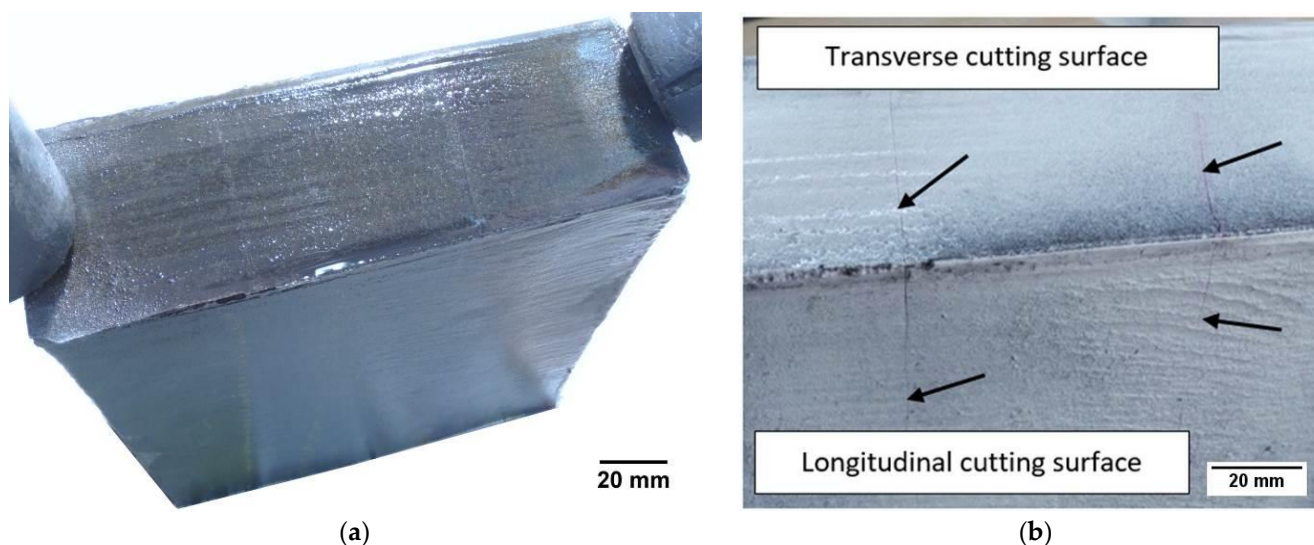
For the tests, a rod with dimensions of 260 mm × 200 mm × 55 mm after thermal cutting with an acetylene-oxygen burner was used. The automatic Eckert cutting machine with gas torch with A-MD nozzle (Eckert AS, Legnica, Poland) was used to cut the workpiece. Cutting process was carried out with the following process parameters: diameter of a gas nozzle 6 mm, gas flow 600 dm³/min, oxygen pressure 300 kPa, cutting speed 140 mm/min. A general view of the cut rod is presented in Figure 1a. The chemical composition of the tested steel is given in Table 1. Magnetic particle tests were performed on the cut rod. The results of the magnetic particle tests showed the cutting surfaces with cracks (Figure 1b).

Figure 1. General view of the cut rod after: (a) cutting, (b) painting with primer paint and magnetic particle test.

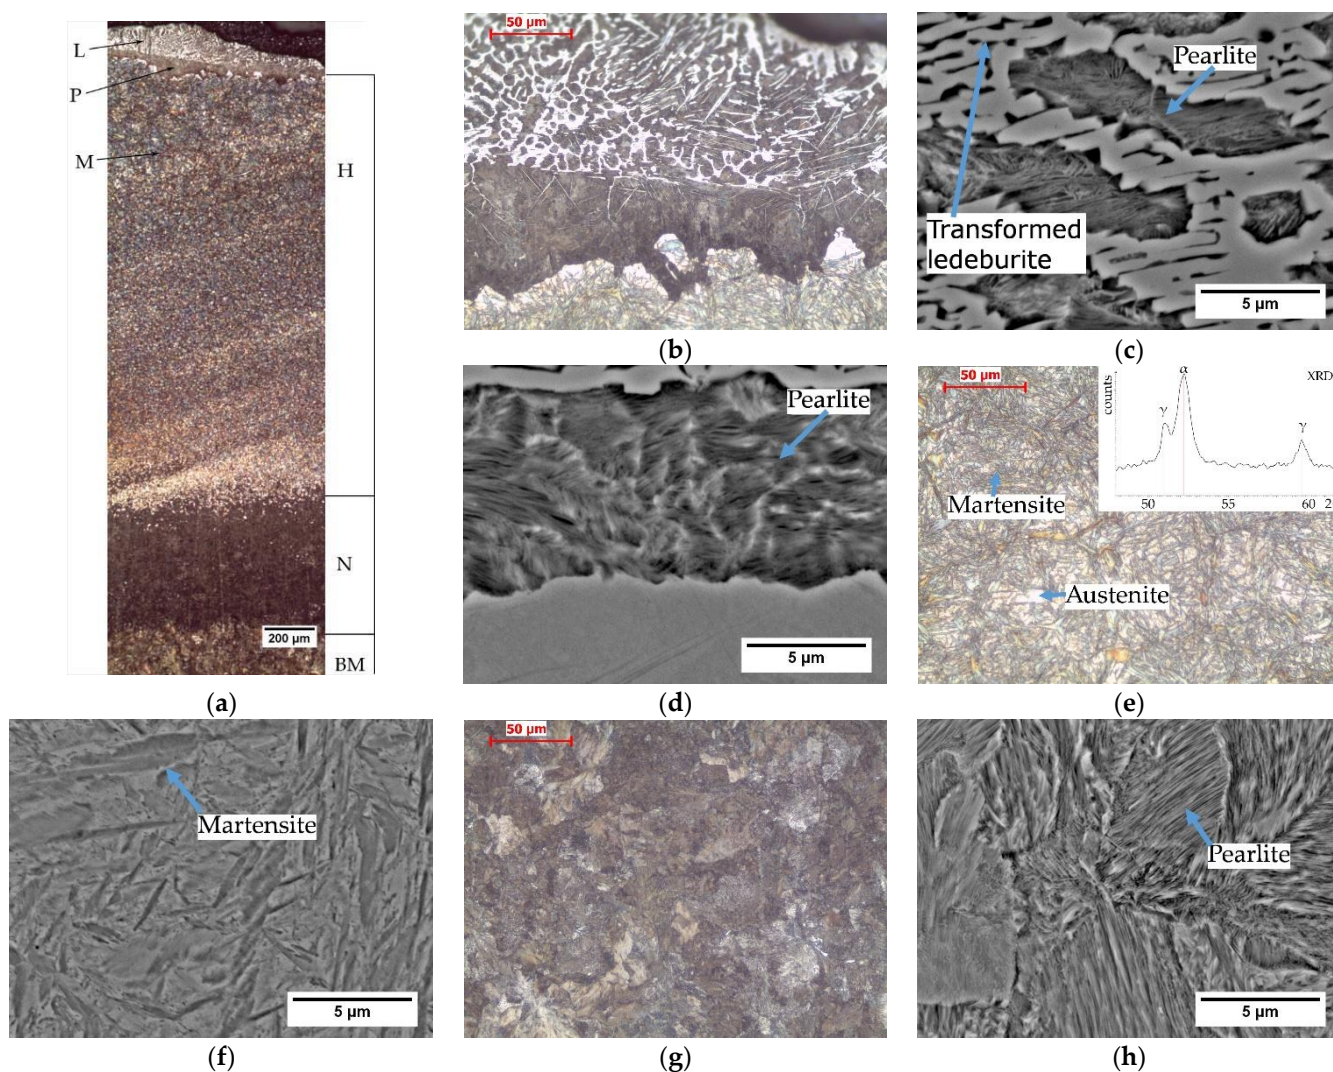
The microstructure analysis revealed the presence of a heat affected zone (HAZ) under the cutting surface. Figure 2a shows the HAZ microstructure with marked areas of hardening, normalization and the pearlitic microstructure of the base material that was not transformed during cutting.

A characteristic feature of the structure after thermal flame cutting is the presence of a layer of liquid metal with a structure containing transformed ledeburite, pearlite and secondary cementite (Figure 2b). Under the solidified metal layer, there is a dark unhardened zone with the structure of fine pearlite and secondary cementite, and then the hardened area. The presence of pearlite under the solidified metal layer is the result of a lower cooling rate of the surface layer compared to the deeper layers. The influence of heat release on the cooling rate was observed in several experiments [15,21]. The lower cooling rate is caused by the heat release in the process of solidifying the layer of nonremoved liquid and thus lowering the cooling rate of the steel under the solidified layer. The presence of cementite is the result of carbon diffusion into the steel surface layer. Further away, the cooling rate is high due to the high rate of heat dissipation to the cool material. A similar tendency was observed after the thermal cutting of S355 steel [15,21]. The further area of the material heated in the cutting process to the temperature lower than A_{c1} has a pearlitic microstructure (Figure 2g,h). The base material has a pearlitic microstructure. There is no difference between the base metal microstructure and the pearlitic microstructure of the material heated in the cutting process to the temperature lower than A_{c1} .

The microstructure of the hardened zone consists of martensite and a large amount of residual austenite (Figure 2e,f). The presence of austenite was confirmed by XRD (top right inset in Figure 2e). In the segregation bands with a reduced carbon and manganese content, pearlite appears at the grain boundaries. The hardened area is approx. 3 mm thick. Hardness measurements by the Vickers method showed that the hardness of the hardened layer is very high and exceeds 800 HV10 (Figure 3). It lowers as it moves away from the cut surface. Similar hardness profiles were obtained when cutting S345, S390, S700MC, S690QL steels [22,23].

Figure 2. Microstructure at the cut surface: (a) general view (H—hardened zone, N—normalization zone, BM—base material, L— transformed ledeburite + pearlite + secondary cementite, P—pearlite with secondary cementite, M—martensite with austenite); (b) detail view near cut surface; (c) transformed ledeburite (486 HV0.01), pearlite (222 HV0.01) and secondary cementite (605 HV0.01); (d) pearlite with secondary cementite (375 HV0.01), (e,f) martensite with austenite (820 HV0.01) and XRD pattern in top right inset; (g,h) pearlitic microstructure of the material heated in the cutting process to a temperature lower than A_{c1} —base material (227 HV0.01).

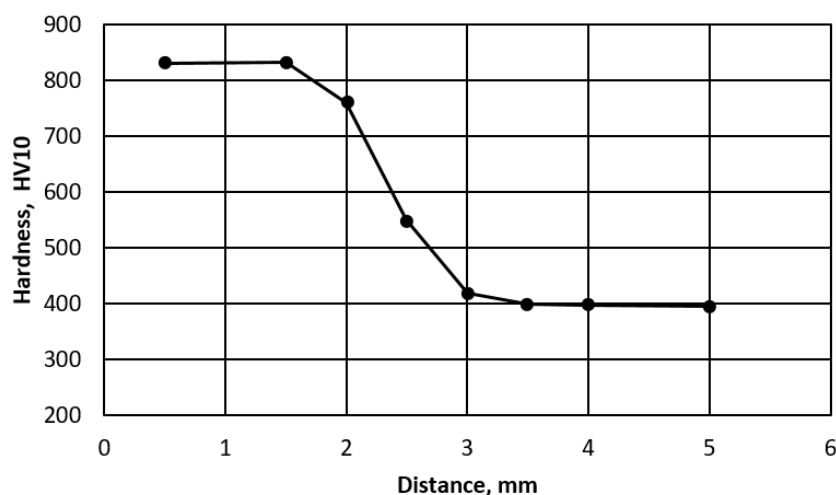
Figure 3. Hardness distribution from the cutting surface.

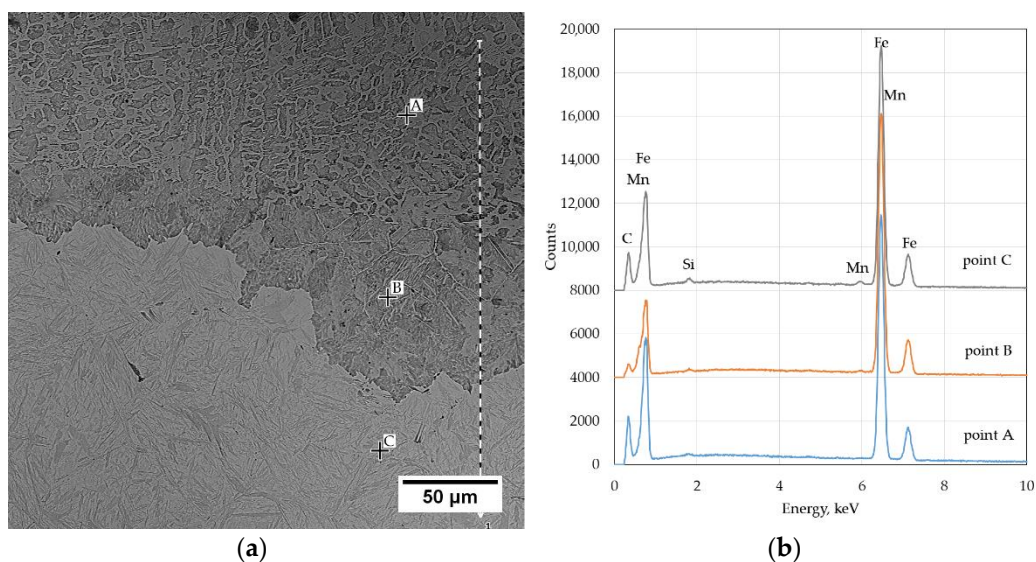
approx. 3.2% (area A in Figure 4) calculated on the basis of equation (1) [20]. The data of the volume fraction of the phases used during calculations was: 59% pearlite and 41% cementite. In the nonmolten metal layer under the solidified liquid layer, the carbon content is about 1.2% (93% of pearlite and 7% of cementite) (area B in Figure 4). In the base material, the calculated carbon content was 0.77 and was close to the average carbon content in steel. The quantitative evaluation of the cementite content showed that the solidified liquid is highly carburized.

Figure 4. The results of the microanalysis of the chemical composition in the areas A, B, and C, performed on a SEM-EDS: (a) microstructure; (b) SEM-EDS results

The Si content at the cutting surface is 0.14% and Mn 0.3% (Table 2). This area is depleted in Si and Mn in relation to the average steel composition. A reduction in the Si content by about 70% and Mn by about 74% was observed. As you move away from

the cutting surface, the content of Mn and Si increases. At a distance of 0.3 mm from the surface, it is 0.18% Si and 0.65% Mn. In the area of martensite with retained austenite, it amounts to 0.45% Si and 1.28% Mn on average, and is close to the average Si and Mn content in steel.

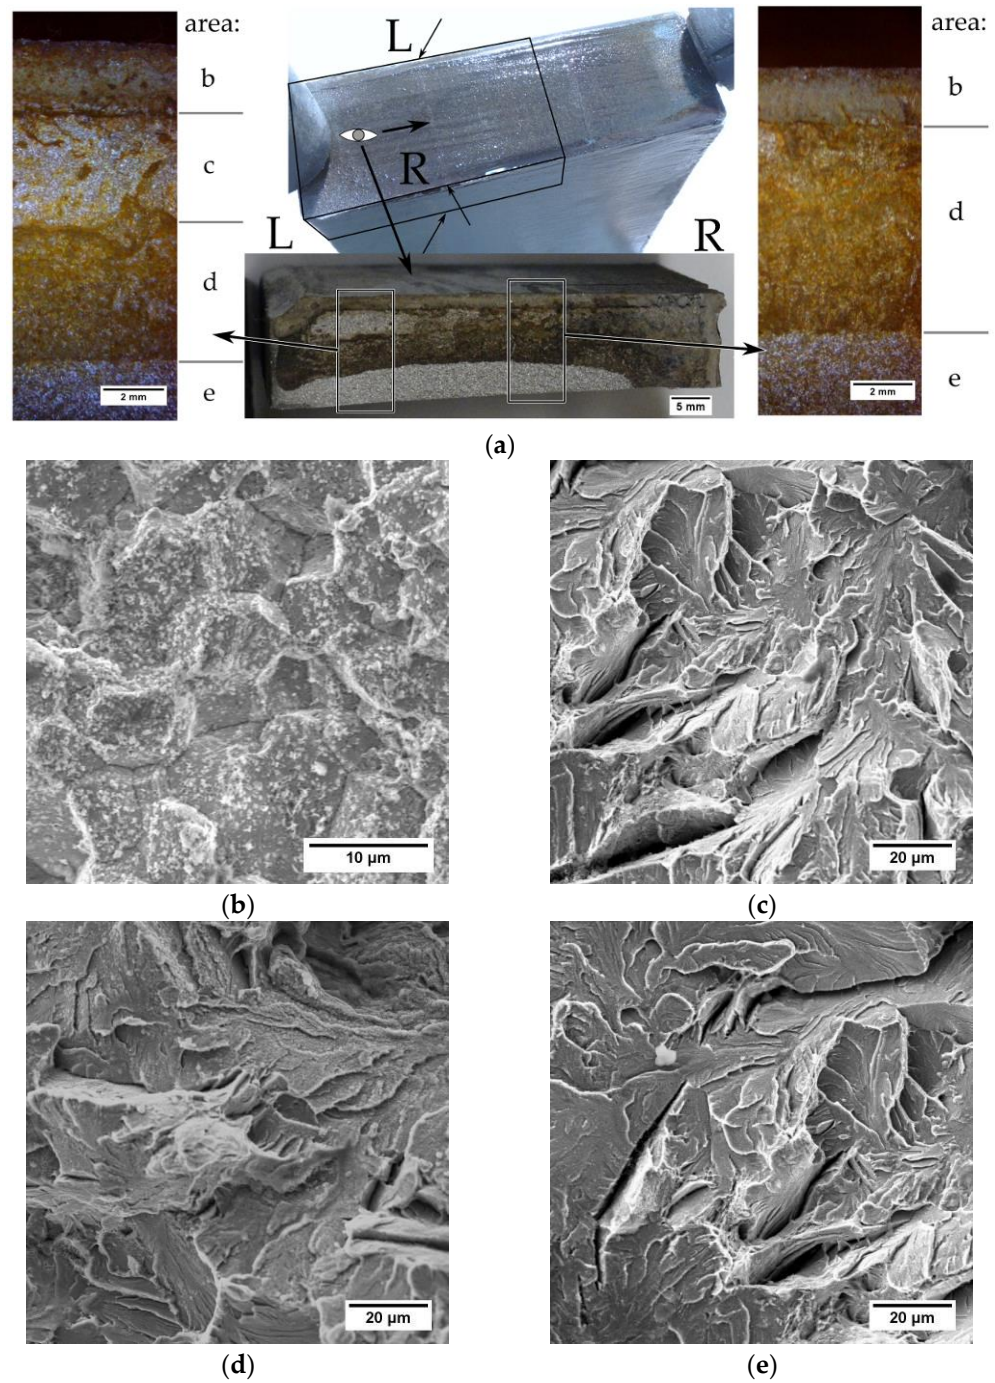
To determine the type of the cracks, the sample was broken from the side of the transverse cut. The analysis of the fracture surface after the sample fracture (Figure 5a, R side) showed that in the area near the surface there is a corroded intercrystalline fracture layer (area b). Under this layer, there is a transcrystalline corroded fracture area (area d). The area of breaking is brittle, transcrystalline and shows no signs of corrosion (area e). A small area of the brittle transcrystalline fracture (area c) was observed near the sheet surface. Fractographic analysis showed no signs of corrosion in this area, indicating that there was no crack (prior to the intended breaking). This area was created in the process of breaking the sample. The atypical appearance of the fracture surface (Figure 5a, L side) indicates that the fracture did not start on the surface in the hardened zone but under the hardened zone in the pearlitic structure. The resulting crack developed towards the inside of the bar and towards the hardened surface. The presence of an unoxidized atypical area (area c) near the sheet surface indicates that a crack could not have formed on the cut surface in the hardened area. Analyzing the L side in Figure 5a, it can be observed that it is not possible for a crack to arise in the hardened layer, stopped its developing and continued to nucleate at a distance from the cut surface.

Figure 5. The appearance of cracks in the sample cut transversely: (a) general view; (b) brittle intercrystalline fracture in the hardened (oxidized) area; (c) transcrystalline brittle fracture in the pearlitic region (not oxidized); (d) transcrystalline fracture with visible corrosion products; (e) sample fracture area (not oxidized).

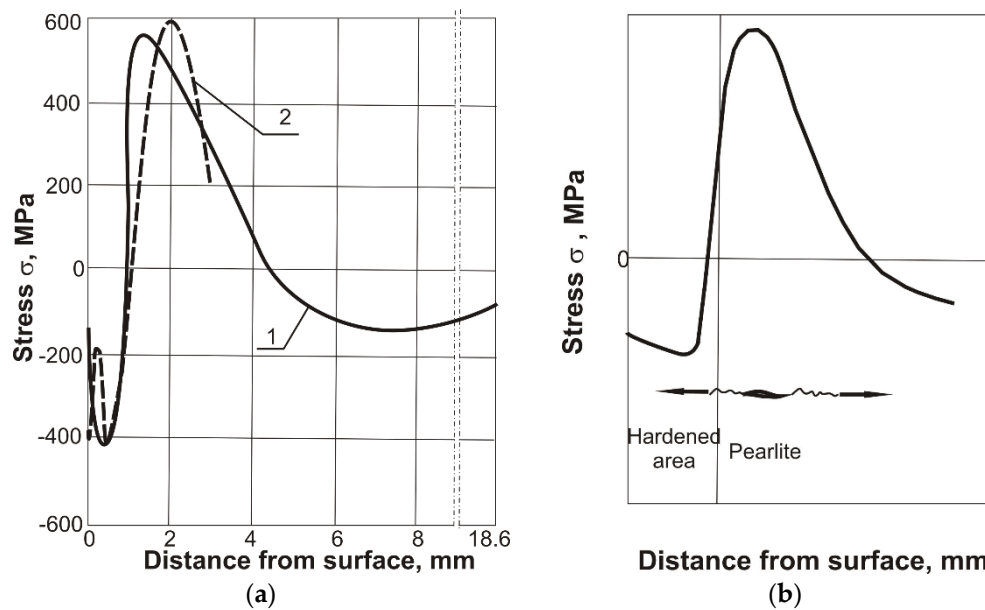
The cracking mechanism in the thermal cutting process can be explained by analyzing the stress distribution. Heating to high temperature in the cutting process causes the near-surface zone to become hardened during the rapid cooling of the material. Compressive stresses occur in the hardened zone due to the phase transitions (Figure 6a) [19,26–29]. Based on the conducted research, it is possible to present the mechanism of steel cracking in the thermal cutting process. Under the hardened layer with a martensitic structure, there is an area of pearlite with maximum tensile stresses. Due to the high brittleness of the pearlite, transcrystalline brittle cracks appear in this region. Figure 6b shows a possible diagram of the development of cracks after thermal cutting. The cracks appear under the hardened layer in the area of maximum tensile stresses and during further cooling they spread both to the hardened surface and to the deeper areas of the base material.

Figure 6. (a) Distributions of circumferential residual stresses in induction hardened 41Cr4 specimen to a depth of 2.3 mm (1) based on [26] and in cutting edge of 40 mm wear-resistant steel plate (2) based on [19]; (b) scheme of crack development under the thermally cutting surface.

Due to its high C content, R260 steel has a high hardness with a surface of over 800 HV. Steels with such a high carbon content are difficult to cut. Therefore, the cutting process should be carried out on preheated bars. To minimize the possibility of cracks appearing after the cutting process, very slow cooling should be used. This will reduce the temperature gradient and stress state below the surface and prevent the excessive hardening of the surface layer.
