Case Report

The Oxinium Arthrogram: A Sign of Oxidized Zirconium Implant Failure

Benjamin M. Frye, MD^{*}, Kelsey R. Laughery, PA-C, Adam E. Klein, MD

Department of Orthopaedics, West Virginia University, Morgantown, WV, USA

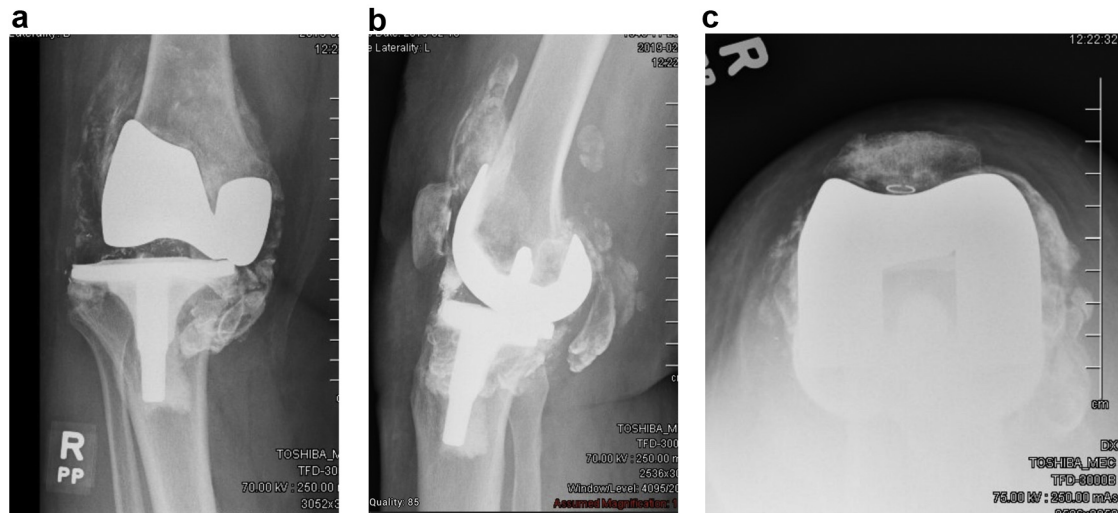
Figure 1. Anteroposterior (a), lateral (b), and sunrise (c) radiographs of a failed oxidized zirconium TKA with resultant Oxinium “arthrogram.”

Radiographs demonstrated a cemented TKA with complete wear-through of the tibial polyethylene on the medial side of the knee with grooving of the medial femoral condyle and medial subluxation of the femur on the tibia (Fig. 1). The resultant wear had deposited debris in the synovial lining of the joint which

appeared radiographically similar to that of an arthrogram. These synovial deposits were radiographically visible throughout the knee joint, into the suprapatella pouch and the posterior recess of the knee. The femoral component appeared to be well-sized and well-aligned, with no signs of loosening. The tibial component appeared well-sized without signs of loosening; however, it appeared to be in excessive varus. Inflammatory markers revealed an erythrocyte sedimentation rate of 8 mm/h (0–15 mm/h) and C-reactive protein of 10.7 mg/L (0–10 mg/L). Operative records confirmed the use of an Oxinium Legion femoral component (Smith and Nephew, Memphis, TN).

Prosthetic joint infection was deemed unlikely, and her indications for revision surgery were catastrophic wear-through of the polyethylene likely from varus malposition of the tibial component resulting in overall varus malalignment of the entire leg. This malalignment led to increased forces and shear through

the medial side of the polyethylene. The resultant arthrogram findings on the radiograph were due to wear and grooving of the oxidized zirconium femoral component against the titanium tibial baseplate.

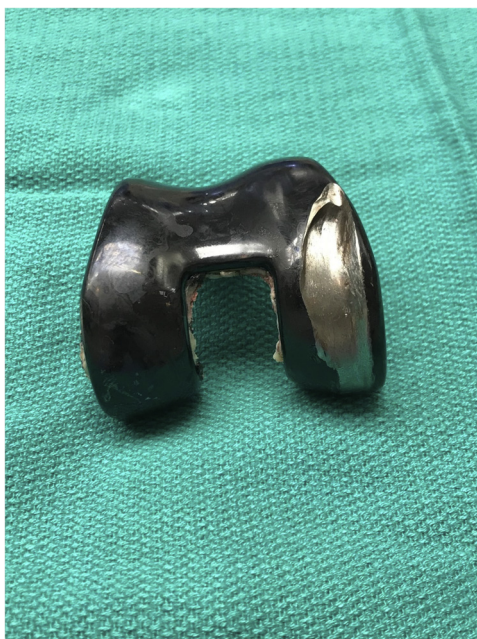
Figure 2. Retrieved femoral component with visible wear, grooving, and exposed underlying zirconium substrate.

At the time of revision surgery, the synovial lining of the knee was completely stained black which corresponded to the areas visible on the arthrogram. The femoral component had a large groove worn into the medial condyle which was deep enough to expose a silver metallic appearance, different than the typical black color of Oxinium (Fig. 2). The tibial polyethylene was completely worn-through medially (Fig. 3). The tibial baseplate had minimal thinning of the peripheral locking mechanism but was also stained black so much so that an imprint of “XLPE” from the backside of the polyethylene was visible (Fig. 4). A complete synovectomy was

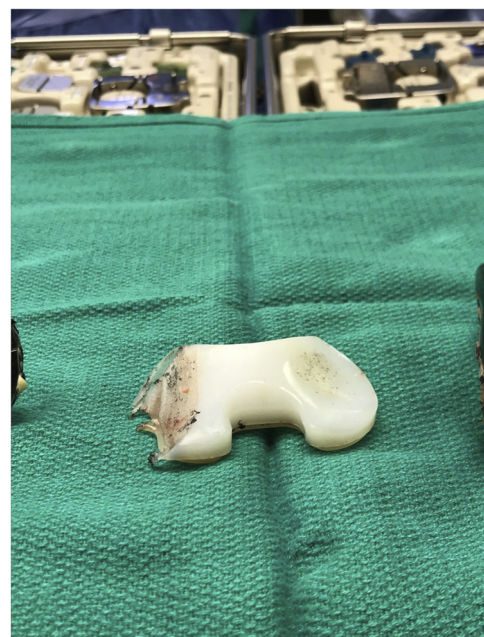
Figure 3. Retrieved polyethylene with evidence of complete wear-through medially.

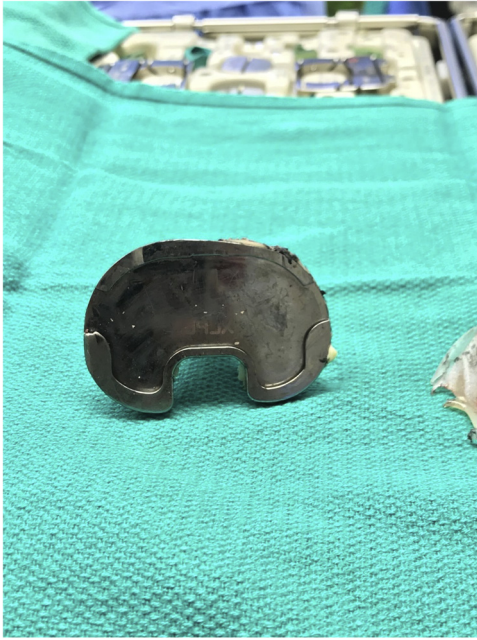
Figure 4. Retrieved tibial component with black staining from oxidized zirconium debris.

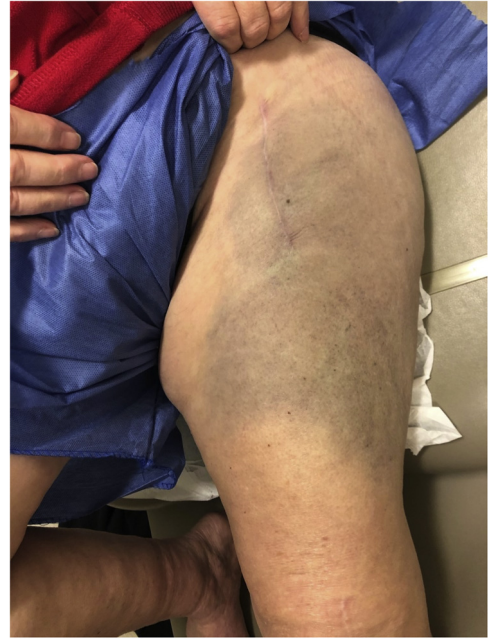
Figure 6. Clinical photograph showing dark skin discoloration in a patient with a failed oxidized zirconium THA with polyethylene liner dissociation.

Physical examination showed a well-healed incision from a direct anterior approach surgery without redness or drainage. However, there appeared to be dark discoloration of the entire lateral thigh (Fig. 6). The patient was able to ambulate with a walker and perform a single leg stance on the operative leg. Range of motion of the hip, however, was limited because of pain and significant grinding and popping.

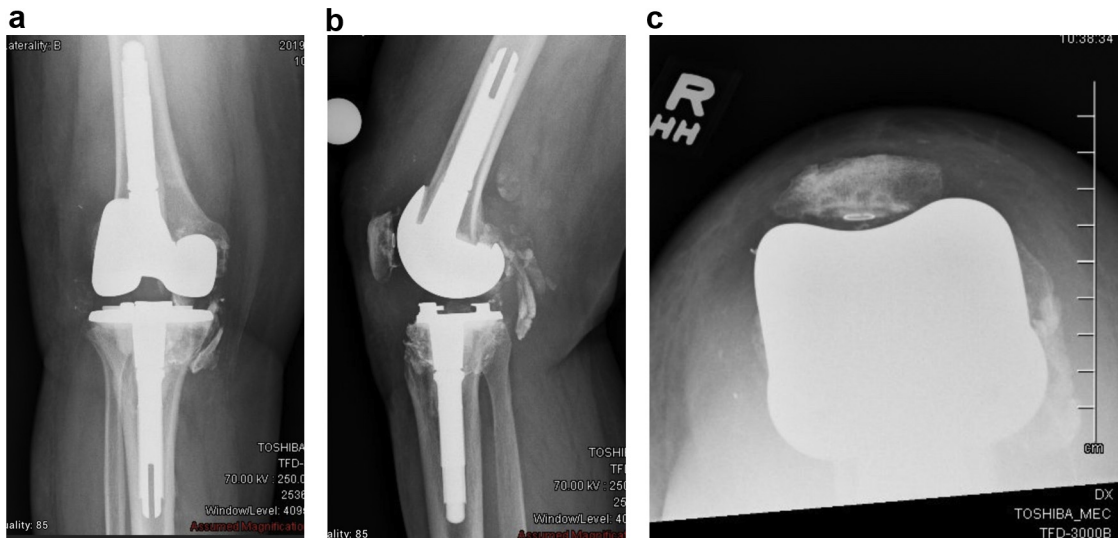
Figure 5. Postoperative anteroposterior (a), lateral (b), and sunrise (c) radiographs after synovectomy and revision to a stemmed, constrained condylar TKA.

performed along with revision of both the femoral and tibial components to a constrained condylar knee replacement (Fig. 5). The patient’s recovery was uneventful, and she obtained significant improvement in alignment, stability, pain relief, and function nearly 2 years from revision.

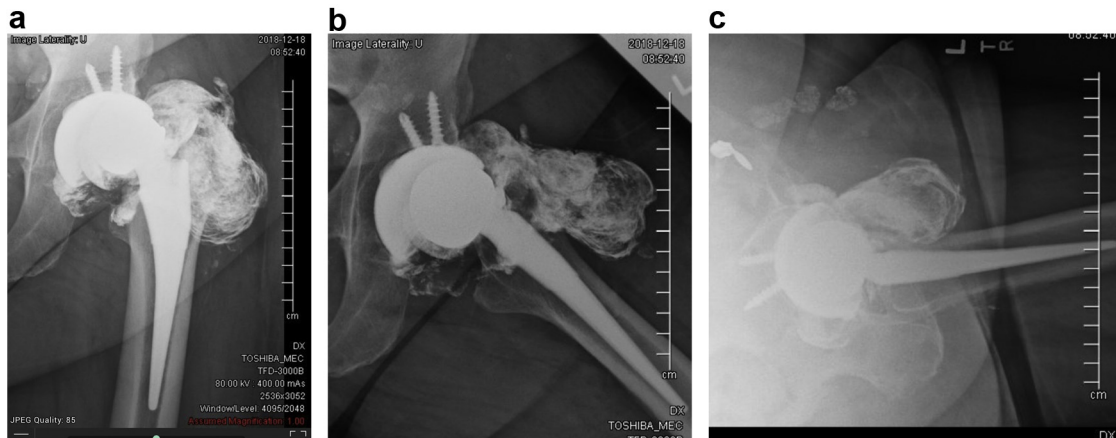
Figure 7. Antero posterior (a), frog lateral (b), and cross-table lateral (c) radiographs of a failed oxidized zirconium THA with polyethylene liner dissociation and resultant Oxinium “arthrogram.”

Radiographs demonstrated an R3 acetabular component and Anthology stem (Smith and Nephew, Memphis, TN). Eccentric positioning and deformation of the femoral head within the acetabulum and an associated Oxinium “arthrogram” was visible on multiple views (Fig. 7). The “arthrogram” outlined a dissociated polyethylene liner with direct contact of the deformed femoral head against the superior rim of the acetabular component. The femoral stem and acetabular component appeared to be well-aligned and well-fixed, but the femoral component appeared

Prosthetic joint infection was deemed unlikely, and the indications for revision were catastrophic failure due to a dissociated polyethylene liner with wear and deformation of the oxidized zirconium femoral head. The resultant “arthrogram” findings on the radiograph were attributed to debris from wear and grooving of the oxidized zirconium femoral head against the titanium acetabular component.

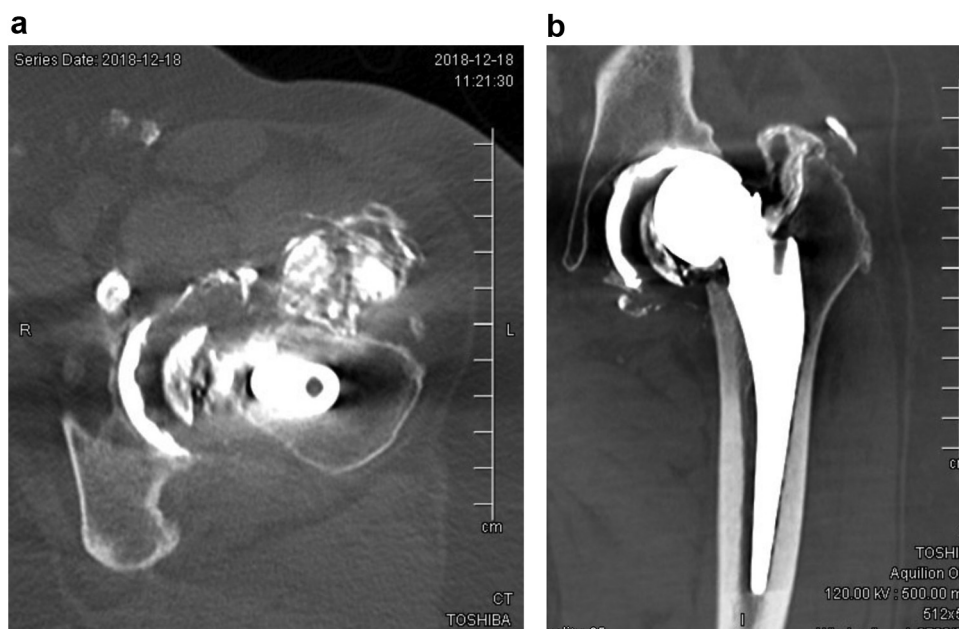
undersized. A computed tomography scan redemonstrated the radiographic findings with a large “Oxinium arthrogram” of the surrounding prosthetic joint tissues (Fig. 8). Inflammatory markers revealed an erythrocyte sedimentation rate of 11 mm/h (0–15 mm/h) and a C-reactive protein of 2.4 mg/L (0–10 mg/L). Operative records confirmed the use of an Oxinium femoral head.

Figure 8. Axial (a) and coronal (b) computed tomography images of a failed oxidized zirconium THA with polyethylene liner dissociation and resultant Oxinium “arthrogram.”

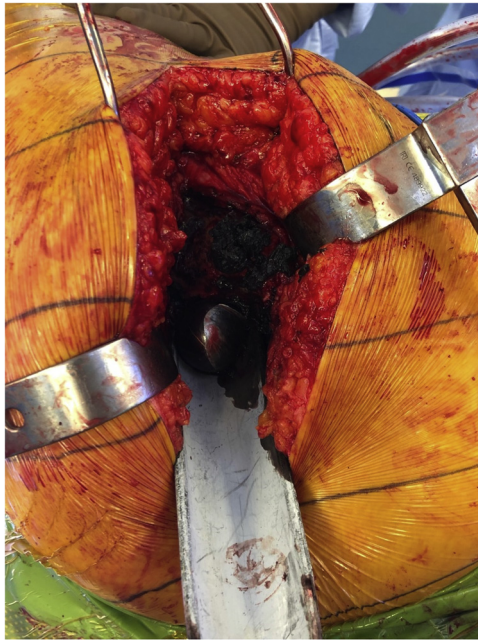
At the time of revision surgery via posterior approach, the prosthetic joint tissues beneath the fascia were found to be completely stained black (Fig. 9). The gluteus medius was found to be thin, but in continuity. A large amount of wear and grooving was found on the Oxinium femoral head deep enough to expose a silver

Figure 9. Intraoperative photograph showing metallosis and dark stained tissues from a failed oxidized zirconium THA with polyethylene liner dissociation.

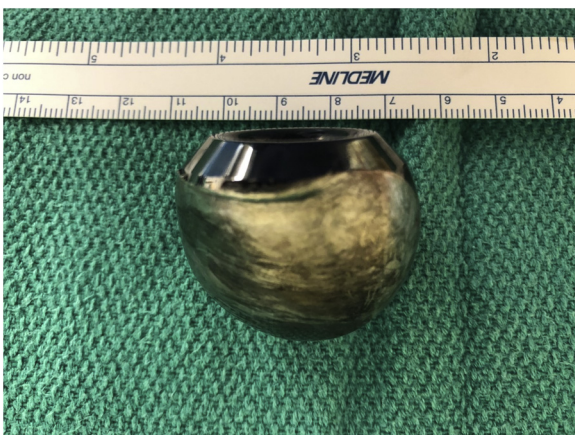
metallic appearance, unlike the black surface of Oxinium (Fig. 10). The polyethylene liner was confirmed to have been dissociated as predicted. Both components were well-fixed to host bone. The retrieved acetabular component showed a small amount of wear on the rim down to the antirotation scallops (Fig. 11). The patient underwent a complete revision of all components (Fig. 12). The patient is 2 years from revision with much improved pain, stability, and function but still complains of some residual pain and weakness. Her lateral thigh discoloration has persisted.

Figure 10. Retrieved femoral head with visible wear, grooving, and exposed underlying zirconium substrate.

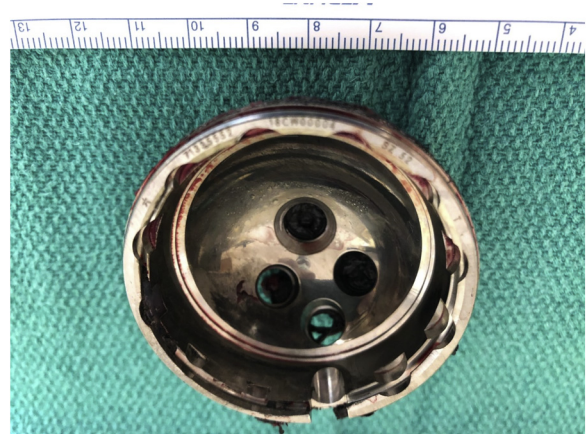
Figure 11. Retrieved acetabular component with visible wear on the rim down to the antirotation scallops.

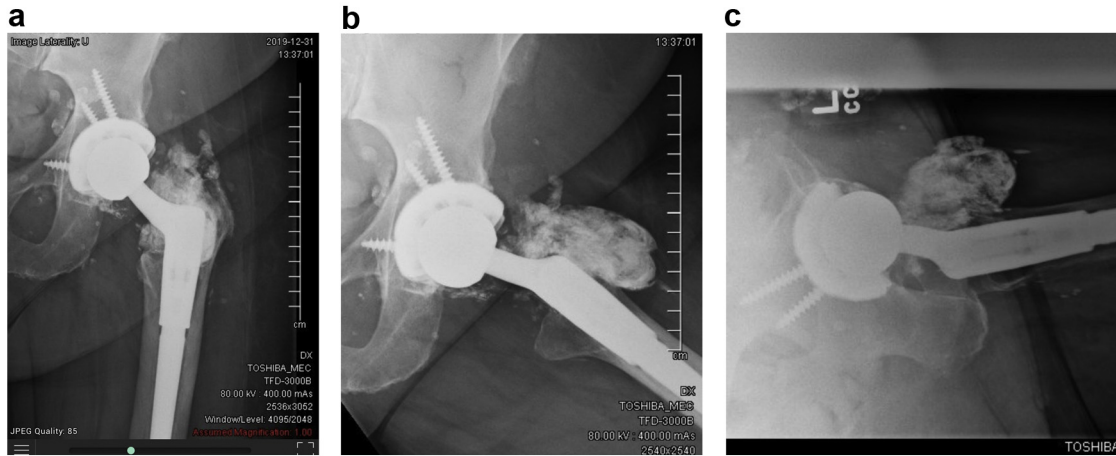
Figure 12. Postoperative anteroposterior (a), frog lateral (b), and cross-table lateral (c) radiographs after synovectomy and revision to a new acetabular component and modular tapered stem.
