Unusual fracture in a Durata lead with shock coil fragmentation and cable externalization

Toshiaki Sato, MD,* Kyoko Soejima, MD,[†] Hideaki Yoshino, MD,[†] Morio Shoda, MD[‡]

From the *Division of Advanced Arrhythmia Management, the Second Department of Internal Medicine, Kyorin University School of Medicine, Mitaka, Japan, [†]Division of Cardiology, the Second Department of Internal Medicine, Kyorin University School of Medicine, Mitaka, Japan, and [‡]Clinical Research Division for Heart Rhythm Management, Department of Cardiology, Tokyo Women's Medical University, Tokyo, Japan.

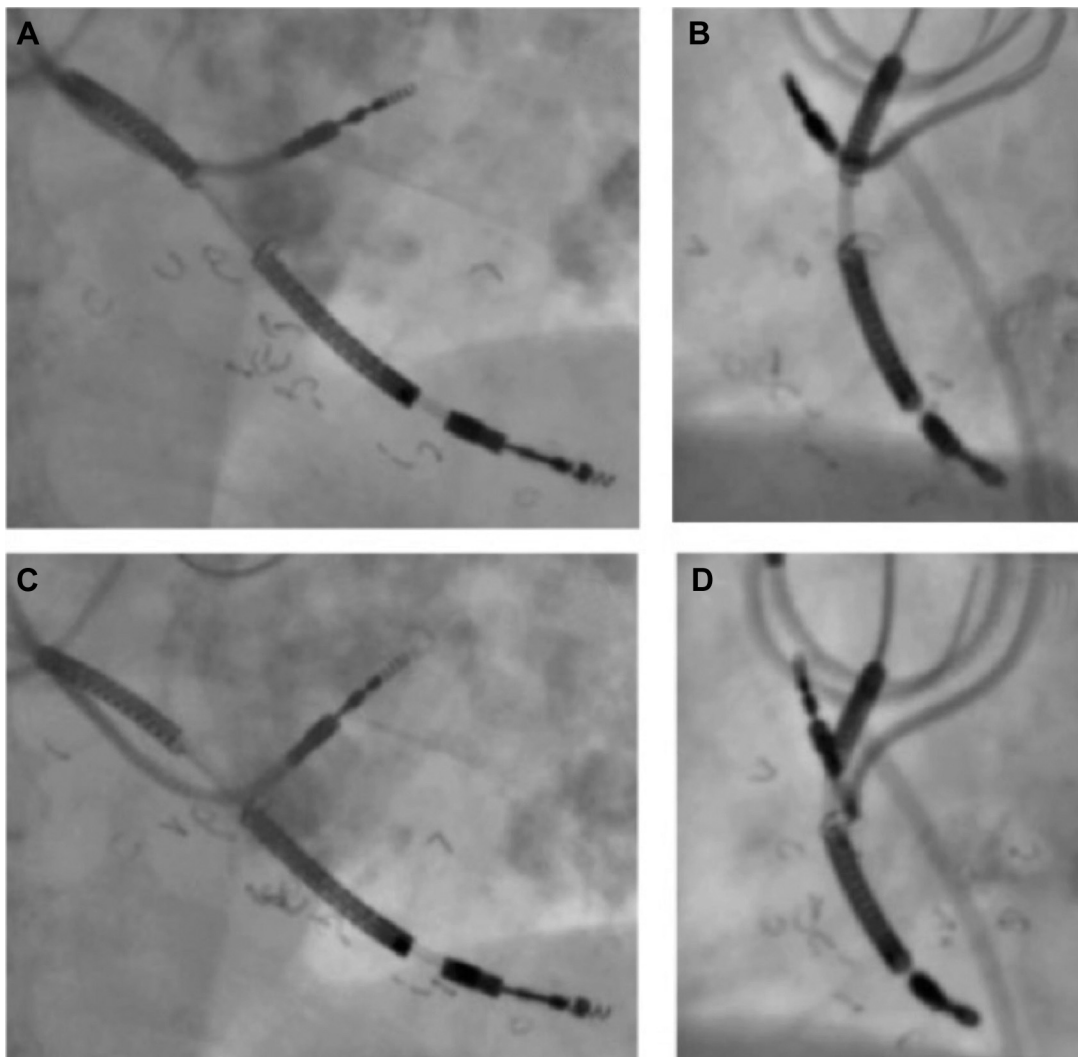
A 50-year-old man with an ICD was admitted to our hospital. An unusual conductor fracture in the ICD lead (Durata 7120; St Jude Medical, Sylmar, CA) was found with shock coil fragmentation in the right ventricle (Figure 1, Supplementary Video, available online).

In June 2013, fragments of the distal coil were noted in the right ventricle on the fluoroscopic images (Figure 1). Residual shock coil protruded from the lead body. The measurements, including RV pacing threshold (0.75 V / 0.35 ms), sensing (9.2 mV), and impedance (RV and RV shock coil were 546 Ω and 430 Ω , respectively), were normal. In retrospect, splitting of the RV shock coil was appreciated on a radiogram 3 months prior to this event.

Figure 1 Fluoroscopic views of the leads. **A:** right anterior oblique view, diastolic phase; **B:** systolic phase; **C:** left anterior oblique view, diastolic phase; **D:** systolic phase. The right ventricular (RV) shock coil was torn off and coil fragments were embolized in the right ventricle. The piece of residual shock coil protruded from the lead body. The bottom edge of the pacemaker lead was scraping the defibrillation lead between split RV shock coils (Supplementary Video available online).

We decided on lead extraction and discussed the option of open heart surgery to remove the fragments. However, a third thoracotomy could be associated with a higher risk of bleeding and infection in this patient, who was currently receiving anticoagulants, hemodialysis, and prednisolone. Thus, percutaneous extraction was performed. The patient had a history of pacemaker pocket infection and underwent pocket revision without lead extraction in 2010. Therefore, all leads were extracted, although generator pocket reinfection was not apparent. The ICD lead was removed first. The protruded end of the RV shock coil was pulled back into the laser sheath (12F; Spectranetics, Colorado Springs, CO). The RV pacemaker lead was extracted, although it was strongly adherent to the tricuspid annulus, outside the anuloplasty ring. Finally, the atrial lead was successfully

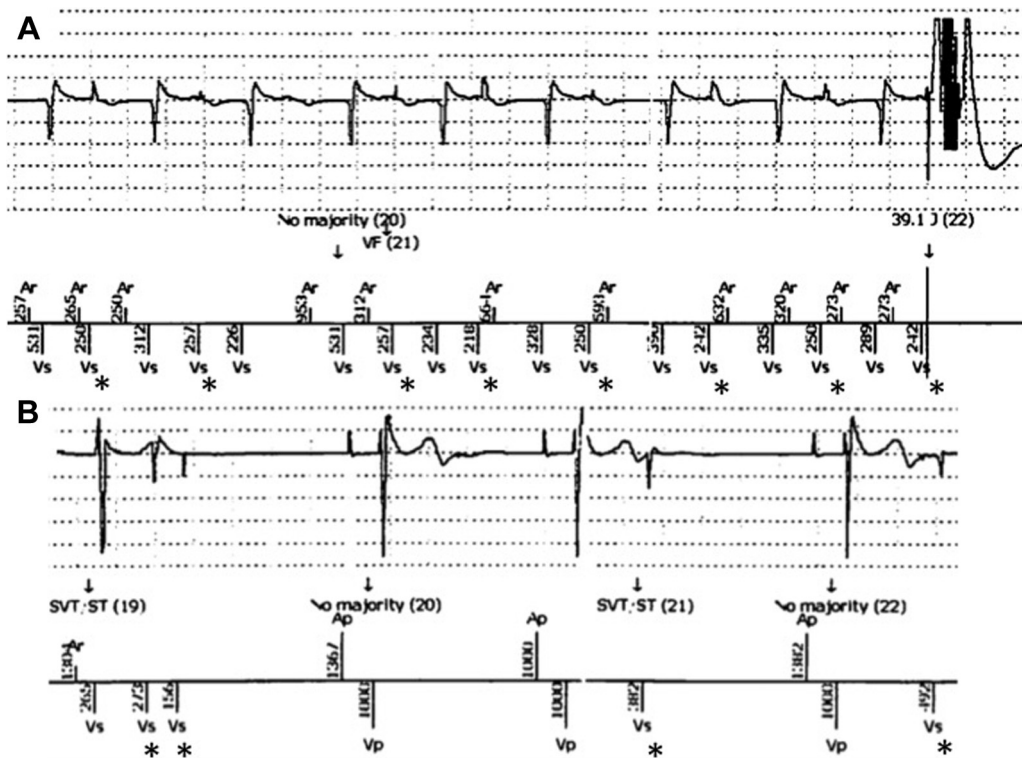
In October 2011, an inappropriate shock occurred owing to oversensing of nonphysiological potentials (Figure 2A).

These spike potentials with various amplitudes were recorded on the T wave by the pacemaker lead. Spike potentials were not reproducible either by body motion or by manual manipulation of the ICD pocket. In August 2012, nonphysiological noise was apparent just after the delivery of current. Therefore, the pacemaker lead was abandoned and an ICD generator was reconnected to the defibrillation lead for RV apical pacing and sensing. A chest radiograph did not demonstrate problems with the leads. Measurements of the Durata lead were 1.0 V at 0.35 ms for the RV pacing threshold and 4.6 mV for sensing. The impedance of RV pacing and RV shock coil were 512 Ω and 399 Ω , respectively. We confirmed that the spike potentials were not detected by the Durata lead during the procedure and before the discharge. However, 9 days after the procedure, spike potentials were recorded after RV sensing or RV pacing and on or just after the T wave by the defibrillation lead during an episode of nonsustained ventricular tachycardia (Figure 2B).

Figure 2 Spike potentials on T wave recorded by right ventricular (RV) pacemaker lead and then implantable cardioverter-defibrillator (ICD) lead. **A:** An ICD generator was connected to the residual pacemaker lead for RV septal pacing and sensing. T-wave synchronous spike potentials were oversensed prior to delivery of inappropriate shock. **B:** The defibrillation lead was then used for RV apical pacing and sensing. The nonphysiological potentials were apparent after RV sensing or RV pacing and on or just after T wave. A marker channel with atrial and ventricular intervals is also shown. Asterisks on the marker channel denote oversensed signals.

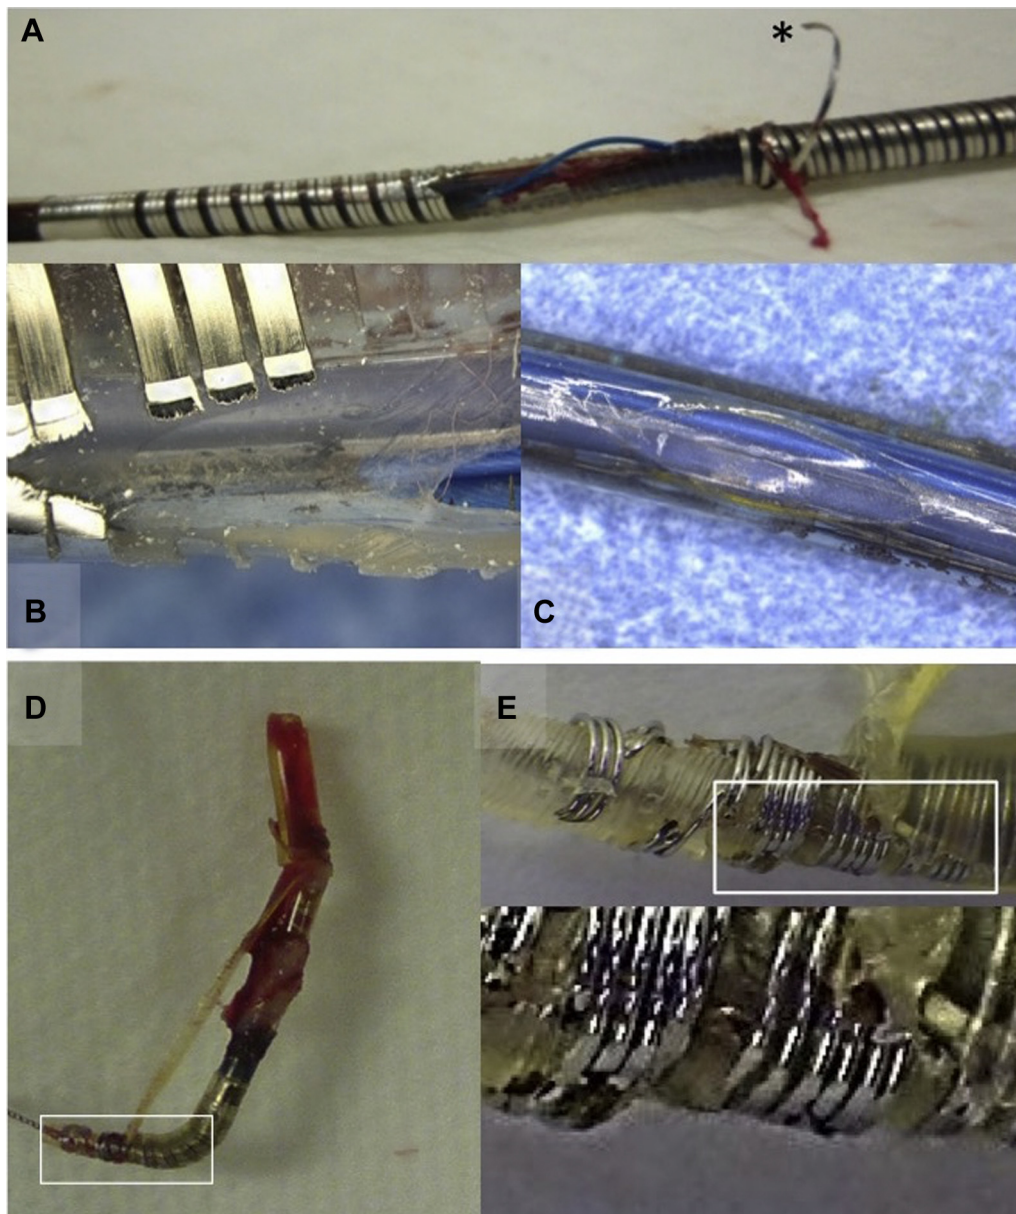
The extracted ICD and RV pacemaker leads were sent to the respective manufacturers and detailed evaluation was conducted (Figure 3). External abrasion through the RV shock coil and breaching of the ring electrode lumen was noted at 4.5 cm from the distal tip of the Durata lead. One of the ring electrode cables was also abraded open in this region. The broken end of the RV shock coil was shifted distally. Part of a residual shock coil protruded from the lead body. External abrasion breaching the silicone-polyurethane copolymer (Optim) sheath was noted proximal to the RV shock coil at 8.2 cm from the distal tip. Flattened conductors were apparent in the ring electrode cables of the pacemaker lead (Figure 3E) as well as the residual RV shock coil (Figure 3B). We could not precisely differentiate lead

damage owing to lead friction vs extraction, although the metal compression suggested lead interaction.

We present a case with an unusual disruption of shock coils from a Durata defibrillation lead caused by friction against the residual pacemaker lead. The electrical parameters, such as impedance, RV sensing, and pacing threshold, were stable, although only the spike potentials on the T wave were recorded by the RV pacemaker lead and then by the defibrillation lead before the conductor fracture.

The cable connected to the ring electrode was externalized from the extracted shock lead. The Durata lead is less susceptible to “inside-out” insulation failures compared with Riata and Riata ST leads.³ A coating with silicone-polyurethane copolymer (Optim) may prevent exteriorized cables.^{4,5} In a study by Jenney and colleagues,⁵ Optim insulation was clearly superior in abrasion resistance to silicone. However, the Optim layer does not cover the silicone elastomer insulation under the shock coils. Recent reports have described insulation failure of the Durata lead.^{6–9} To prevent tissue ingrowth, the cross section of the outer wire of the shock coil is not round but flat and thin. The thickness of the flat wire of the Durata lead was 0.076 mm, whereas the diameter of the round wire of the Riata lead was 0.18 mm. The Durata shock coil may have been too fragile to withstand the friction with the coexisting lead. Valentino and colleagues² reported that a Durata

Figure 3 The defibrillation lead and the pacemaker lead. **A:** The extracted shock lead is shown. The broken end of the right ventricular (RV) shock coil protruded from the lead body (*). **B, C:** External abrasion through the RV shock coil and breaching of the ring electrode lumen is noted at 4.5 cm and 8.2 cm from the distal tip. **D:** The insulation and ring electrode cables were broken at 5.0 cm from the distal tip of the pacemaker lead. Flattened conductors owing to friction between leads were apparent in the ring electrode cables of the pacemaker lead (E) as well as the residual RV shock coil (B).

During the procedure of upgrading to an ICD, lead removal may be considered in patients with RV pacing leads that are functional but are not being used after implantation of the defibrillation lead. However, the extraction of functioning pacemaker leads is not generally recommended in the literature.¹¹ Therefore, when upgrading the implant, the operator has to confirm in multiple views that the defibrillation lead is not in contact with the remaining pacemaker lead to avoid friction between leads.
