CASE REPORT

Limitation of the bandpass filter in preventing oversensing of pectoral myopotentials over the long-term follow-up

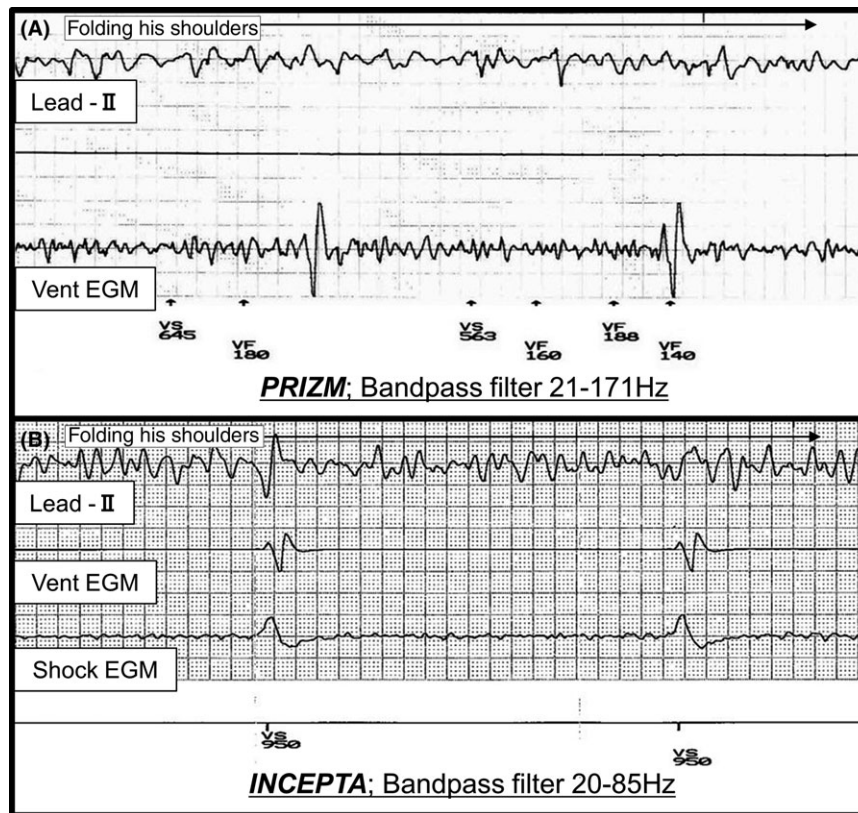
FIGURE 1 Pectoral myopotentials were documented by flexing his shoulders during the generator change. A, Myopotentials were documented in the ventricular EGM when the implantable cardioverter defibrillator (ICD) lead was still connected to the old ICD (PRIZM II). B, The myopotentials were clearly removed from the ventricular EGM when the new ICD (INCEPTA) was connected

washing his hands. Interrogation of the device revealed sensed R-waves of 5.2 mV, an RV pacing threshold of 0.9V at 0.4 ms, and ICD lead impedance of 525 Ω . The electrogram (EGM) was checked, and the myopotentials were easily documented in both the shock and ventricular EGM (ring-coil) recordings by grabbing his hands in front of him, while not by touching the leads or can from the outside. Therefore, oversensing of the pectoral myopotentials was suggested. No significant change was observed in the chest X-ray, and the myopotentials could not be eliminated by device reprogramming. A generator change was decided due to battery depletion, and also a new lead implantation was considered to treat the myopotential oversensing.

The new ICD was an INCEPTA (F161 VR DF-1, Boston Scientific Corp., St. Paul, MN, USA) and had a different bandpass filter range than the old ICD (PRIZM; 21-171 Hz, INCEPTA; 20-85 Hz). The INCEPTA ICD had a low-pass filter, which was appropriate for attenuating high frequency components, and additionally, we also expected the Boston Scientific noise rejection algorithm to reduce the oversensing. The operation was performed with local anesthesia, and the myopotentials were easily documented by flexing his shoulder muscles (Figure 1A). The PRIZM ICD was removed from the pocket and no connector problem existed. The INCEPTA ICD was implanted, and the patient was again instructed to fold his shoulders. The high-frequency noise disappeared dramatically from the ventricular EGM, on the other hand, the bandpass filter was applied only for the ventricular EGM, and the myopotentials were still observed on

the shock EGM (Figure 1B). Defibrillation threshold (DFT) testing was properly performed with 14J, and as the new ICD was suspected to have correctly identified the potentials with the use of the bandpass filter, the implantation was completed without implanting a new lead.

have a higher risk of all-cause mortality.^{1,2} In the present case, myopotentials were suddenly documented 8 years from the lead implantation, and as previously reported,³ no significant change was observed in the lead impedance. In the first procedure, the connection problem was completely denied during the generator change, and upon the pocket exploration, no identifiable insulation damage to the lead was observed. Nevertheless, the observation of pectoral myopotentials indicated an insulation defect in the lead outside the pocket, or a microinsulation defect inside the pocket, which was difficult to identify.^{4,5}

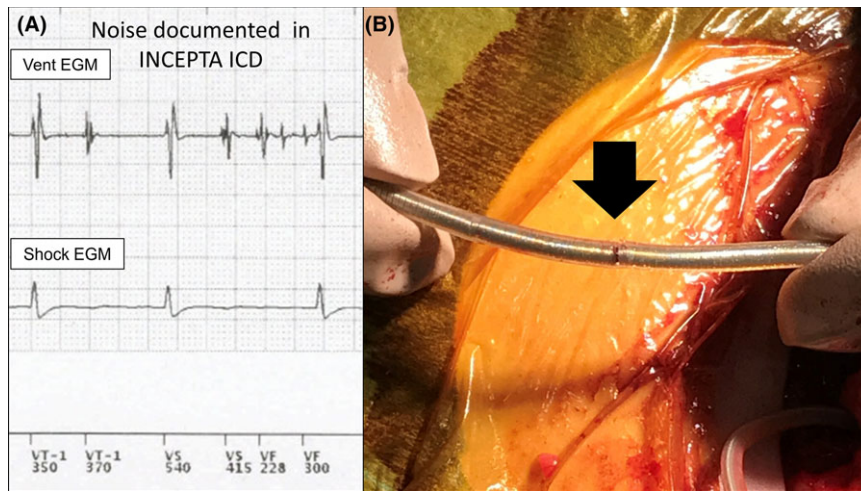
No myopotentials appeared on the ventricular EGM for 4 years, but a new type of noise was suddenly documented again during a regular ICD check in September 2017 (Figure 2A). Interrogation of the device revealed sensed R-waves of 5.1 mV, an RV pacing threshold of 1.3V at 0.4 ms, and ICD lead impedance of 470 Ω . The noise was documented during pectoral muscle exercise, while not by touching the leads or can from the outside. No inappropriate ICD shocks occurred, but a new shock lead implantation, and also an upgrade to a cardiac resynchronization therapy defibrillator (CRT-D) was planned. During the operation, a fractured shock lead was observed, which was not confirmed during the past procedure (Figure 2). The fracture point was located in the loop inside the pocket, which was a relatively strongly curved point. A new ICD lead was placed in the RV apex, and the patient was upgraded to a CRT-D device without performing an ICD lead extraction.

FIGURE 2 A, Noise documented during the pectoral muscle exercise in the ventricular EGM of INCEPTA. B, An ICD lead fracture was found during an upgrade to a cardiac resynchronization therapy defibrillator

Four years later, a new type of noise was documented during the ICD check (Figure 2A). Thirteen years had passed since the ICD implantation, and an actual fractured shock lead was observed during the CRTD upgrade. There was no significant change in the lead impedance, but the development of a lead failure was strongly suspected. The band pass filter was able to eliminate the pectoral myopotentials in 2013, but the development of the insulation fracture may have resulted in new sensing of the noise related to the pectoral muscle exercise, and was difficult to eliminate by the band pass filter.
