RESEARCH ARTICLE

Assessing the reliability and degradation of 10–35 years field-aged PV modules

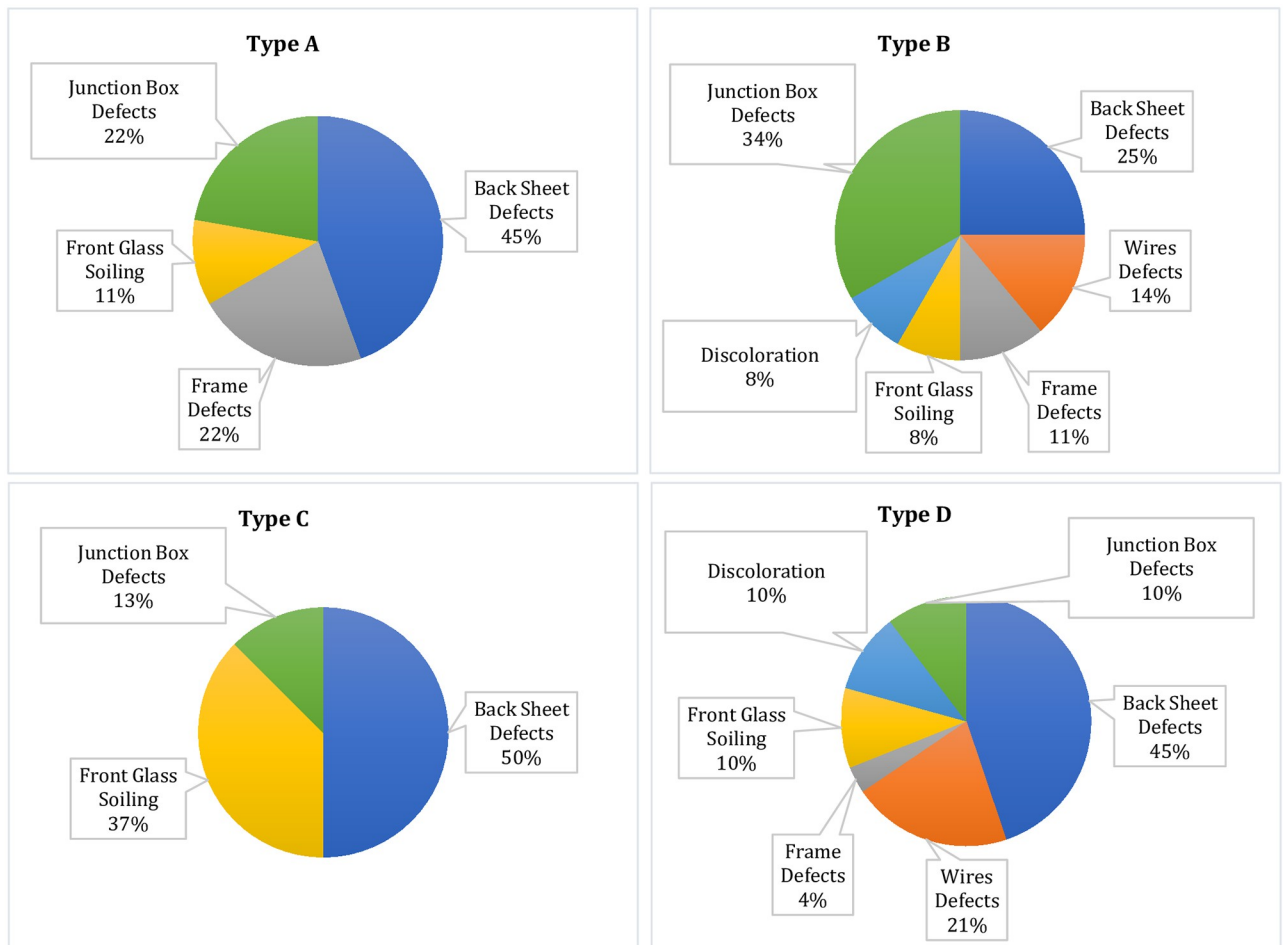
Fig 1 shows different defects observed in all the four types of modules in the form of the percentage of their occurrence. The percentage occurrence helps us in the quantification of different defects observed during the examination process. To understand the percentage occurrence of the defects, we look at Type A modules in Fig 1, where the junction box defects are 22%, backsheet defects are 45%, frame defects are 22% and front glass soiling is 11%. It means that out of the total defects found in Type A modules, 22% were related to the junction box, 45% to backsheet, 22% to frame, and so on. Thus, the greater the percentage of a defect type, the greater is its presence in the modules.

The percentage occurrence of backsheet defects is greatest in all four types of modules. The defects observed in the backsheet include discoloration, delamination & bubbling, slightly chalking (formation of a white powder), scratches/cracks, and burn marks. The discoloration of the backsheet is caused by the short-wavelength radiations present in the solar spectrum, which chemically degrade the backsheet when incident on it. The backsheet is generally made up of three layers bonded together using an adhesive. Exposure to extreme humid environment causes the loss of adhesion properties of the adhesive which results in delamination of the backsheet. In addition to this, the moisture or atmospheric gasses can enter into the laminate through the permeable and/or degraded backsheet and get trapped due to different permeation properties and give rise to bubble formation. The chalking is originated from the photothermal degradation of the outer surface of the backsheet, which brings the internal additives to the surface and causes its easy abrasion. Scratches or cracks are the results of the

Fig 1. Percentage occurrence of different defects in the modules under observation.

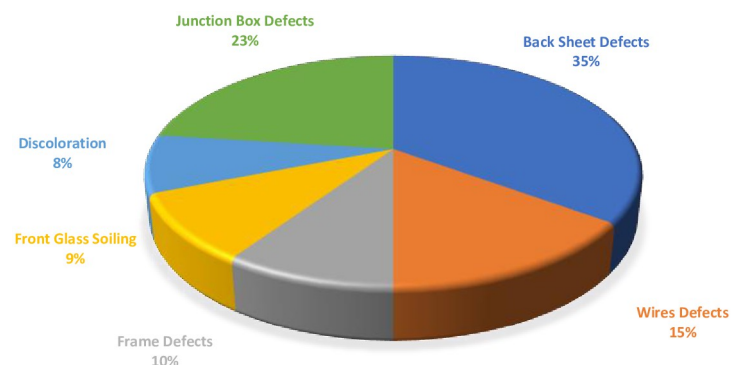
Fig 2. Percentage occurrence of defects (combined) in Type A, B & D modules.

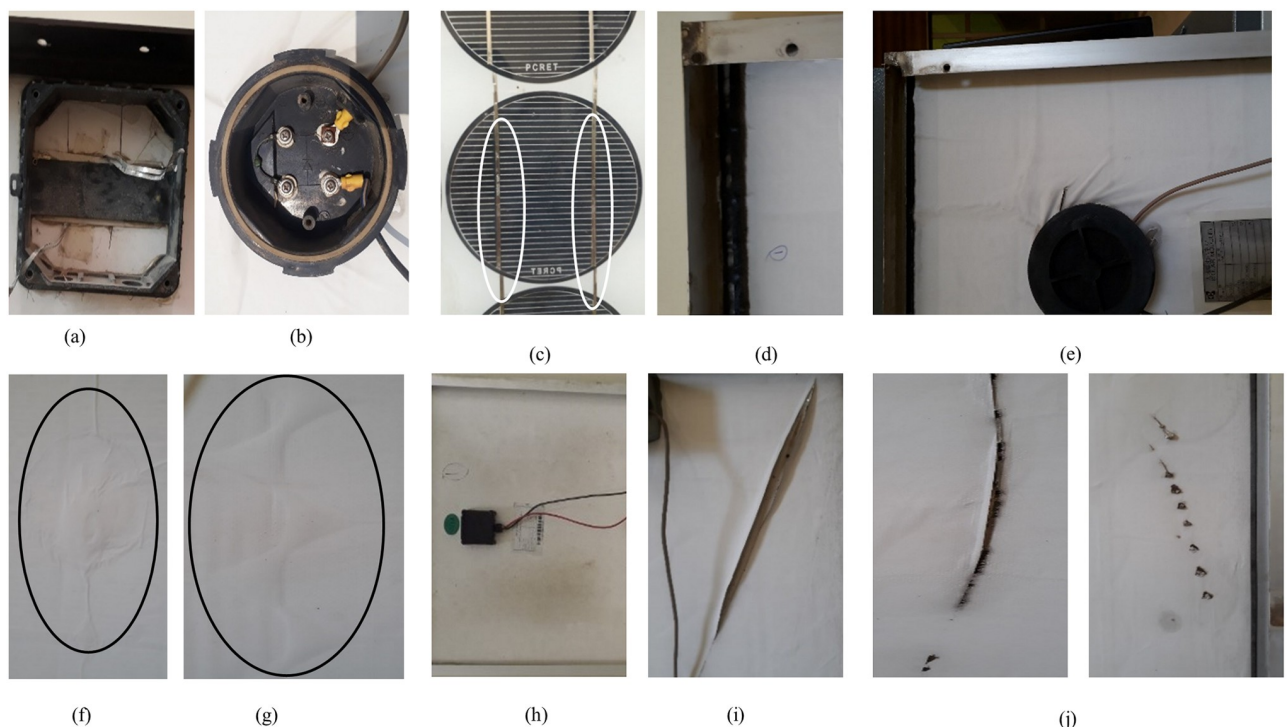
slightly chalked and discolored which is because of their photothermal degradation. On the other hand, the backsheets of Type A, B, and D modules exhibited the different defects mentioned above. This is because these modules were exposed to an extreme humid environment throughout their life (30+ years) which caused the delamination, cracks, and bubbling of the backsheet in them. The JB of the Type C modules was only slightly damaged while all the other types of modules showed various defects related to JB. These defects include cracking, warping, embrittlement, and weakening of adhesion. Moreover, the JB of some modules had loose lids while some did not have any lid attached with them. The wire defects were seen in Type A, B, and D modules only, as the JBs of the Type C modules were intact, thus they protected the connecting wires from degradation. In the former types, the connecting wires of some of the modules were corroded and some did not have any connectors attached to them. Another defect observed during the visual inspection was the frame defect, found in Type A, B, and D modules. The frame of some of these modules was loosely attached (weakening/loss of adhesion) while other modules showed corrosion of some part of the frame. The representative images of the defects observed during the visual inspection are shown in Fig 3.

Fig 3. Defects observed in visual inspection: (a) & (b) Broken junction box and corroded wire in Type A & B respectively, corrosion of (c) busbars (Type A) & (d) metallic frame (Type B), (e) & (f) delaminated backsheet in Type B & (g) Type D, (h) discoloration of the backsheet (Type C), (i) & (j) scratch/crack & burn marks on backsheet in Type D.

the corrosion of the busbars and burn marks on the cells were also found during the visual inspection. The corroded busbars of the Type A module are shown in Fig 3(c) (encircled in white) and those of Type B are shown in Fig 6 (encircled in yellow) while the burn marks found in the Type D module can be seen in Fig 4.

The defects observed in the visual inspection can cause safety issues like electrical, physical, and fire hazards. The defects found in the backsheet like burn marks, cracks or scratches, and delamination can cause electrical hazards. Discoloration (or browning) of the EVA and corrosion of the metal strings observed in the modules have the tendency to cause electrical, fire, and physical damage. The different defects observed in the JB and connecting wires may cause electrical, physical, and fire hazards [18]. Interestingly, all these defects which have safety hazards associated with them, are the highest occurring defects in the modules studied, as seen from Figs 1 and 2. Moreover, it was observed that one defect may lead to another; as discussed above, the EVA browning caused the corrosion of busbars and the generation of hotspots in the module. Also, the defective backsheet can become the root cause of other failure modes in the modules; when the delamination occurs near the junction box (Fig 3(e)) or the frame, water may enter into the module during the heavy rainy season or when there is dew, and cause corrosion of the busbars. Thus it can be inferred, that the corrosion of the busbars and Cu ribbons observed in Type B modules (Fig 6) occurred due to the degradation of the EVA and backsheet. Moreover, the corrosion of the busbars observed (Fig 3(c)) is due to the ingress of moisture into the module.

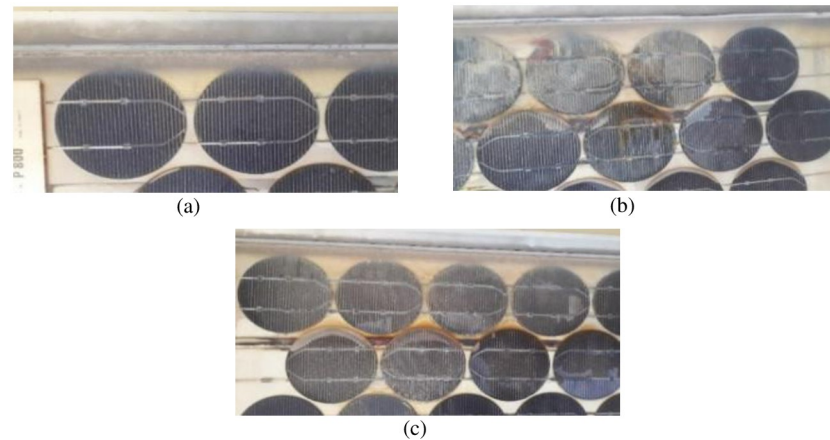
Fig 4. Visual inspection of Type D modules showed: (a) discoloration near the cell edges, (b) & (c) discoloration of EVA & burn marks on the Si-cells.

Type B and D modules showed all six types of defects, one of which was the discoloration of the encapsulant: ethylene vinyl acetate (EVA). During the production of EVA, certain additives are added to it which include curing agents, UV absorbers, UV stabilizers, and anti-oxidants. EVA is degraded (discolored) due to the high dose of UV light (in the solar spectrum) and high temperature that the module receives while working in the field. Different levels of discoloration have been reported in the literature, ranging from light yellow to yellowish-brown and dark brown with the greatest loss in the performance relating to the greatest discoloration [37–41]. In this study, Type D modules showed a light yellow to yellowish-brown discoloration (Fig 4) while dark brown discoloration was observed in Type B modules (Fig 5).

and corrodes them [39–42]. The corrosion of the busbars is shown in yellow dashed circles while that of Cu ribbons can be seen in red dashed circles. For comparison purposes, images of the portion of the modules where busbars were not corroded are also shown in Fig 6. Greater discoloration was observed where busbars were corroded as compared to those where busbars were not corroded (blue rounded rectangle). In case when only a portion of the encapsulant gets discolored, it can produce the partial shading effect and thus cause hotspot generation due to the mismatch within the module [19, 42]. This was observed in Type D modules, where only a portion of EVA showed discoloration (Fig 4). In this case, the cell covered by the discolored EVA produces lesser current than the other cells in the module which results in reverse biasing of the shaded cell. Due to this mismatch, the covered cell gets heated up and ultimately burns. Fig 4 shows the burn marks on the cells in the Type D module.

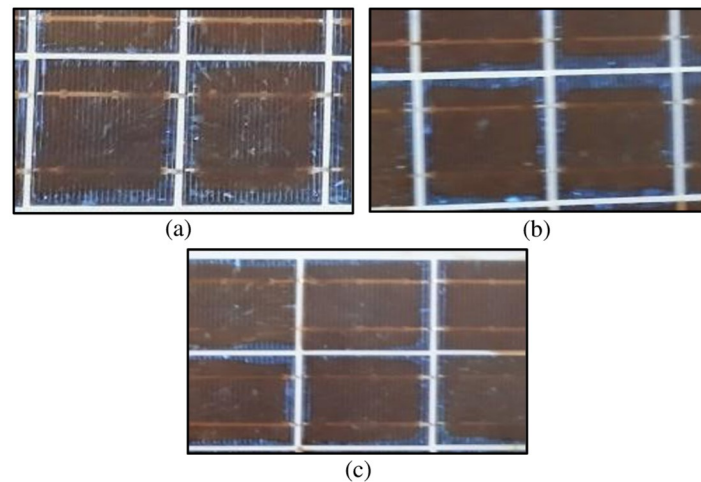
During the visual inspection, the encapsulant of Type B modules exhibited dark brown color, displaying severe degradation in them which is shown in Fig 5. The browning was greatest closer to the center of the cells and almost no browning was observed near the edges or in the region between the cells, making a square pattern over the cell. This is because of photo-bleaching over the edges or the regions between cells due to the diffusion of oxygen into the module (Fig 5). Similar effect has been reported in the literature previously [29, 32, 33, 37, 38].

Fig 5. Discoloration of Type B PV Modules (effect of photo-bleaching is visible) in: (a) Module B (1), (b) Module B (2) & (c) Module B (3).

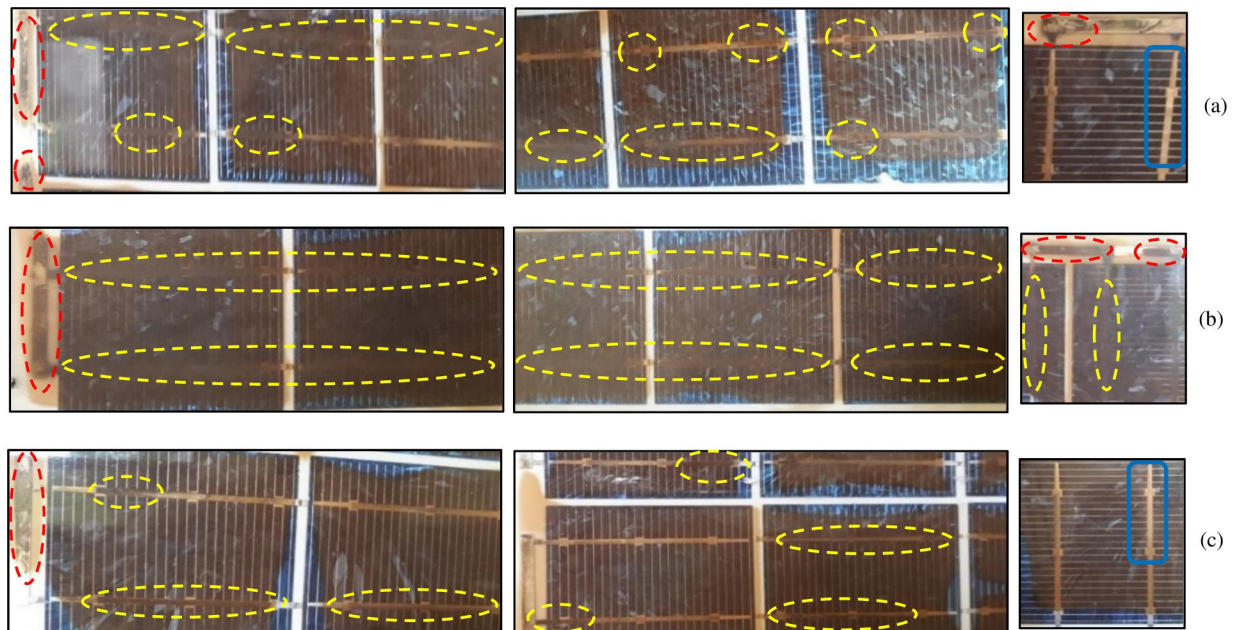
Fig 6. Corrosion of the metallic parts in Type B: (a) Module B (1), (b) Module B (2) & (c) Module B (3).

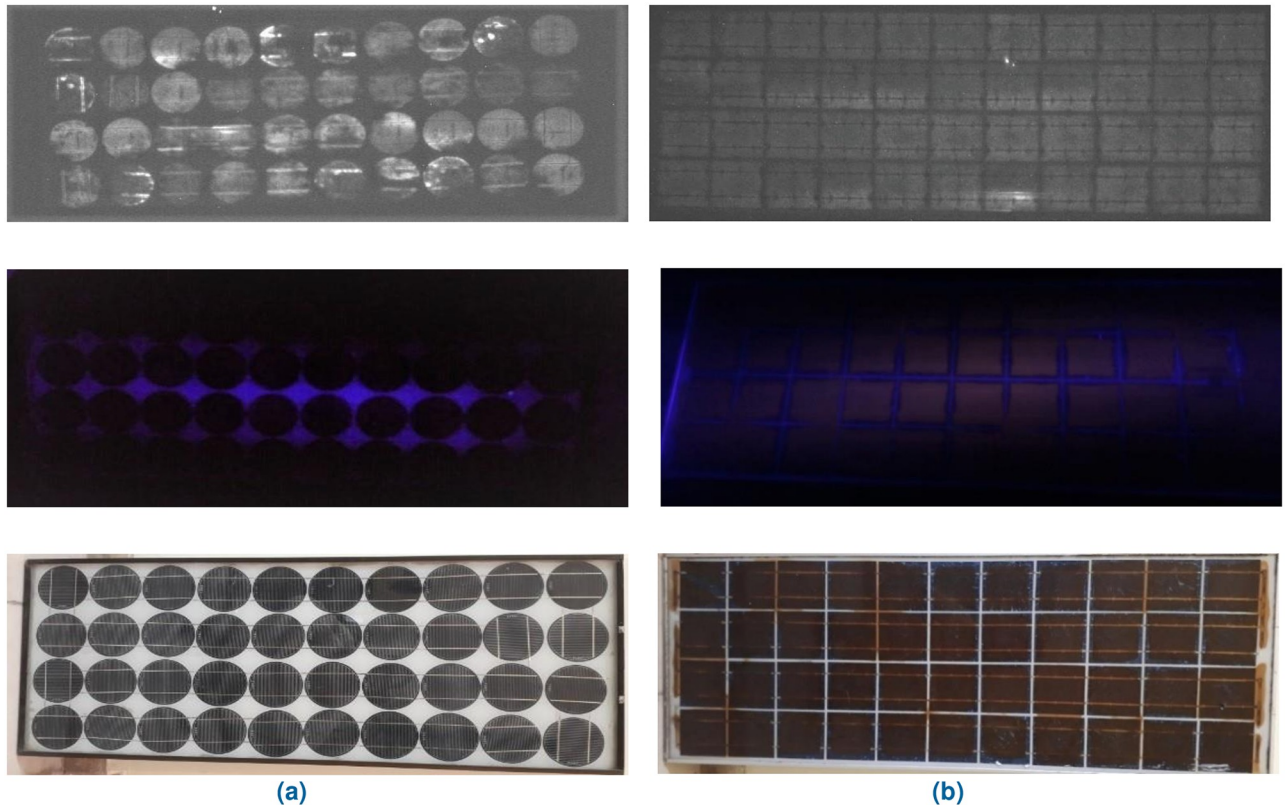
The electroluminescence (EL) and visible light (VL) images of the modules under observation are presented in Figs 7 and 8. The EL image detects the defects in the module, which cannot be seen through the naked eye, as a mismatch in the brightness (lighter and darker regions). The dark areas of the EL image represent the defective parts of the cell that do not take part in the current generation. Fig 7 shows such dark areas for both Type A and B modules. Moreover, an irregular pattern in the EL image of the PV module represents the degradation of the encapsulant and burning effect of solar cells. The portion encircled in red, shown in Fig 8(b), represents such a type of degradation in the Type D module. This type of defect arises due to several reasons which include reverse biasing of the cell or part of the cell, partial shading of the module, presence of non-uniformities, and any defect that causes shunting. All these factors contribute to the hot spot generation and cause the burning of the cell [18]. The discoloration of the EVA in the module is visible in VL images (Figs 4 and 8(b)). This discoloration causes reverse biasing which ultimately leads to burning.

Fig 7. EL, UV-F and VL images of (a) Type A & (b) Type B modules.

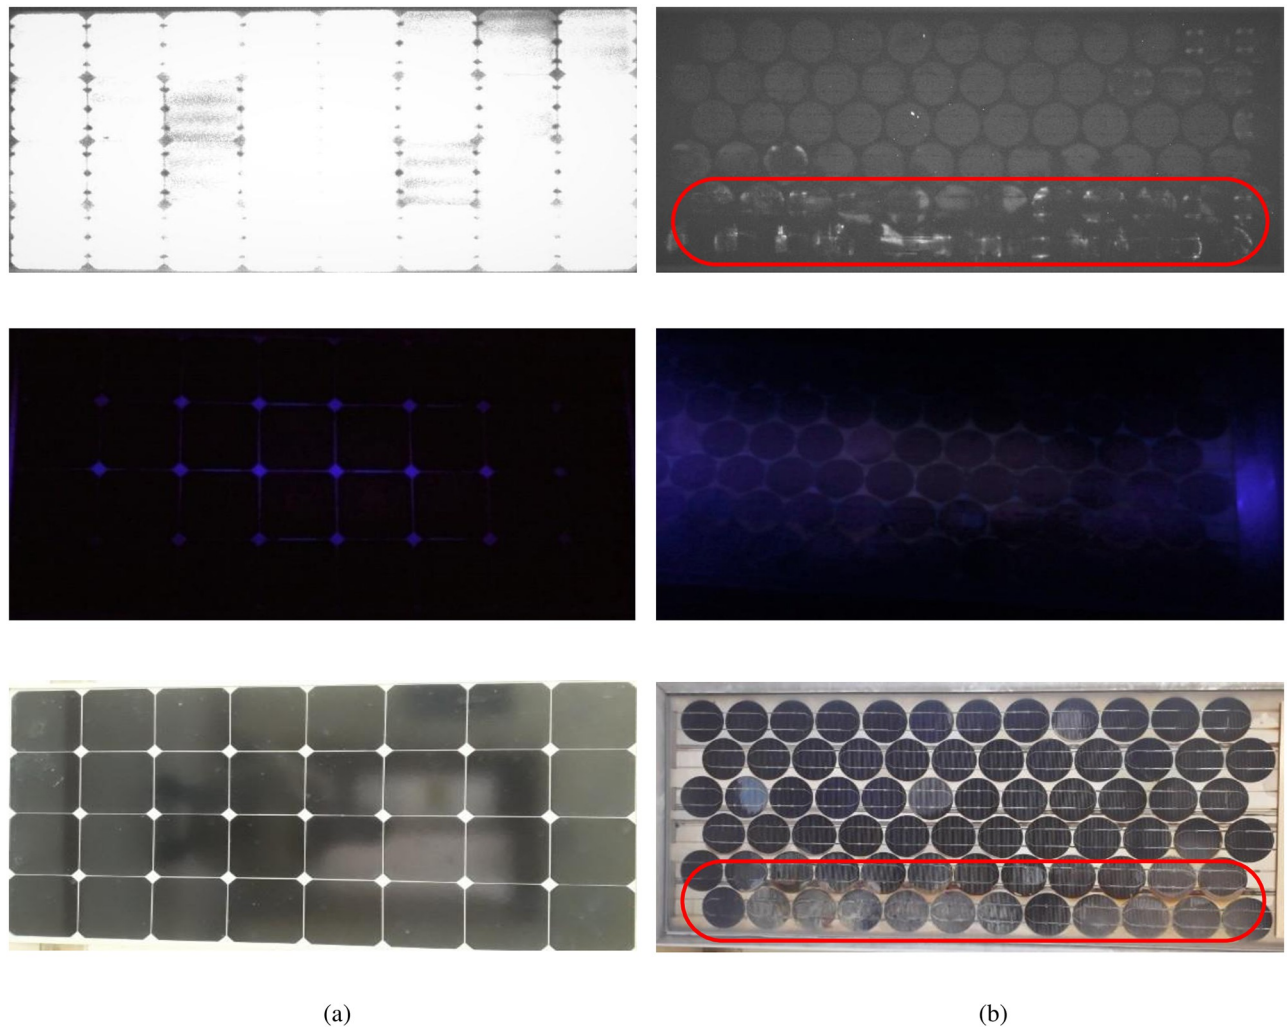
Fig 8. EL, UV-F and VL images of (a) Type C & (b) Type D modules.

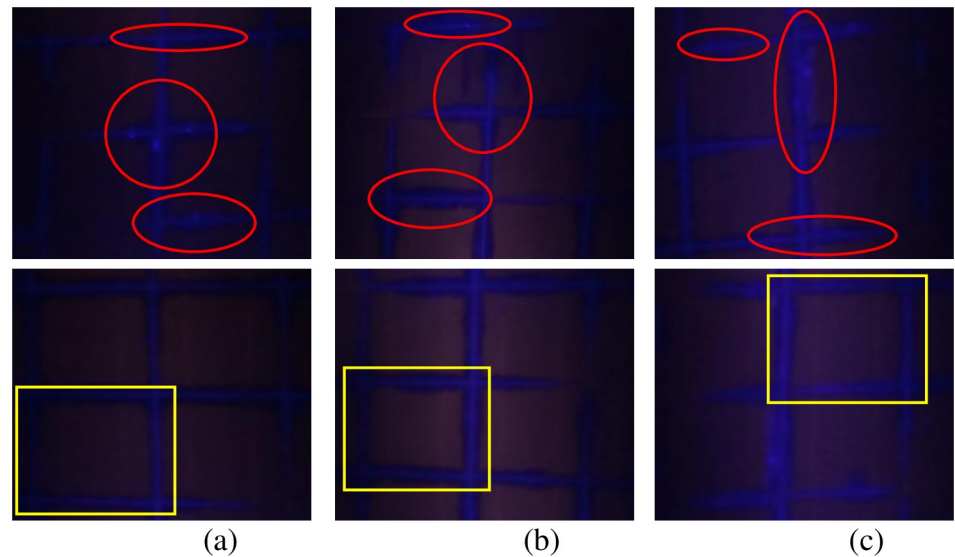
Type B modules which showed a 26.18% drop in the short circuit current, as can be seen in Fig 9. Browning also affects the module indirectly by degrading other components alongside. The acetic acid and other volatile products of EVA degradation can cause the delamination effect in the module [39, 42–44]. This was observed during the visual inspection when the delamination of the backsheet was found in Type B and Type D modules only (shown in Fig 3). Moreover, along with the browning of the EVA, corrosion of the metal conductors and burn marks were also observed in the Type B and D modules. The corrosion of the busbars and copper (Cu) ribbons in Type B modules is shown in Fig 6. The reason for this corrosion is that the acetic acid in combination with the moisture coming into the module attacks the metallic parts

analyzed using UV-F imaging. By looking at the UV-F images of the Type B modules in Fig 9, the photo-bleaching effect (encircled in red) is quite evident. Moreover, Fig 9 also shows the square pattern (shown in yellow boxes) formed because of the competing reaction between the browning and the photo-bleaching of EVA.

Fig 9. UV-F images of Type B modules (a) Module B (1), (b) Module B (2) & (c) Module B (3).

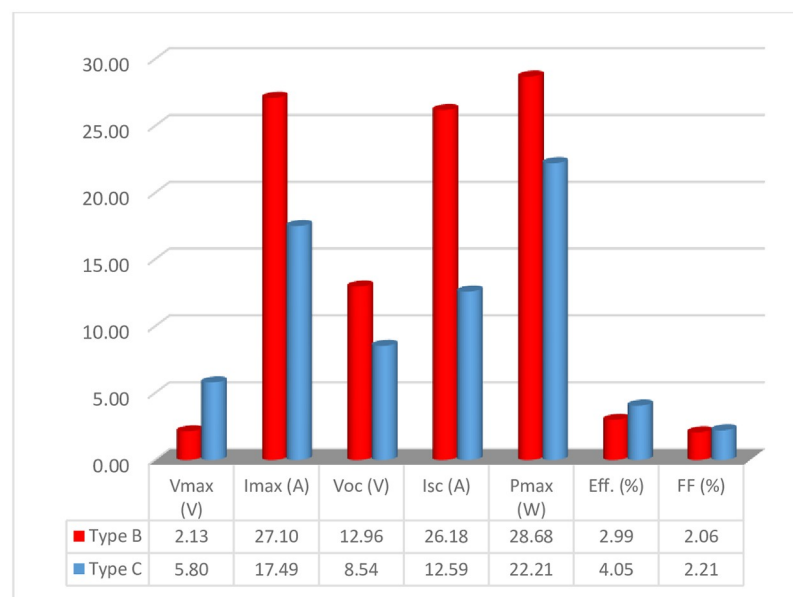
the FF and VOC was observed. Similar results have been previously reported in the literature [38, 39, 45]. Moreover, the Type B modules were old with an initial efficiency of 10% while that of Type C modules was 18%. Thus, a lesser decrease in the efficiency of Type B modules had a greater impact on their performance (as seen in Fig 10).

The power output after 10 years of field life for Type C modules is 77.79% which is lesser than the estimated power output (90%) for the modules after 10 years of field exposure [39]. This greater drop in the output power may be attributed to the poor quality materials used for the Type C modules. The percentage degradation per year in the electrical parameters of the Type B and Type C modules is shown in Table 3. Considering the percentage degradation/year in I_{SC} and P_{max} of the Type C module which is 1.26 and 2.22%/year respectively. This degradation is very high as compared to the specified limit of the power output after 10 years of field life. Such a high degradation rate will not only reduce the power output of the degraded modules but can also reduce the un-degraded modules' performance as well as the integrity. As obvious from Table 3, the percentage degradation/year in Type C modules is greater than Type B showing the poor quality of manufacturing/materials used in Type C modules.

Fig 10. Percentage decrease in the performance parameters of Type B & Type C modules (Eff. & FF degradation is in percentage points).
