Defibrillation threshold testing: What is all that noise?

KEYWORDS Defibrillation threshold testing; Device explantation; High-voltage shock; Implantable cardioverter-defibrillator; Noise (Heart Rhythm Case Reports 2019;5:457–460)

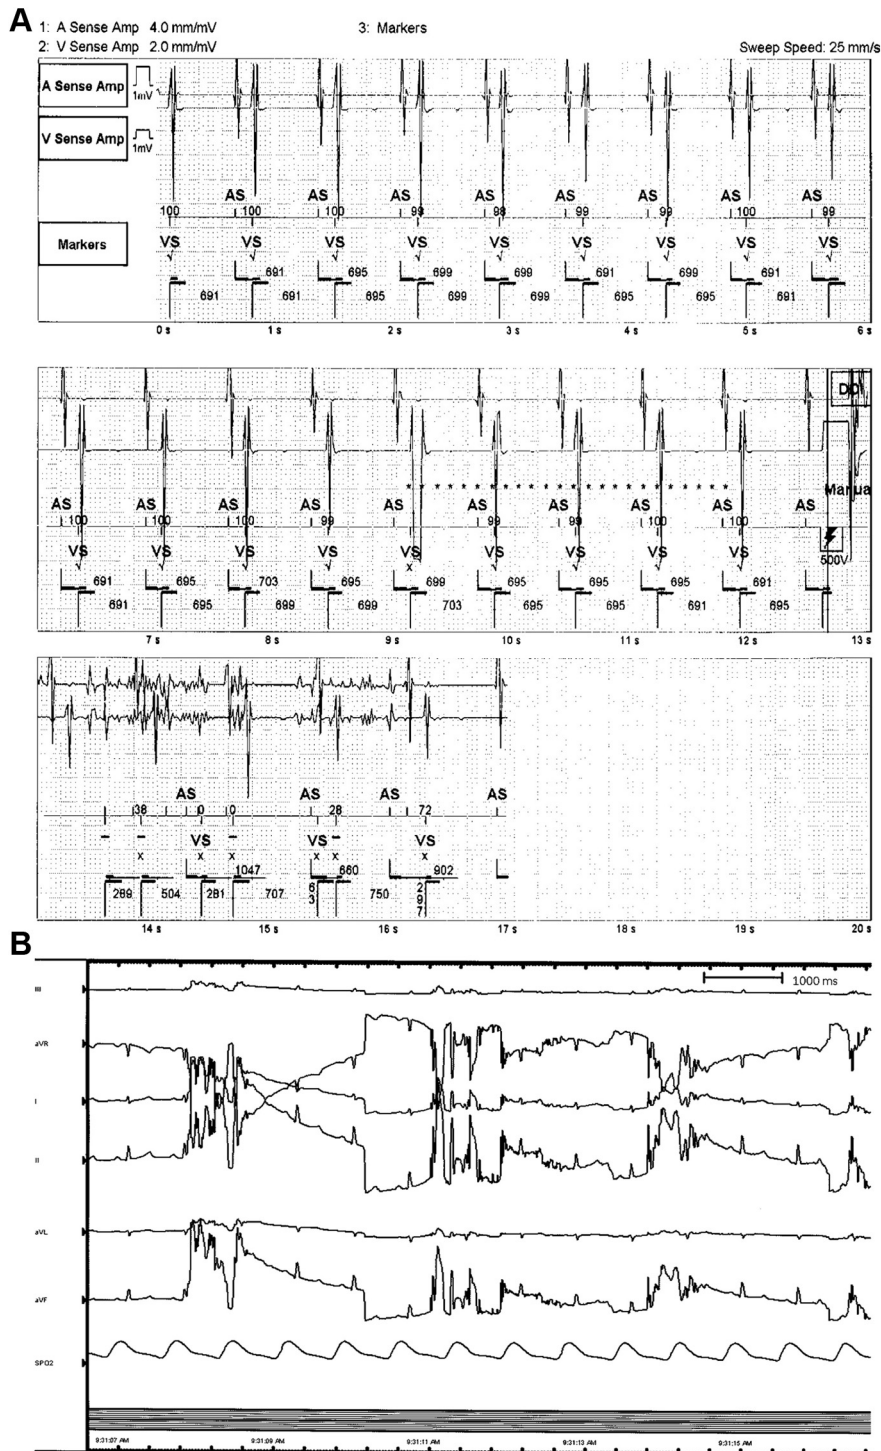
Figure 3 Noise recorded on **A**: stored intracardiac electrograms from the implantable cardioverter-defibrillator (ICD) and **B**: external electrocardiogram monitoring following a synchronized high-voltage shock prior to ICD explant at another hospital.

made to explant the entire ICD system and reimplant a new ICD at another institution specializing in lead extraction. To explore whether the ICD noise observed previously was reproducible, a synchronized high-voltage shock was delivered by the ICD at the beginning of the procedure (prior to explant). Following this shock, the same noise was seen on both leads (Figure 3A) and external ECG monitoring system (Figure 3B). The ICD generator and leads were inspected at

Unfortunately, we do not have a definite explanation for the noise, and bench-top and saline bath testing performed by the company failed to replicate the noise we have observed or identify the cause of the malfunction. The most plausible explanations are a short circuit involving the ICD generator and/or high-voltage component, or current leakage after a high-voltage shock. However, the ICD lead parameters appeared to be satisfactory when checked before and after the DFT, with normal RV high-voltage lead impedances.
