Case Report

Volar Locking Plate Breakage after Nonunion of a Distal Radius Osteotomy

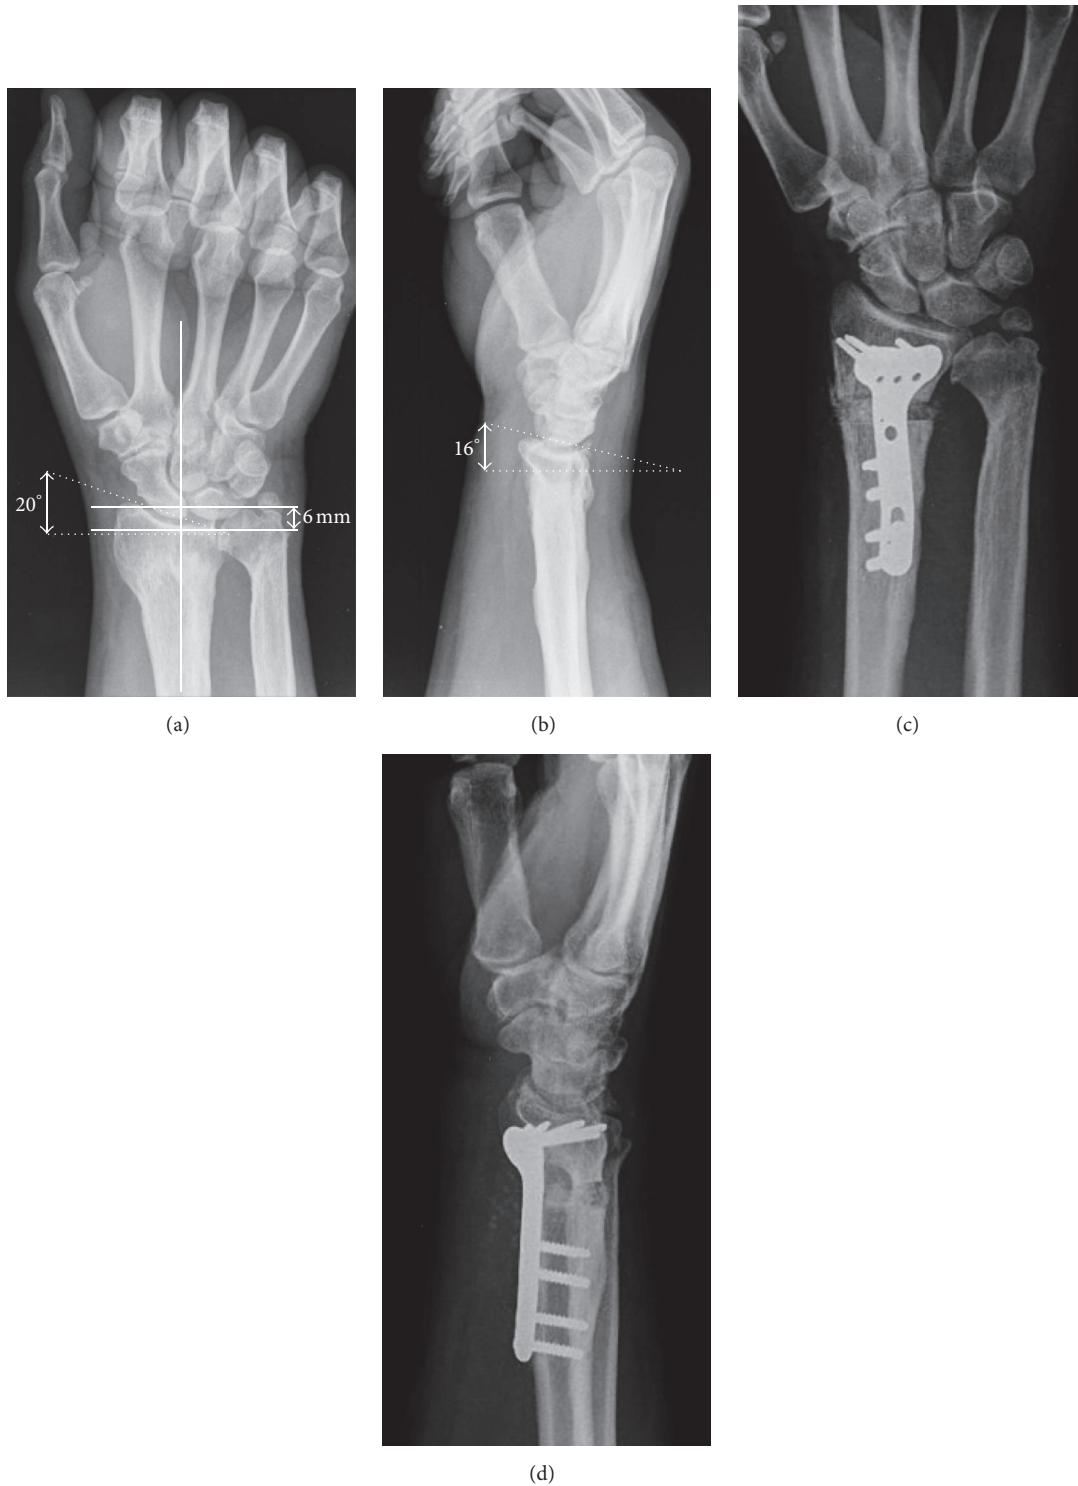
treated with a cast for a six-week period. Plain radiographs and computed tomography images showed distal radius malunion with a loss of volar tilt and radial inclination and positive ulnar variance (Figure 1). Volar corrective osteotomy and internal fixation with a stainless steel volar locking plate (VLP) (Trimed Volar Bearing Plate™, Valencia, CA, USA) were performed (Figure 1). Distal to the osteotomy, three angle-stable locking screws were used on the radial side and one cancellous screw was placed on the ulnar side. One nonlocking cortical screws and three angle-stable locking screws were used proximally. The osteotomy site was grafted with demineralized bone matrix (Allomatrix, Wright Medical Corporation). The postoperative radiographs showed an improvement of the palmar tilt and radial inclination from -16° to 2° and 20° to 22° . Ulnar variance decreased from 6 mm to 0 mm. Postoperatively, the forearm was immobilized in a plaster cast for 3 weeks before starting rehabilitation. Two months after surgery, the splint was discontinued all day

FIGURE 1: (a-b) Plain radiographs preoperative images showed DR malunion with a loss of volar tilt (-15°), radial inclination (20°), and positive ulnar variance (6 mm). (c-d) Postoperative radiographs showed DR osteotomy with a correction of volar tilt (2°), radial inclination (22°), and ulnar variance (0 mm).

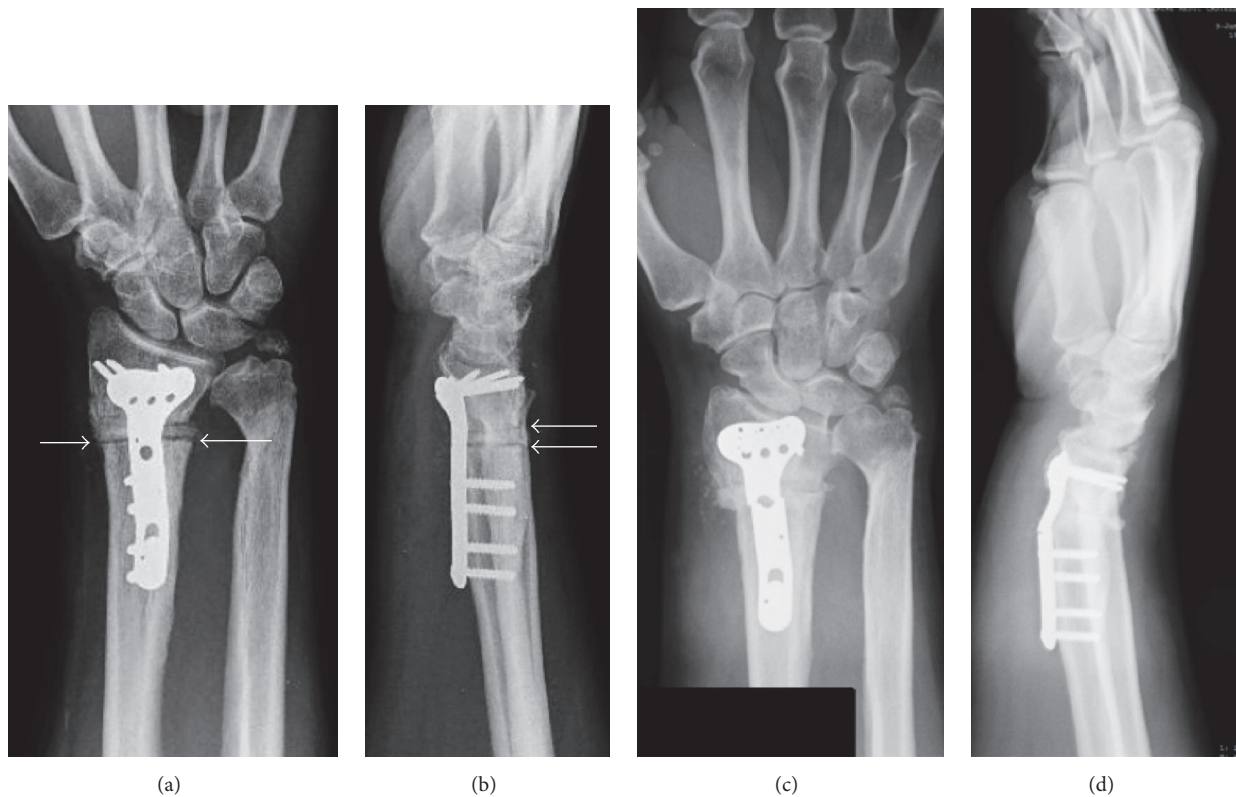
that the plate was broken through the unfilled screw hole at the osteotomy site and reduction was lost (Figure 2). Clinical examination revealed wrist tumefaction, shortening, and DR displacement. After ruling out infection, the patient was reoperated on, removing plate and screws. The nonunion

FIGURE 2: (a-b) Plain radiographs postoperative images at 3-month follow-up showed a development of radiolucent lines surrounding the graft at the osteotomy site (white arrows). (c-d) Plain radiographs postoperative images at 4-month follow-up showed plate breakage through the unfilled screw hole at the osteotomy site without plate bending or screw loosening.

we could not fill the last diaphyseal screw, was created after the large corrective lengthening osteotomy. Plate breakages seem to occur in the vicinity of unfilled screw holes, adjacent to the fracture or osteotomy site [1–4, 11]. A locking mechanism on the screws implies that they cannot loosen out of the plate, increasing the load on the plate itself. If the biological environment is not conducive to fracture healing, the forces through the implant are exaggerated. Additionally, this high-stress area corresponds to the “bend” on these precontoured plates. It is corroborated by Trease et al.’s experiment, in which they axially loaded both locked and nonlocked plate constructs in osteotomy models and found that these always failed through the unfilled screw holes at the osteotomy site [11].

Both biological and biomechanical factors need to be considered when deciding on the type and mode of plate, the use and the type of bone graft, and the duration of immobilization. In our case, plate breakage appears to have occurred as a result of a combination of multiple factors as the large corrective lengthening osteotomy, the use of demineralized bone matrix instead of bone graft, and the inappropriate fixation technique (unfilled screw on the osteotomy site), rather than the choice of plate.

was corrected and fixed with a longer stainless steel VLP (Trimed Volar Bearing Plate™, Valencia, CA, USA). Distal to the osteotomy, six angle-stable locking screws were used. One nonlocking cortical screws and six angle-stable locking screws were used proximally, filling all the proximal screw holes. The DR nonunion site was grafted with autologous iliac crest bone graft. The plaster cast was removed at six weeks and replaced by a removable splint, beginning physical therapy at that time. In addition, the material, including plate and screws, was sent back to the manufacturing company in order to analyze and detect any molecular material defect. None of these studies demonstrated anomalies in manufacturing process or metal composition.

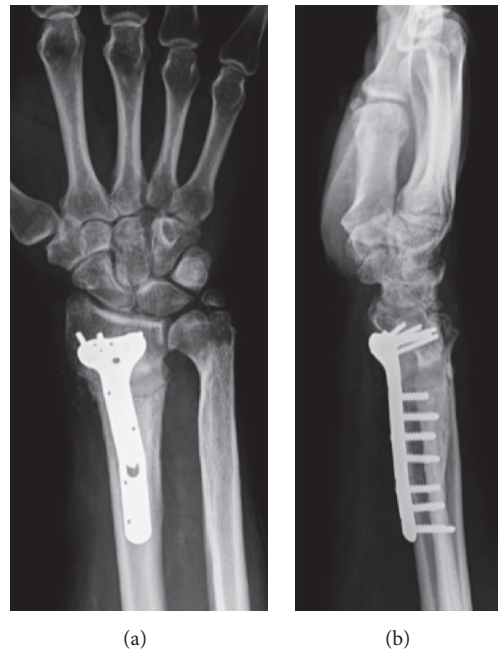
At the follow-up at eight months after the initial surgery, the fracture had consolidated clinically and radiologically (Figure 3). ROM was 60°–50° of flexion–extension and radial–ulnar of 15°–25°, all movements being completely painless. His grip strength was 80% of the opposite wrist and he restarted his job. One year after the last surgery, the patient remains painless and performs all activities.

FIGURE 3: (a-b) Plain radiographs postoperative images at 8-month follow-up showed DR fixation with a longer stainless steel volar locking plate.
