Cause of the “power-on reset” phenomenon other than electric magnetic interference in a patient with a pacemaker

Kyoichiro Yazaki^{*}, Masahiro Watarai, Mitsuru Kahata, Asako Kumagai, Koji Inoue, Hiroshi Koganei, Kenji Enta, Masato Otsuka, Yasuhiro Ishii

Department of Cardiology, Cardiovascular Center, Ogikubo Hospital, Tokyo, Japan

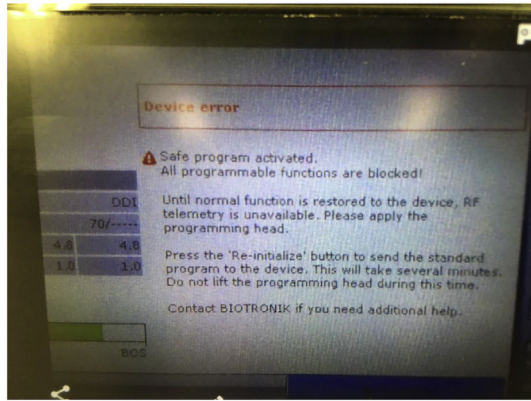
A 67-year-old man with a dual-chamber pacemaker (Biotronik, Etrinsa DR-T) implanted because of advanced atrioventricular block visited our clinic for a routine examination. After placing the programmer wand, an unusual message appeared (Fig. 1). We noticed

that the pacemaker had already been reprogrammed to the safe back-up mode of DDI with a lower rate of 70 bpm. We completed re-initialization to set a standard program for the device according to the guidance displayed on the monitor. Daily remote monitoring revealed that the measured pacemaker and lead function values were within acceptable limits and that sufficient battery life remained since the previous day (Fig. 2A). A 12-lead electrocardiogram (ECG) revealed atrial-sensed ventricular-paced rhythm just before the examination (Fig. 2B). Furthermore, there was no evidence indicating that the patient experienced obvious exposure to electromagnetic waves. We confirmed the absence of functional abnormality in the pacemaker and lead after re-initialization. This phenomenon has not recurred for at least 12 months.

Fig. 1. Device error alert. The monitor showed that the safe back-up mode had been activated just after placing the telemetry wand.

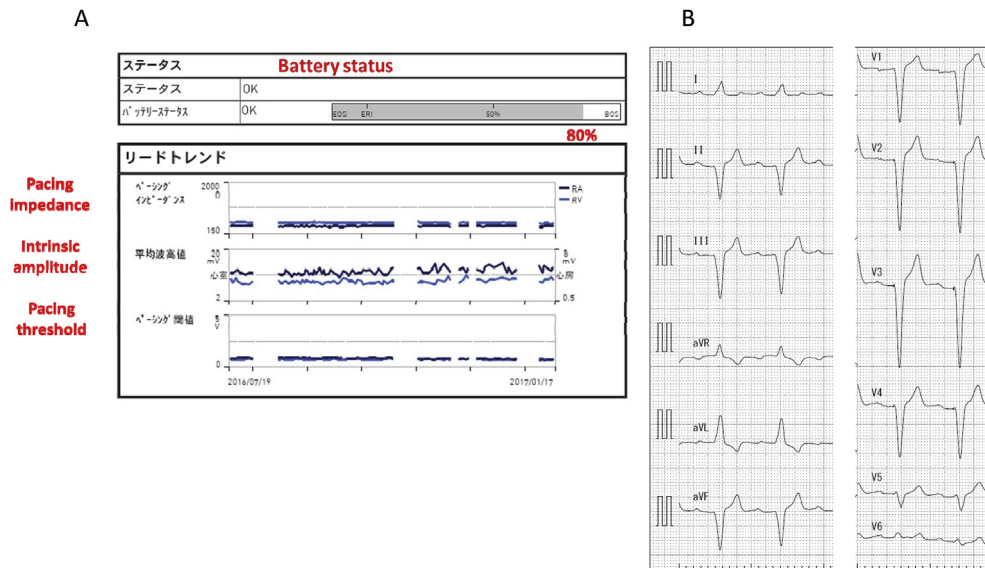
Fig. 2. Device monitoring and electrocardiogram results. (A) The results of daily monitoring the day before the examination. The 6-month trends of pacing impedance, intrinsic amplitude, and pacing threshold were within the normal ranges. The battery life was 80%. (B) A 12-lead electrocardiogram revealed the pacemaker working in the DDD mode just before the examination.
