Fire incidents in Bed-head panels: Causes and recommendations for prevention

Ashok Kumar¹, Raman Sharma¹, Rahul Jalaunia¹, Sameer Aggarwal²,
Rajesh Kumar³

Departments of ¹Hospital Administration, ²Orthopaedics, and ³Fire Officer, PGIMER, Chandigarh, India

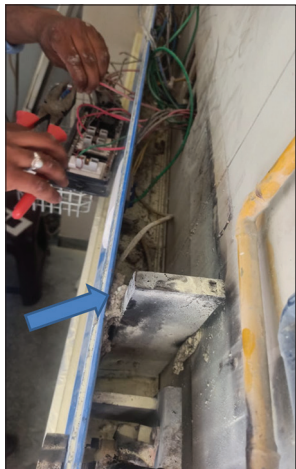
The engineering and manifold services also reported within minutes to inspect the site of the incident. The immediate cubicle was sealed for repair and root cause analysis of the incident. After thorough inspection and maintenance work and due clearance by the electrical, biomedical, and manifold departments of the institute, all services were restored. No casualty was reported. No major loss of property was reported. The *prima facie* after thorough inspection and inputs from all the stakeholders, it was totaled that the fire might have occurred due to a spark in one of the electric points of the panel which had initiated ignition in the lint already deposited in the point overtime and was augmented by the leakage of oxygen from the oxygen outlet in the bed-head panel itself [Figure 1]. A few such incidents have been reported by Sankaran K *et al.* in the Neonatal Intensive Care Unit (NICU) of the Royal University Hospital, Saskatoon, Canada, where the fire had been reported in the sealed cabinet enclosing the electrical wires and manifold

Figure 1: Bed-head panel

pipes and the reason of fire had been stated as a spark igniting lint, allowing the cabinet's relatively fire-resistant materials to burn easily.^[8] In the institute itself, two such fire incidents in the Bed-head panels have been reported earlier in the intensive care units (ICUs).^[11] In the institute itself, two such fire incidents in the bed-head panels have been reported earlier in the ICUs.

Henceforth, after detailed deliberations and fact-finding, it was accentuated that regular cleaning and scheduled maintenance of these panels are some of the key factors for mitigating such incidents. Also, measures shall be explored to have the panels with segregated electrical and manifold units.
