# A case series of anomalous high pacing lead impedances in normally functioning leads

Abdul R. Mourad, MD,<sup>\*</sup> Michael H. Kim, MD, FHRS,<sup>\*</sup> Malcolm M. Kirk, MD, FHRS<sup>\*†</sup>

From the <sup>\*</sup>Alpert Medical School of Brown University and Cardiac Electrophysiology Service, Rhode Island Hospital, Providence, Rhode Island, and <sup>†</sup>Cardiovascular Institute of New England, Cranston, Rhode Island.

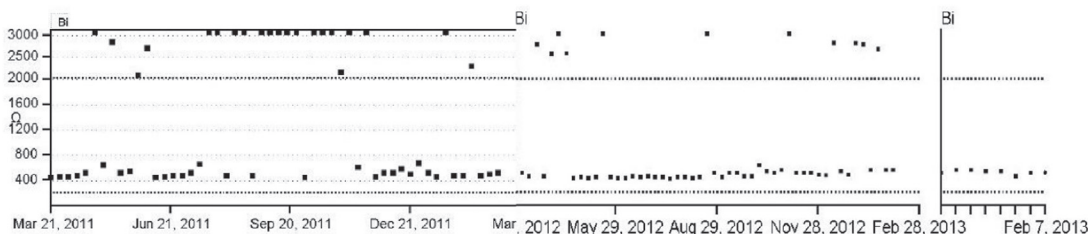
received a vibratory alert from his defibrillator about 5 weeks after implantation. Interrogation showed a single value of pacing impedance greater than 3000 ohms. The device was interrogated, and impedance was normal, as were all other functions of the device. A chest radiograph was obtained and appeared normal. Lead pins were fully seated in the header. No noise had been recorded on the ventricular lead. SJM technical services felt it was a sporadic event. Over the next 3 months, however, sporadic high pacing impedances continued to occur. Values between 2000 and 3000 ohms were seen periodically. High-voltage impedances were always normal. Interrogation in the office showed ventricular pacing impedance values ranging from about 500 ohms to 600 ohms. This finding continued to happen over the next 7 months. The abnormality was isolated to high pacing impedance values (2000–>3000 ohms) recorded through remote monitoring, but never at the time of in-office interrogation, and never high-voltage impedance abnormalities, pacing or sensing abnormalities, or noise on the lead (Figure 1A). We felt that the clinical picture did not suggest a true lead abnormality, but rather an abnormality within the generator. All downloads from the device were sent to SJM technical services. Eventually, technical services hypothesized that there could be a buildup of oxidation owing to the dissimilarity of metals between the Medtronic lead stainless steel pin and the titanium set screw of the SJM header block, causing sporadic high pacing impedances. This would explain why the same abnormality was not seen with SJM defibrillation leads, which have pins made of MP35N. The buildup of oxidation was hypothesized to occur in the absence of any pacing, which would dissipate it.

**Figure 1** Impedance trends from St Jude Medical Merlin remote monitoring for the 3 patients show variation in the pattern of sporadic high impedances. **A:** Composite impedance trend over the first 2 years for patient 1. Multiple high impedances are seen. **B:** A single high impedance value was seen in patient 2, a few months after he had been programmed to a mode that avoided ventricular pacing. A few moderately high impedances were also seen in this patient. **C:** Patient 3 had a single high impedance value occurring 27 months after implant.

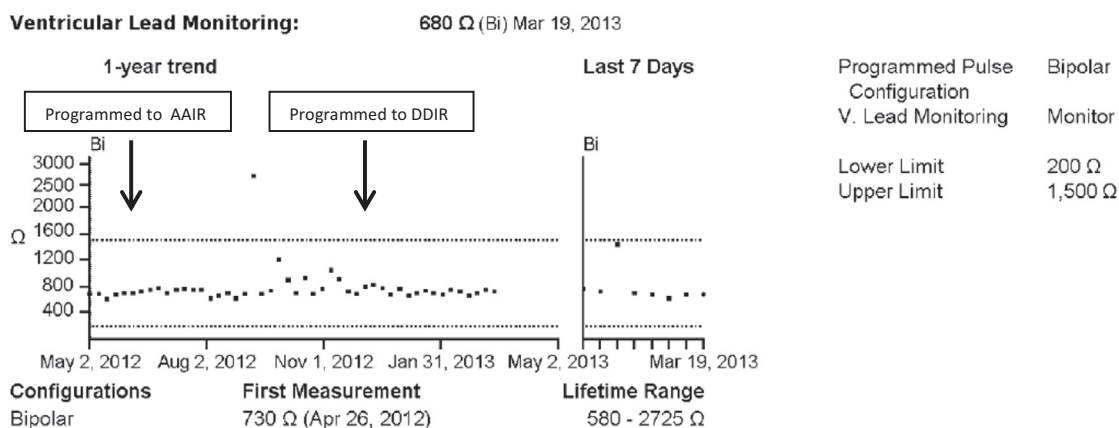
B

About 3 months later, an alert occurred for a single high pacing impedance value of 2725 ohms (Figure 1B). Subsequently, he was programmed back to DDI pacing, and high pacing impedance values were not seen, consistent with the hypothesis that the buildup of oxidation between the lead pin and the header block occurred in the absence of any ventricular pacing.

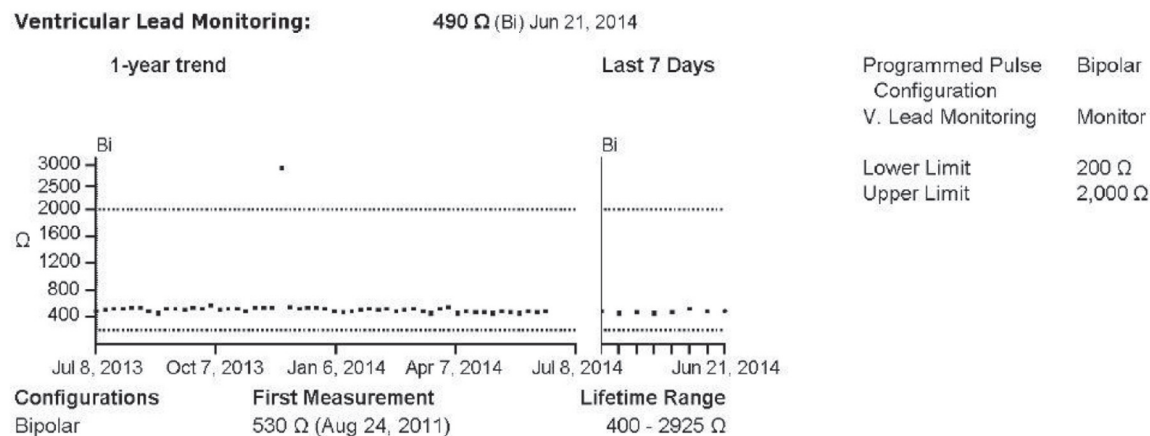
C

The third patient had an SJM Fortify VR implanted in August 2011. His ventricular lead was a Medtronic model 6935 lead. Twenty-seven months after implant (November 2013), he had an alert for a pacing impedance greater than 2000 ohms (Figure 1C). He was programmed VVI 40 with AutoCapture off at that time, with a 0% pacing burden. No abnormalities of the lead were found. This patient recently had a defibrillator generator replacement in December 2014. At the time of replacement, the lead was confirmed to be fully seated in the header and the set screws were tight. (The generator replacement was for early sudden battery depletion, which was not felt to be connected to the issue of sporadic high impedances. Testing of the explanted generator is currently pending).
